GEOMEMBRANE SYSTEMS IN THE NETHERLANDS AND ABROAD - RISKS AND LESSONS-LEARNED

ABSTRACT: This article gives an overview of risks and lessons learned about geomembrane constructions in The Netherlands and abroad. Subjects that will be discussed will include risk-assessments and quantification of risks regarding geomembranes, welding procedures, stability issues of slopes, backfill and retaining structures, installation damage by handling and weather circumstances, and external influences after completion. The aim of this paper is to emphasize an integral approach during the entire process and importance of acknowledging quality risks to all involved companies. The success of a watertight and durable installation will depend on an integration of design aspects, materials, construction issues and quality assurance. To avoid risks during lifetime attention shall be given to proper restrictions, maintenance issues and monitoring of leakage/durability. The article presents examples, to illustrate risks and lessons learned.

This article is supporting a specialty session at the Eurogeo6 congress Ljubljana (Slovenia) in September 2016. A full colour summarized version of this article is pu

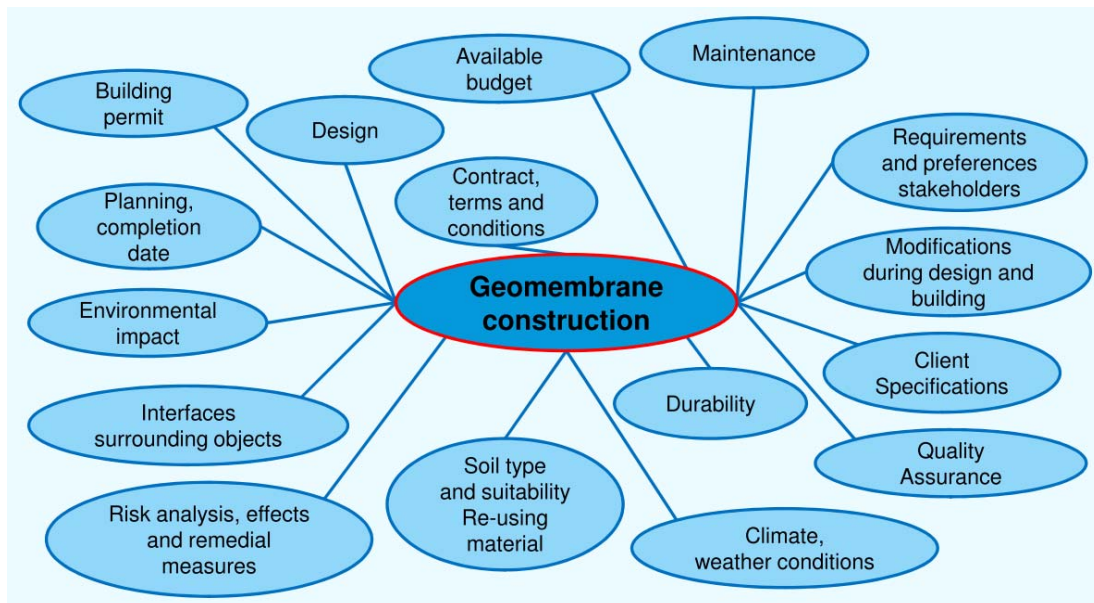
Figure 3. Notable issues for an integral approach locating the geomembrane in a central position [Gerritsen].

The issues shown in the sketch will influence decisions in the design and construction method. Explanation to the issues of an integral approach is given below.

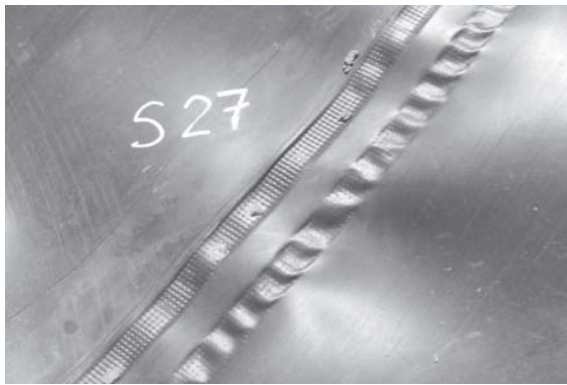
Figure 6. Example of poor nip roller tracking in a HDPE wedge weld [Scheirs]

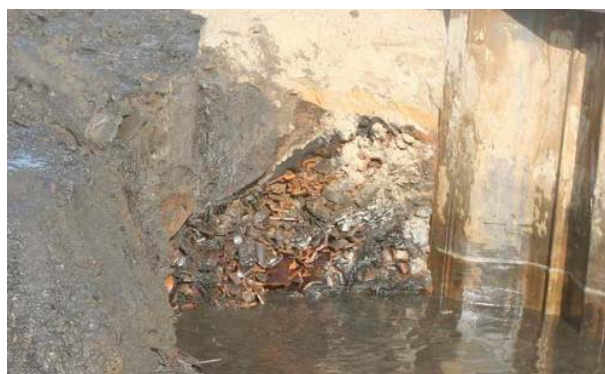
Figure 8. Presence of an un-expected dumpsite with ceramic material and environmental pollutions at a project site with a planned submerged geomembrane [Gerritsen].

Related to this issue many examples in projects are known, observing worse circumstances during the excavation or covering stage (see figure 8 and 9). In case these circumstances are neglected and no actions are taken, this can result in direct physical damage to the geomembrane.

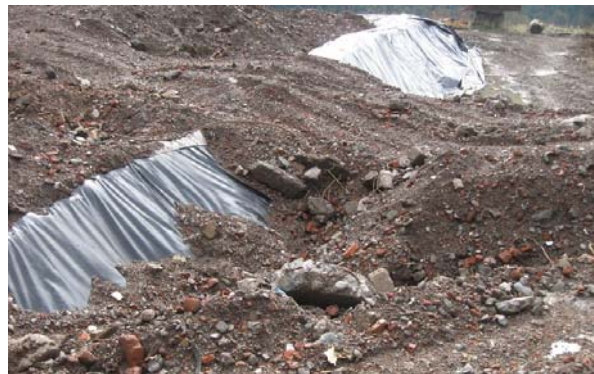
Figure 9. The presence of sharp/big stones without protective geotextiles will significantly increase the risk on damaging the geomembrane [Gerritsen].

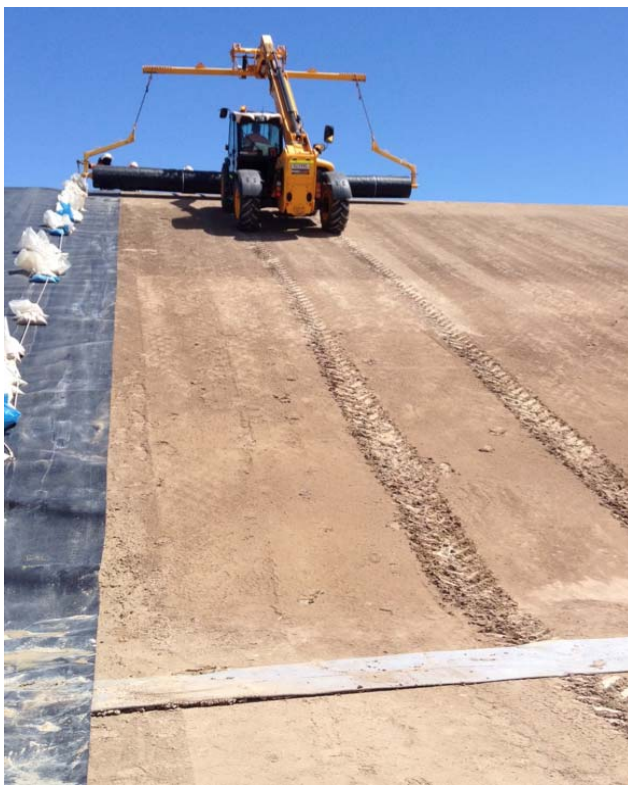
Figure 11. Unacceptable damage to sub grade and improper working method by construction equipment [Scheirs]

The subsoil on which the geomembrane will be installed needs to be clear from sharp subjects which may puncture through the geomembrane. In figure 10 to 12 several examples are given of unacceptable sub grades. The starting point for suitability of soil material adjacent the geomembrane shall be that the material is free of admixtures with sharp stones, desiccated sub grade, boulders, concrete blocks, tree roots, construction waste (wood, beams, steel rebar, nails, piles, drainage or sewage pipes, foundation materials etc.). In case of building in urban areas with a long history or reconstruction works it can be presumable the excavated soil and surface will not be clean enough. In case of admixtures the material can be mechanical sieved by on plant installation or sieving equipment (see figure 13). In case the sand material has a lot of fines (problem of reaching the required degree of compaction) the fines can be removed. The same extraction can be done by presence of too much coarse material (gravel/boulders).

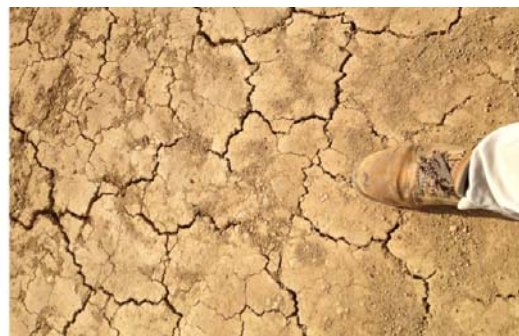
Figure 10. Unacceptable desiccation of clay sub grade [Scheirs]

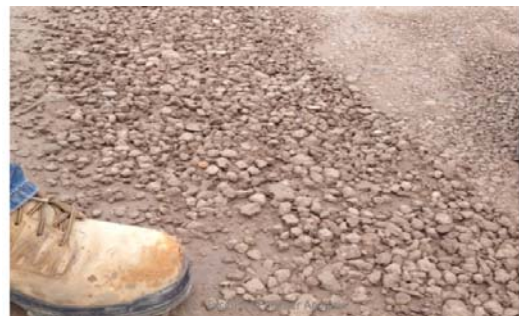
Figure 12. Unacceptable sub grade for direct (HDPE) geomembrane installation [Scheirs]

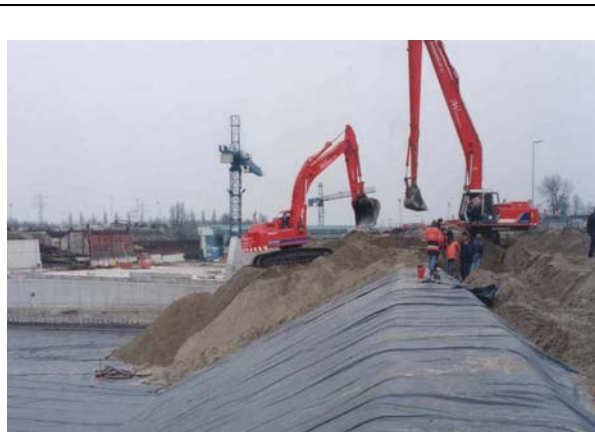
Figure 15. Risk to instability soil backfill and severe damage geomembrane, using a wrong backfill sequence at the geomembrane structure [Ref. Dutch directorate for public Works and Water Management]

The presence of groundwater is affecting in a prior case the stability of slopes and retaining structures. Groundwater can be seen as a ‘sneak murderer’ for building pits, so also in the construction of geomembranes. The conditions of groundwater are of major importance, and also the proper working of dewatering devices (deep wells, filters, etc.). In case the dewatering devices (pump generators) fail, a quick build up of water pressure can occur, this can cause severe problems to the stability of geomembrane construction. Also excessive rainfall can lead to problems by rapid increasing groundwater levels, exceeding the design water levels or overflow of the working area. Another failure mechanism can be leakage through retaining walls (sheet piles). In the Netherlands several cases are known of groundwater conditions which damaged the excavated slopes or already installed geomembrane structure during the construction process (see figure 15 and 16). These situations are unintentional.

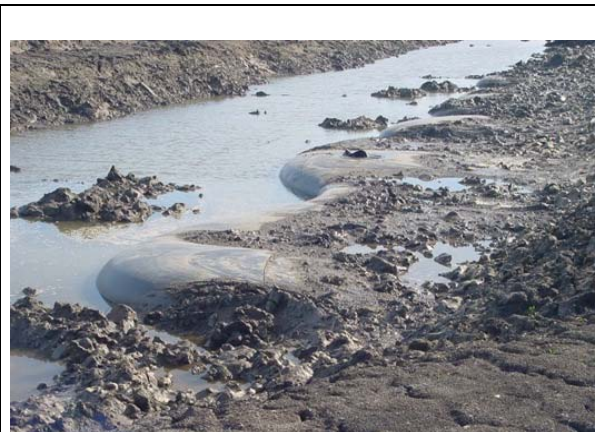
Figure 16. Geomembrane whales due to uplifting water pressure below the geomembrane related to improper backfilling levels [Genap].

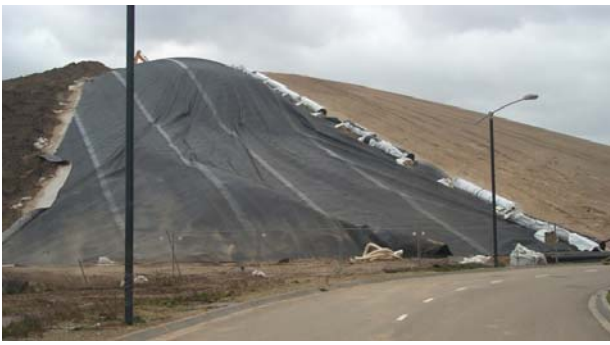
<p>Figure 17. Low temperature with frost during the unpacking and installation of a PVC-p geomembrane given delays around wintertime [Gerritsen].</p>	<p>Figure 18. Major effect of wind influence at an uncovered geomembrane field, causing intense safety risks for personnel and quality issues to the geomembrane [Gerritsen].</p>

Wind may influence the quality as well since a firm wind blow may blast away the uncovered geomembrane. The geomembrane should not be installed during high wind speed > 5 Bft and assure sufficient back fill after unrolling before final back fill is placed. In case of suddenly strong or increasing wind speed, this can cause intense safety risks for personnel and quality issues to the geomembrane (see figure 18).

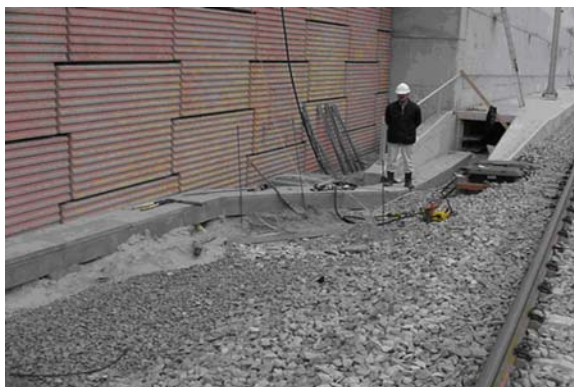
Figure 23. Geomembrane perforation below a underground railway track by installing earth pins for de-electrification [Dutch railway authorities]

Damage/puncturing geomembrane by human activities is a likely cause for damage. The existence of a barrier is often ‘forgotten’. Examples can be drilling, digging and foundation works. Examples are available of placing foundations for a large advertising column through a geomembrane liner. Also planting trees can harm the integrity on the long term. For the first years trees are small, but after 10-20 years the root systems can be enormously wide and deep. Another example is the geomembrane perforation below an underground railway track by installing earth pins for de-electrification (see figure 23). For this case several tests and evaluations have been carried out to find the best solution, knowing removing the pins, injection techniques or maintain the pins at location (perforated). From a test set-up it was concluded the best way was to maintain the pins, knowing a minimum of leakage.
