Stability analysis of the old sanitary landfill slope reinforced with HDPE geogrid after a long time of service

ABSTRACT: The paper presents analysis of geotechnical parameters of waste material and strength parameters of HDPE geogrid reinforcing a landfill slope, after a long term of exploitation. Geogrids are used particularly where forces interact in one direction in reinforced earth structures such as road embankments and steep slopes. The main purpose of a geogrid installation on a slope is the improvement of slope stability and bearing capacity of the subsoil. The geogrid installed in a landfill is exposed to the mechanical and chemical factors (e.g. changes in a wide range of pH and high temperatures) as well as to the different weather conditions. To investigate the influence of the geogrid parameters changes in time, the analysis of slope stability were performed. For the purpose of the geogrid parameters changes in time, the samples were excavated from the landfill slope and analyzed in the laboratory. The tests characterised material properties, geometry determination and also the mechanical properties - tensile strength and strain measurements. Obtained results were co

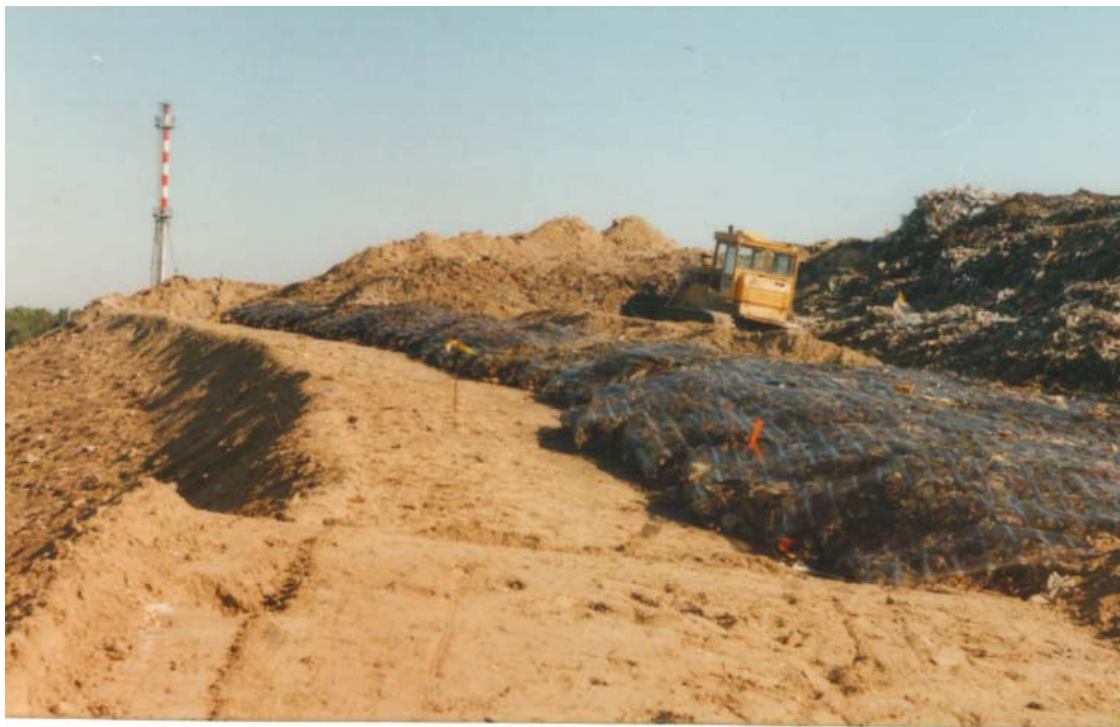
Fig. 2 The process of geogrid installation on the landfill (1993)

The main objective of the reclamation works was to allow as much as possible disposal of municipal waste on the landfill. However, due to the composition of the ballast waste, which did not meet the filling material specific requirements, a new method of compaction and slope filling was adopted. The reason for that was to basically make the material useful for a road embankment construction. Based on the waste mechanical characteristics (high compressibility) and compaction difficulties (recompression effect after compaction), the decision on mixing the waste with well graded material was made. The sub-base of the road was constructed in layers. For a single compaction, a layer of 0.6 m of ballast waste and 0.3 m layer of sand were compacted. The compaction was achieved by using 10 runs of 13 t padfoot compactor (vibrations 2200 rpm), improving the waste-sand mixing (Fig.2).

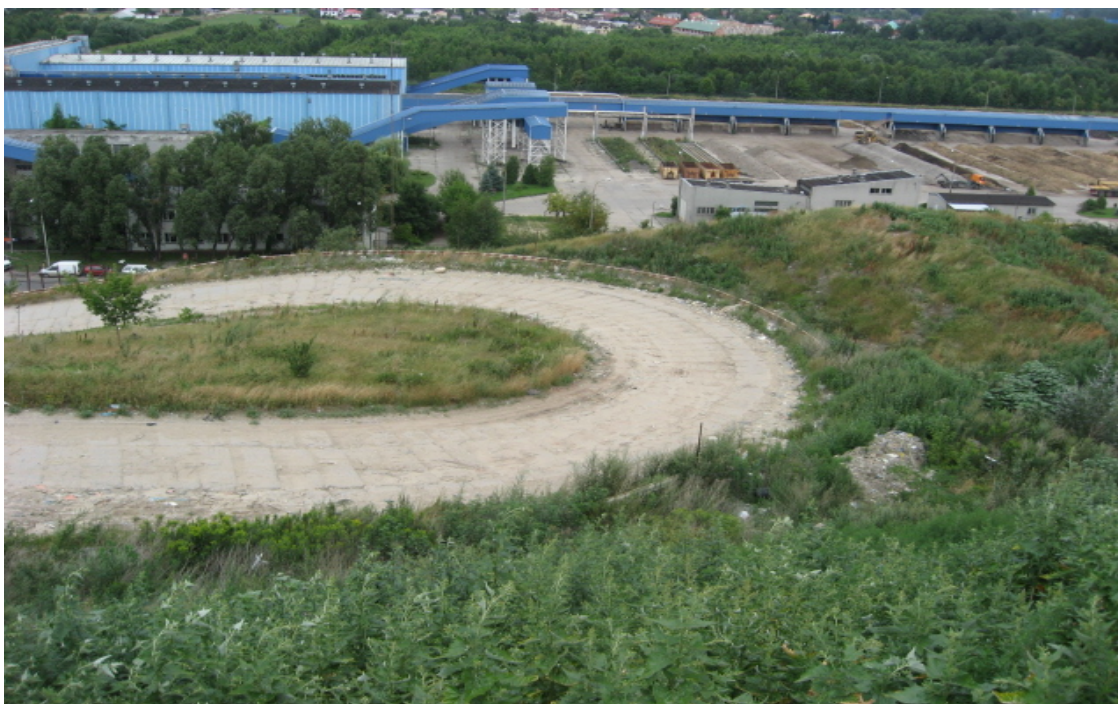
Fig. 3. The access road on Radiowo landfill in 2013

In November 2013 three samples of geogrids were collected from the landfill after 20 years of exploitation (sample size: length about 1.20 m, width approximately 1.0 m). The samples were excavated from the first layer of the structure (Fig. 1) located at the access road to the landfill (Fig. 3).

In this particular location the HDPE geogrid is exposed not only to the chemical and environmental impacts but also to the mechanical load, caused by the slope itself and loading of the incoming trucks filled with waste. The samples were extracted using mechanical diggers. They were removed from the edge of the road near the concrete slabs. Also the top layer of sand and waste was excavated in the same way. However, in this case the process was stopped when the distance of 0.3 m from the geosynthetic was reached. Then excavation was continued manually by using a shovel to avoid damaging of the geogrid. The sampling location is presented in figure 4. After the sample was excavated it was carefully raised and laid between two films of black PE and transported to a laboratory for further testing.

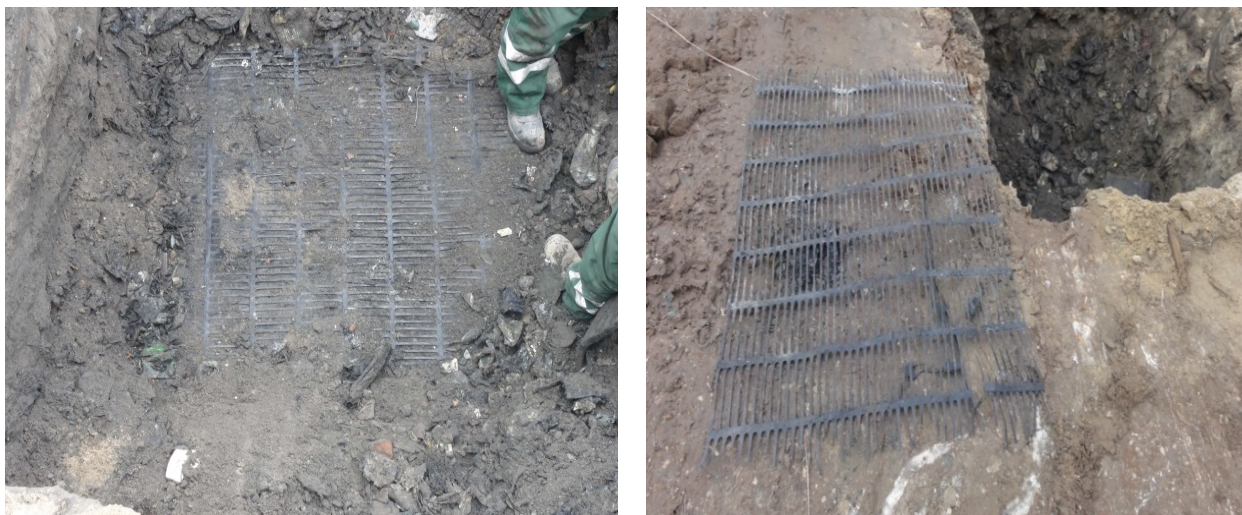
Fig. 4. Geogrid HDPE samples collected after 20 years of service

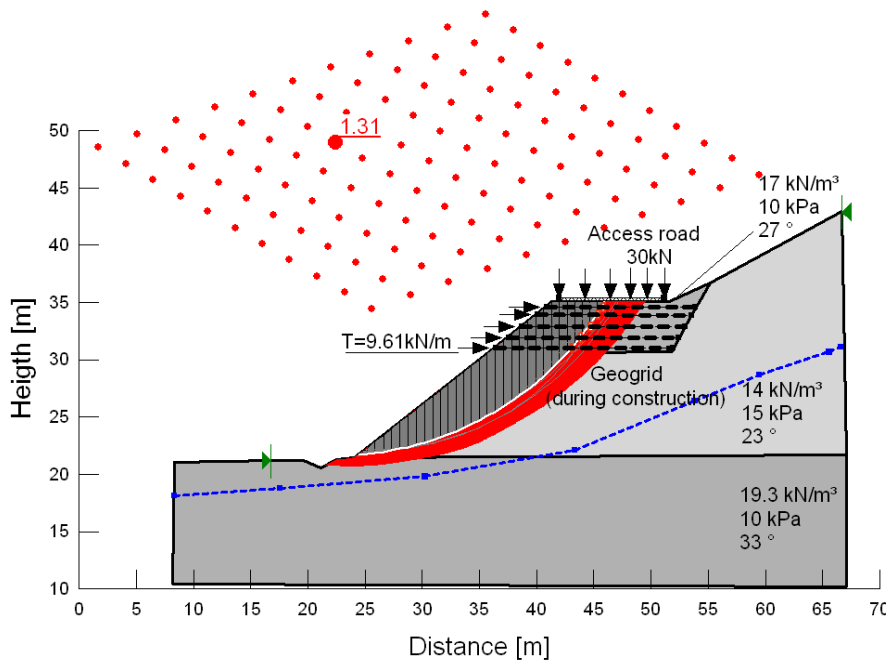
Fig. 5. Slope stability analyses for newly built geogrid, of nominal tensile strength of 9.61 kN/m

For the purpose of estimating the influence of geogrid strength, changing over time on the landfill slope, the analyses of local stability were performed. There were two scenarios considered. One when the slope is reinforced with newly built in geogrid and another for conditions where geogrid was exploited on the landfill for 20 years. The analyses (Fig. 5 and 6) were performed by using LEM. For the first case (Fig. 5) the strength parameters for the geogrid were applied as recommended by the supplier: 9.61 kN/m -long term strength (Tensar. 1990). For the latter scenario the factor of safety was computed based on the actual geogrid tensile strength, determined in laboratory using samples excavated from the slope after 20 years of its exploitation (Fig. 6). The geotechnical parameters of the filling material were adjusted and increased due to compaction and sand mixing of the waste. New parameters were as follow: for technological road sub-base: $\gamma = 17 \text{ kN/m}^3$, $\phi = 27^\circ$, $c = 10 \text{ kPa}$, and for waste filling the slope: $\gamma = 14 \text{ kN/m}^3$, $\phi = 23^\circ$, $c = 15 \text{ kPa}$. The parameters of the subsoil remained unchanged. The computed factor of safety for two considered cases were $F = 1.31$ and $F = 1.45$ respectively, for the geogrid of nominal tensile strength 9.61 kN/m and for laboratory tested value of 42.63 kN/m.

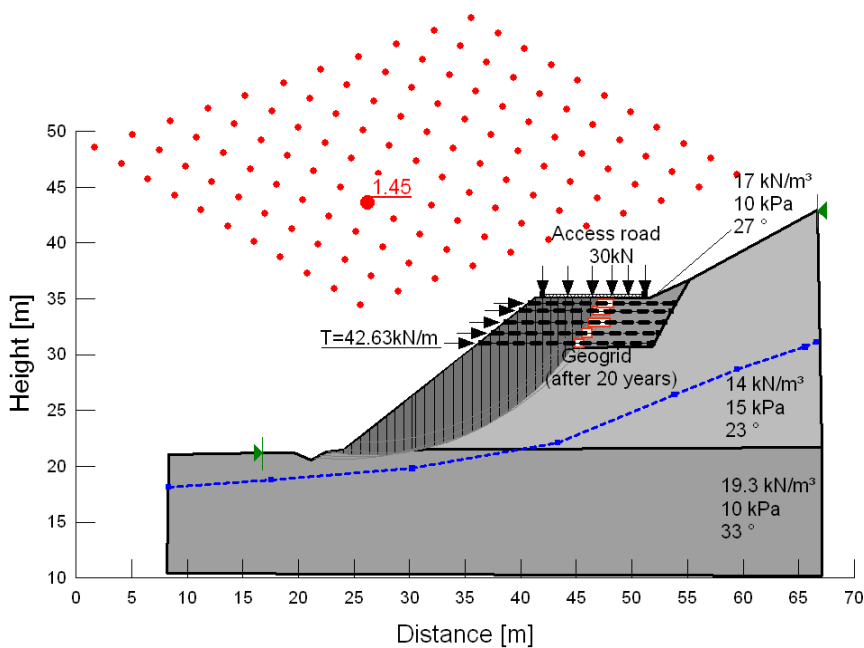
Fig. 6. Stability analyses of the slope reinforced with geogrid after 20 years of exploitation (measured tensile strength of 42.63 kN/m)

The paper presents also the analyses of reduction factors and determination of long term tensile strength of geogrids, according to the most recent recommendation given in EBGEO and also to nominal values provided by the material suppliers in early 90's. The mean short term strength for HDPE geogrid samples was determined in laboratory conditions. On this base the overall values of reduction factors for geogrid exploited for more than 20 years on Radiowo landfill were calculated. Moreover, the slope stability analyses for the reinforced landfill slope applying modified geogrid tensile strength and geotechnical parameters of filling material were presented. The research revealed that the factor of safety increased as much as 10 % after 20 years of landfill exploitation. Based on the laboratory tests and numerical computations the conclusion is that a careful and reasonable determination of reduction factors for reinforcing materials is crucial, especially for such hazardous environment of serviceability. The research showed that the tensile strength of material used in the study has not yet been exceeded and assures safe exploitation of the technological road in the future.
