Protection of Pier Foundation of Zhongsha Bridge at

Zhuoshui River

ABSTRACT: Zhongsha Bridge located at Zhuoshui River is part of Sun Yat-sen Freeway, the traffic artery in Taiwan. Over the years its pier foundations were exposed because of continuous erosion and deposition. The farmland on the river bank adjacent to the bridge was also in great danger due to the floods in typhoon seasons. With a view to solving the problems, geotextile tubes ACETube[®] were used to build a multilayer structure to fortify the pier foundations and enhance the embankments with geotextile mattresses ACEFormer[™] covering the surface of the geotextile tubes to prevent them from external damages. The construction method with geosynthetics reduced concrete and made good use of in-situ sand and soils which proved to be eco-friendly and cost-effective.

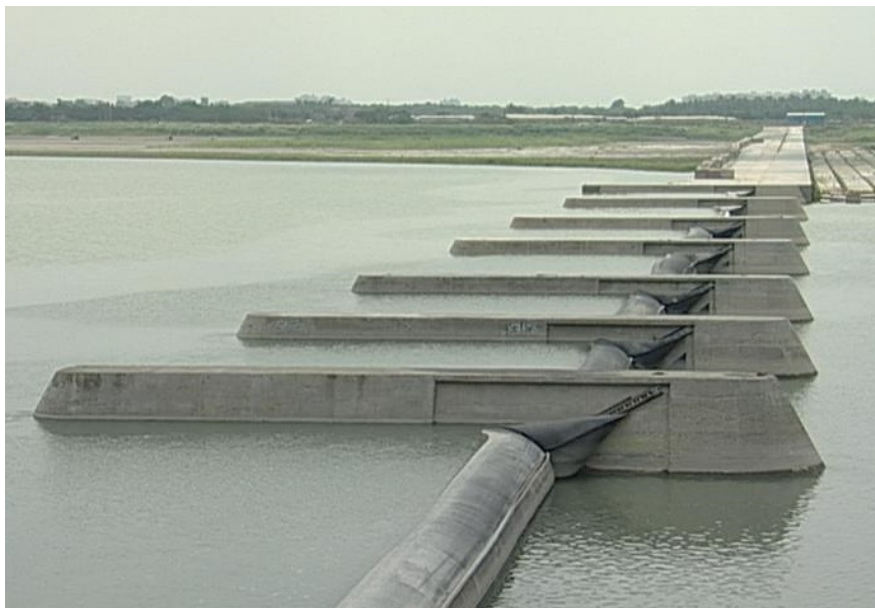
Weirs (Fig.2-1) by the traditional method are commonly built to alter river flow and treated as a barrier composed of concrete blocks, among which reinforcing bars are used as connection materials. In most cases, weirs are built on certain positions based on riverbed height. One of weirs functions is to protect riverbeds and to maintain groundsill of rivers.

Fig. 2-1 Weir (photo by website)

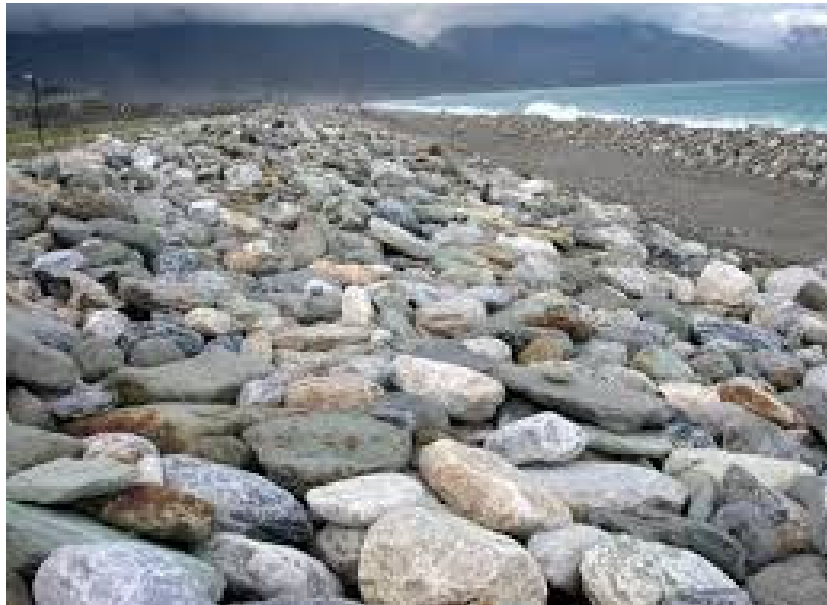
Other regular traditional methods are Riprap protection (Fig.2-2) and Gabion protection (Fig.2-3). Riprap is made from rock or other materials such as concrete blocks and pebbles used to armor shorelines, streambeds or bridge abutments so that it may take the form of protection. The main concern while design is weight of riprap rocks. In other words, strength of protection mainly depends upon weight of riprap rock. We must take both riprap sizes and flow velocity into consideration if Riprap method is used for protection projects.

Fig. 2-2 Rip-Rock (photo by website)

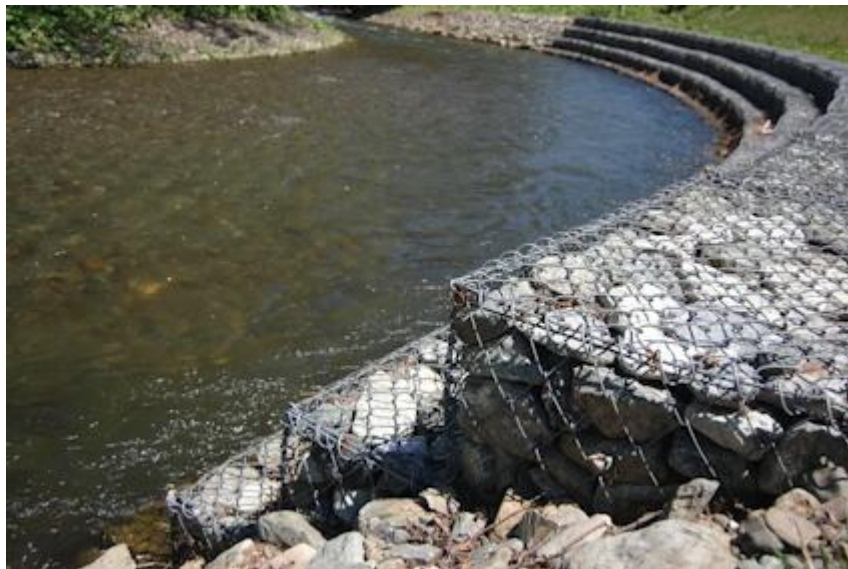
A gabion made of galvanized steel wire is something like a cage or box filled with rocks, concrete or pebbles. Gabion walls and gabion baskets are used to stabilize the slope, riverbanks or shorelines against erosion. It is so-called Gabion protection method. Strength of a gabion depends on the steel wire with the characteristic of flexibility. When erosion occurs in stream beds or bridge abutments, gabions may deform due to outside instability and structure weight so that the gabion structure could prevent further erosion from river flow.

Fig. 2-3 Gabion (photo by website)

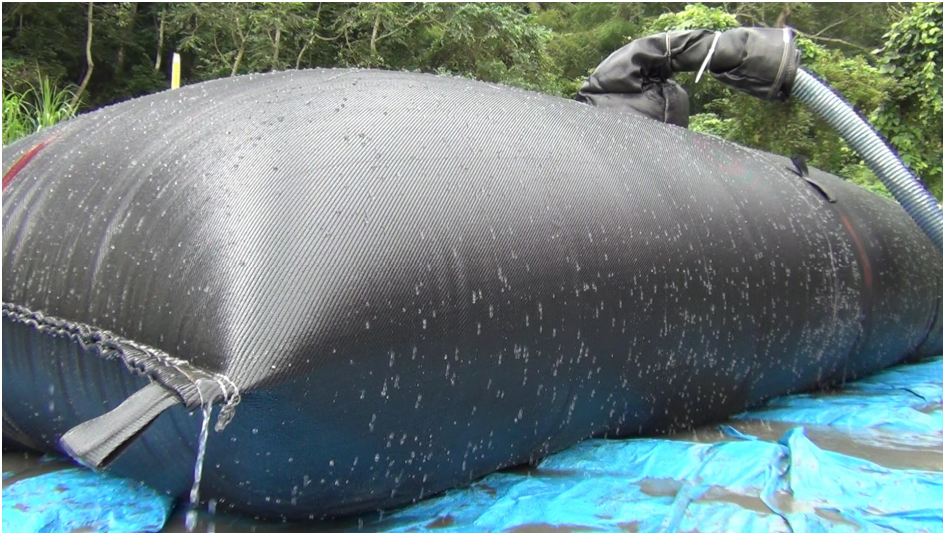
Revetment protection with Geotextile tube as Fig2-4, *ACETube[®]* is made of high-strength synthetic fabric. In order to maintain an environmental scenario, it is an eco-friendly way to take advantage of in-situ resources. While *ACETube[®]* is filled with in-situ soil (river sand, sea sand or sludge), it not only can stabilize the embankments, but also prevent shoreline erosion from water flow or waves. Thanks to the characteristics of high permeability, acid-alkali and UV resistance on geotextile, *ACETube[®]* can be treated as a semi-permanent structure. These advantages make long-term use possible.

Fig 2-4 ACETube®

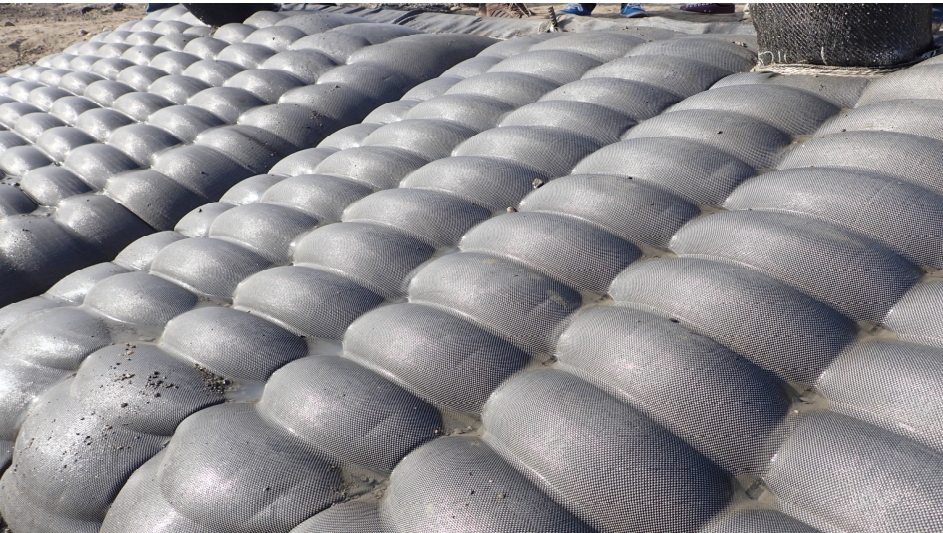
Revetment protection with Geotextile Mattress as Fig2-5, *ACEFormer[™]* is made of high-strength synthetic fabric. Two layers of woven fabric are sewn to form a tube-like structure. *ACEFormer[™]* has various advantages, such as: high permeability, high strength, simple installation, easy to move and so on. *ACEFormer[™]* can be filled

up with concrete at low pumping pressure and installed based on in-situ terrain to form a slope-protection or shoreline protection structure.

Fig 2-5 ACEFormer™

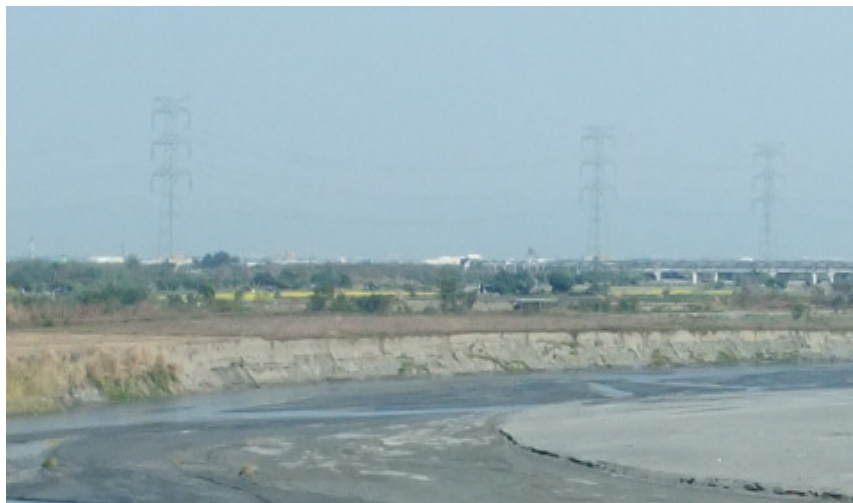
Before construction, the bridge abutments were built in the high beach which was directly eroded by water flow (Fig3-2). However, the beach was being eroded for a long time because there was no protection structure for the abutments. Erosion made the beach line closer and closer to the embankment. It not only affected resident safety, but also caused damage to the crops. The traditional method with gabions was adopted for the shoreline protection. In the beginning gabion-protection did work. However, long-term erosion by typhoons and flood in the downstream of Zhuoshui river lead to the high beach ground sill collapse, and consequently it produced a bridge scour around abutments and caused embankment instability. Just as Fig3-3 shows, it did cause gabions deformed due to scour, and the structure was damaged as well.

Fig. 3-2 Erosion by Flood

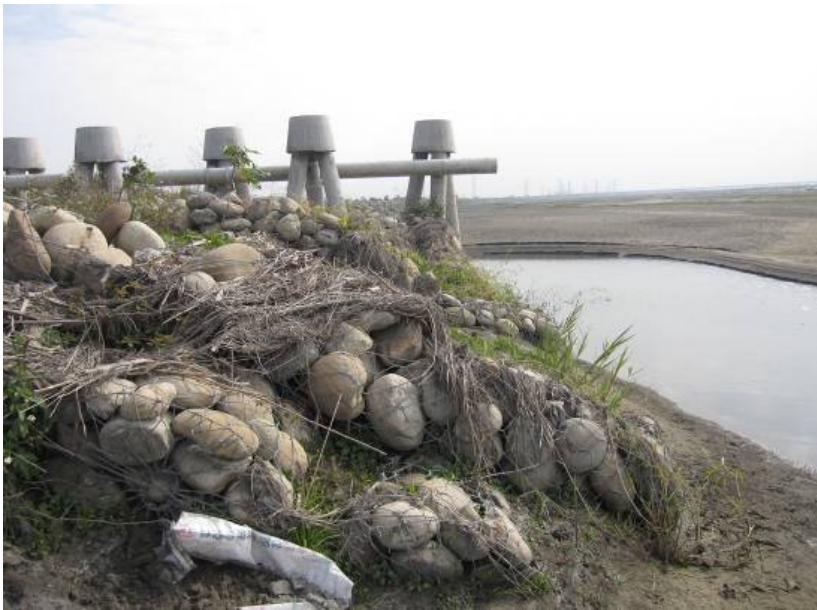
Fig. 3-3 Gabion Failure

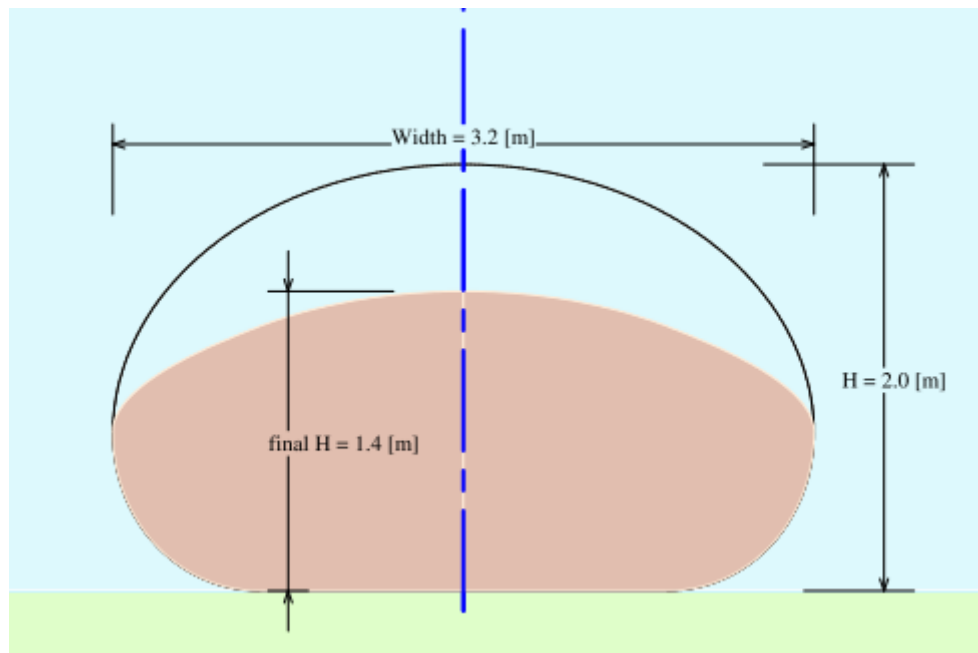
According to in-situ terrain, analysis was made by GeoCops software to design ACETube[®] with circumference 8.6m and parameters were assumed based on properties of in-situ filling materials. Filling height of each ACETube[®] can reach 1.4m as Fig.4-1 shows. 4 layers of ACETube[®] must be stacked to reach required height 5.6m. Between layers in-situ gravel was paved evenly, and then covered with a layer of geotextile. Stacked ACETube[®] make not only the filling materials compact, but also structure stable.

Fig. 4-1 Analysis Result (by GeoCops)

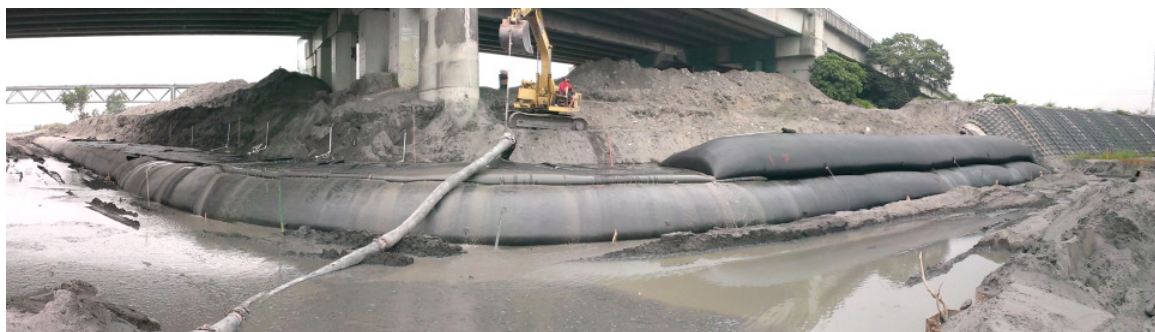
ACETube[®] can be used for Near Natural River Construction. This case is located in a meander. Therefore construction was completed in a bend of the sinuous Zhuoshui river. It caused many difficulties under construction. More anchors were required for fixing ACETube[®]. Besides, pumping velocity might change according to practical conditions. As Fig. 4-2 shows, after filling, ACETube[®] forms a near natural bend with the local terrain.

Fig. 4-2 Construction (Curve Section)

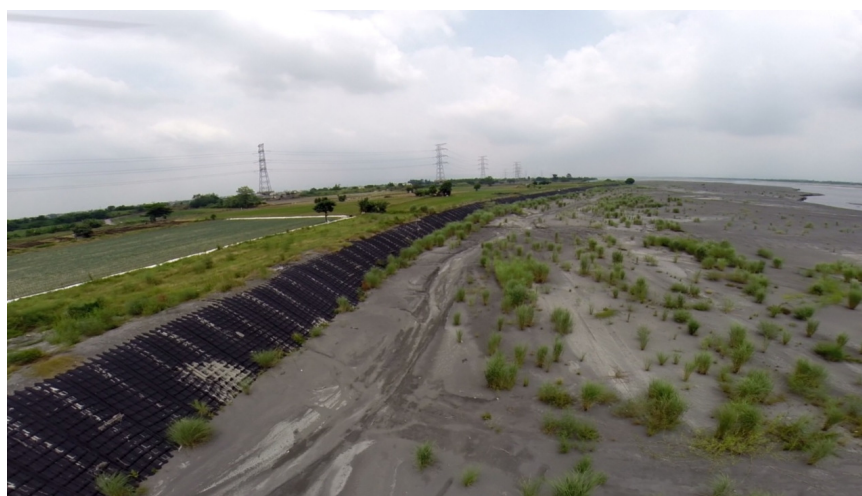
After ACETube® had been filled, then ACEFormer™ would be paved on them. The paving method shows as Fig.4-3. On the top of the structure, ACEFormer™ needs fixed with anchors that were buried in 60 cm deep ditches. The top of ACEFormer™ should be installed under the foundation not less than 2m from erosion. One of ACEFormer™ Properties is permeability. Besides, after filled with concrete, the outside forms as a protective coat as an armor layer from damages of driftwood. The most important thing is that ACEFormer™ not only can protect groundsill of the bridge abutments, but also promote safety of the structure. Filling material of ACEFormer™ is concrete mortar which can strengthen impact resistance from outside collision damage. After construction, as Fig.4-4 shows. The structure obviously can prevent from flood erosion. As a result, it also makes sediments more effectively on the riverbed. The additional value is to make river improvement easier.

Fig. 4-4 After Construction by ACEFormer™

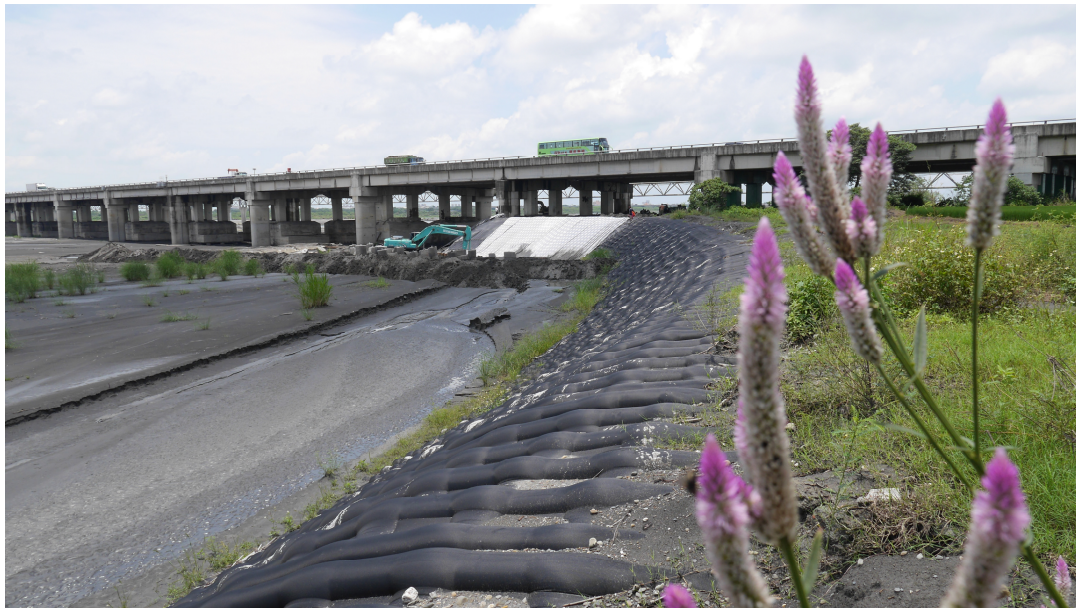
Meanwhile, the flexibility of these materials makes them adaptable to different kinds of landforms and site conditions. It not only makes construction much easier, but also helps the structures co-exist with the environment as Fig5-1. Even typhoons that bring disastrous floods were not able to cause any damage to them.

Besides, the completed structures are good for aggradation. It shows erosion is under control. On the fertile newly-formed land even luxuriantly grows vegetation that makes the site blend with the surroundings.

Fig. 5-1 Currently Landscape
