Comparative monitoring of a Geocomposite Drainage and a draining mask : 2-year-data analysis and moving forward

ABSTRACT: French site of one of the new high speed train line was equipped with temperatures and water content sensors, and with flow rate monitoring, in order to compare two techniques to ensure slope stability : traditional matter using granular materials and an alternative solution using a draining geocomposite. This paper presents the way the instrumentation was installed, and how this experimental site was monitored in order to follow the behavior of the geocomposite, the evolution of the flow during seasons, with respect to the traditional way, and to appreciate any potential clogging. Results show that both techniques project grounds below from rain infiltration and frost, that water occurrences are drained, with a distinction between the two techniques. In order to appreciate clogging and stability problems, the experiment must be followed with material improvement, such as increasing the battery life time or autonomous power supply.

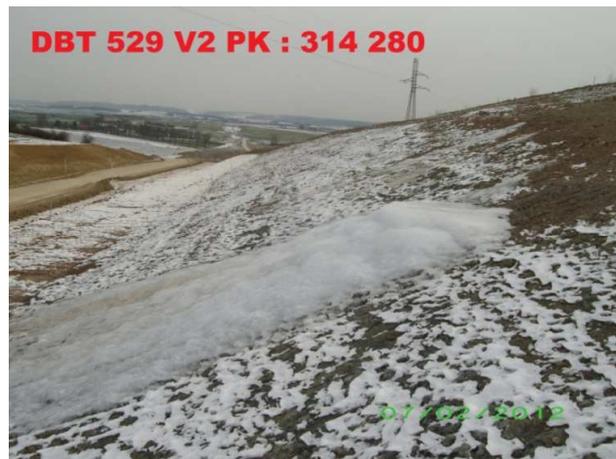
Figure 1 : frozen water occurrences (source: Eiffage)

For safety reason, the site with all instruments was selected far enough from the future tracks, in the upper part of the bank. The locations had to present enough water inlets to allow flow rates measurements. Such locations have to be homogeneous between each other to ease further comparisons of the results. The selected zone compliant with these conditions was bank DBT 529 of batch 35 of the high speed track (LGV Est), near Morhange. These areas had been identified by Eiffage TP as soon as February 2012, while outcoming water froze. General views of the studied site are illustrated in Figures 1 to 3.

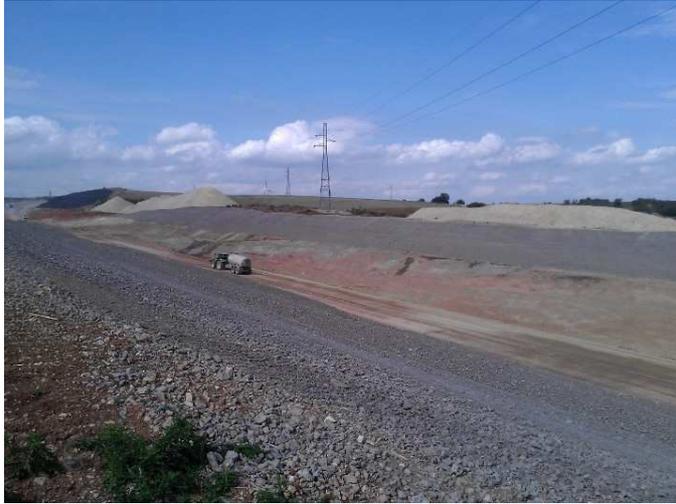
Figure 2 : general view in 2012 (source: Cerema)

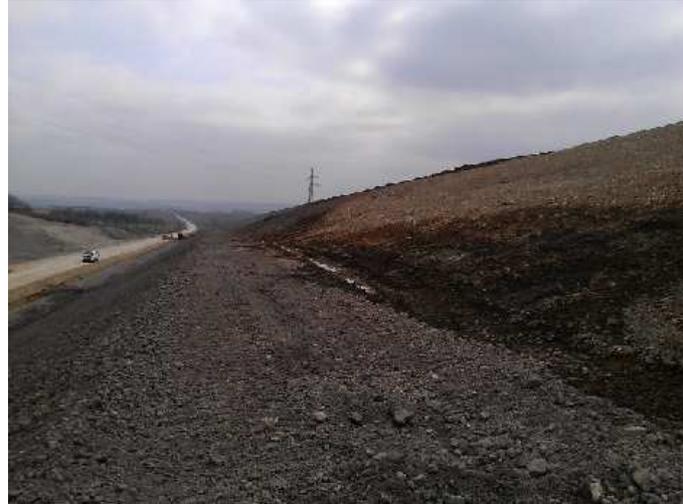
Figure 3 : water occurrences (dark areas) in 2012
(source: Cerema)

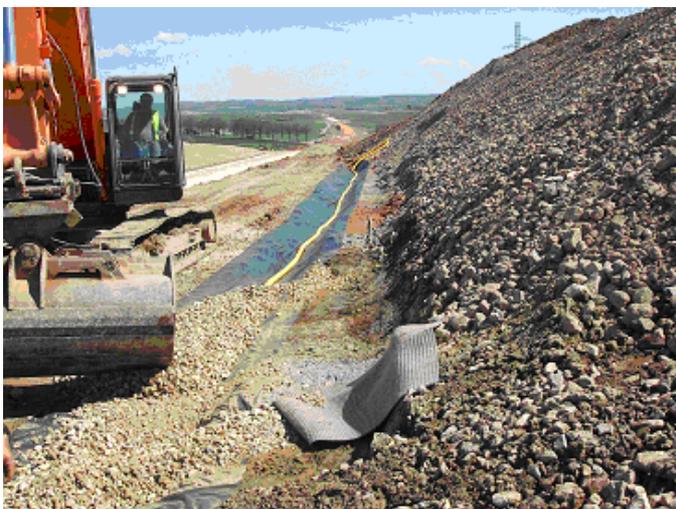
Figure 4 : traditional part (source: Cerema)

Each of the experimental band was elaborated during April 2013 by Eiffage TP. Conventional band consisted in granular material over a 50 cm-thickness. The other band had a draining geocomposite blanket with 50 cm of marls treated on site over it. Ditches were dug at their basis to collect water. All these elements are shown in Figures 4 and 5, while the draining geocomposite section in Figure 6.

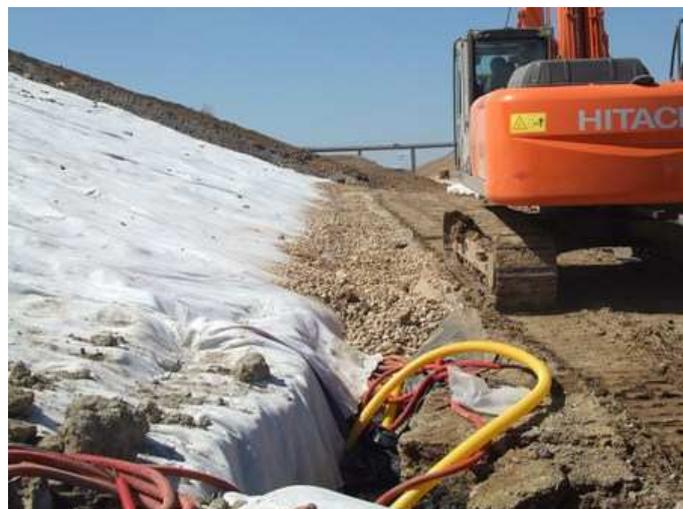
Figure 5 : GCD experimental part (source: Cerema)

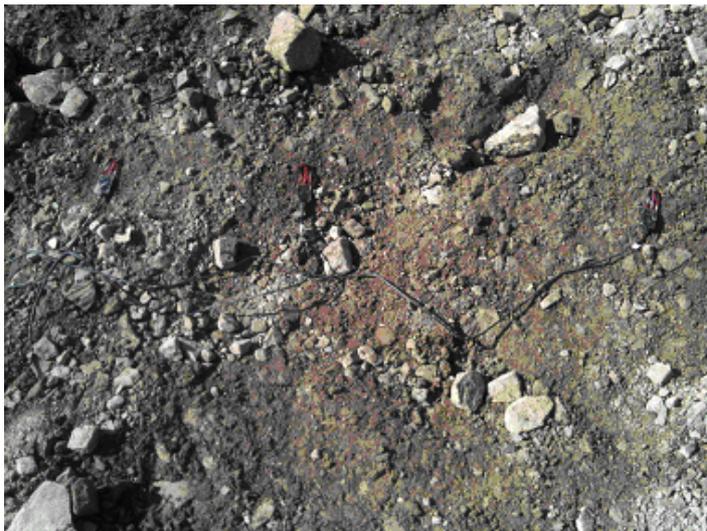
Figure 7 : temperature and water content sensors (source: Cerema)

Water contents and temperatures variations at the interface between the natural soil and granular material, and between the geocomposite and granular material were measured with 5TM probes (from Decagon). These measurements were then correlated with pluviometry data recorded with a rain gage on site to compare flow rates and water contents evolutions over both bands. Data acquisition were connected to batteries to allow an autonomous recording system on the experimental site.

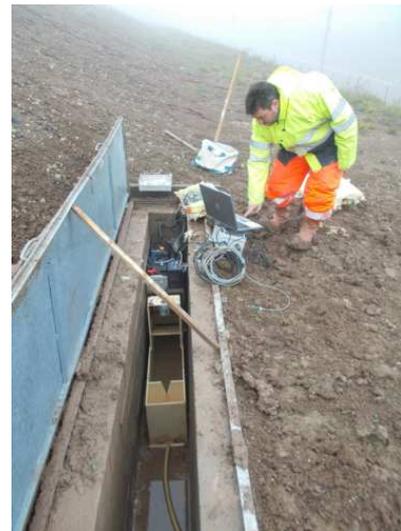
Figure 8 : chamber with flow rate measurement (source: Cerema)

So as to cope with requirements of the objectives of hydraulic performances of both draining techniques, each ditch at the bottom of the band drained the water which level was measured with ultrasonic sensor with a 0.5 mm-accuracy. Knowing the shape of the collection device, standardized approaches were used to calculate corresponding flow rates. The choice consisted in an Aquabac 4 (manufactured by Aqualyse), with a flow rate measurement range from 0 to 1.17 L/s (4.21 m³/s) (Figures 7 and 8).

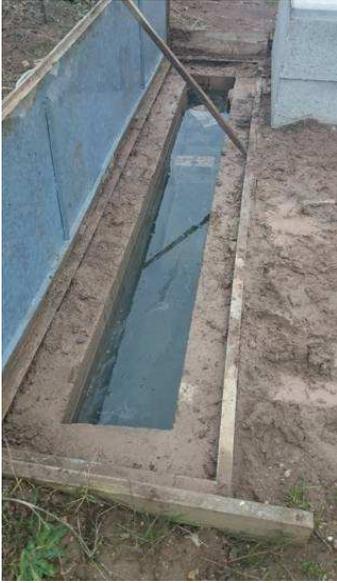
Figure 10 : chamber with water
(source: Cerema)

Once completed, the first measurements were obtained in September 2013, and lasted over nearly a 5-month period. Some disruptions in data acquisition were unfortunately observed because of power supply issue, along with some flooding of data acquisition devices (Figure 10). A solution was brought to this specific one placing the whole acquisition system in a dedicated flood-proof chamber (Figure 11).

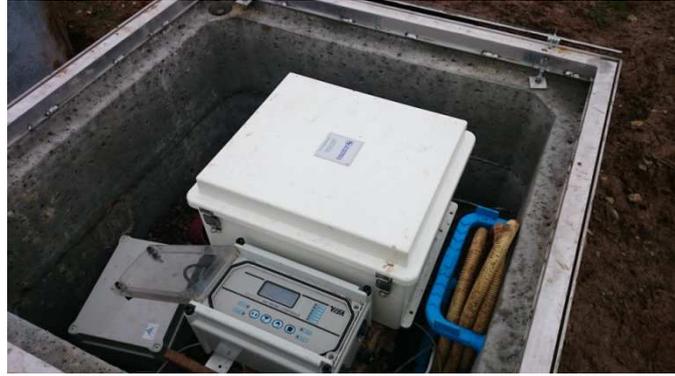
Figure 11 : new data logger chamber (source: Cerema)
