Rehabilitation of an existing RC retaining wall using geogrid reinforced granular fill

O.Dadasbilge*

GEOCON Geotechnical Consultants, Turkey (ozan@geoconltd.com)

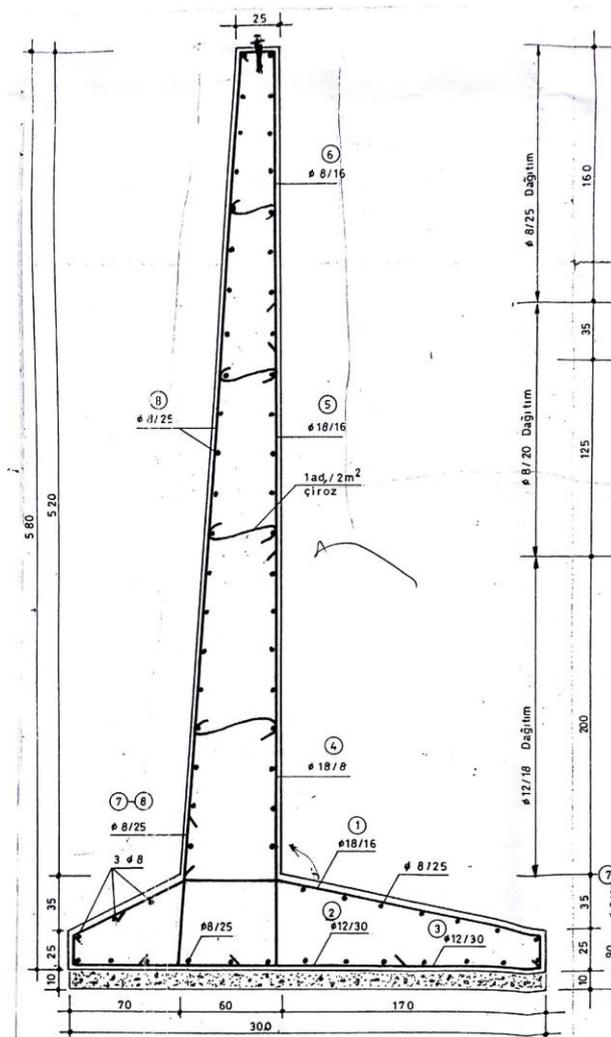
The construction year of the existing conventional RC retaining wall is unknown, but from the photos taken 15 years before the date of the work it is obvious that it is at least older than 15 years. The wall has a “L” shape in plan. The length of the shorter and longer sides are 25m

and 40m, respectively. Clean height of the wall changes from round 200cm up to 520cm. The section dimensions and reinforcement detail of the wall are given in Figure 3 below.

Figure 3: Typical cross-section and reinforcement detail of the existin RC wall.

The wall had undergone a maximum deformation of 60mm, at the top of the corner part. Although no measurement records were present, no sign of continuity could be found. Also optical measurements did not show any further displacement in a one month period. The oil storage company wanted to build 6 new tanks onto the filling platform, right behind the deformed retaining wall. The plan dimensions of the new tank area was given as 6,0m x 19,0m. The total maximum weight of the tanks was given as 350 tons. With the foundation itself the total load reaches about 470 tons. So the maximum vertical base pressure is expected to be around 4,1 tons/m² behind the wall.

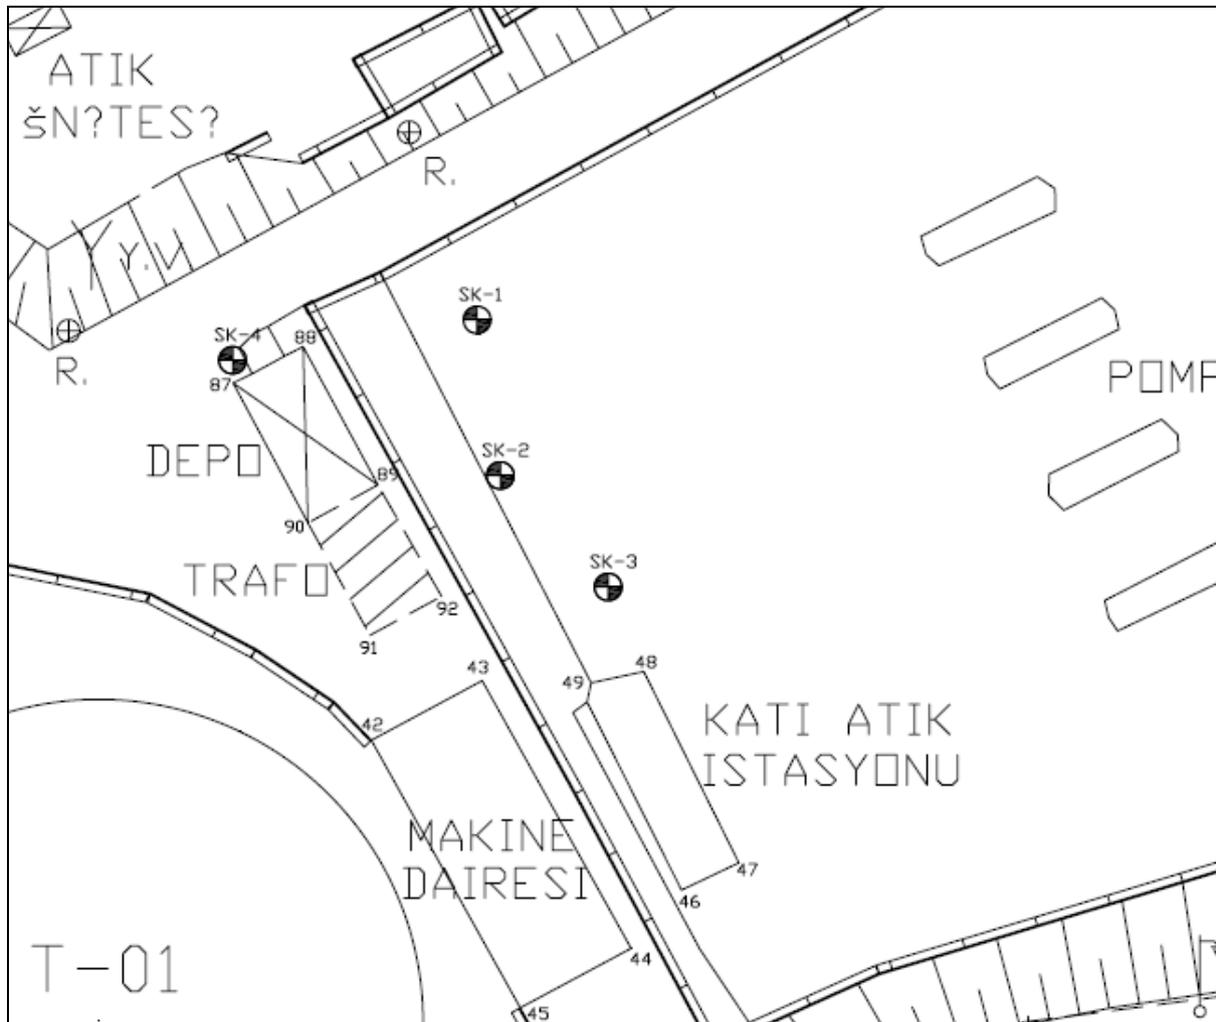
In order to determine the soil profile at the project site 4 borings have been made, 3 of them located behind the wall and 1 borehole located in front of the wall. The depths of the borings are given below in Table-1.

Figure 4: Layout of the soil investigation boreholes

The layout of the boreholes and the soil profile are given in Figure 4 and Figure 5, respectively. A test pit has also been excavated in front of the wall, in order to determine the soil type right beneath the foundation of the wall.

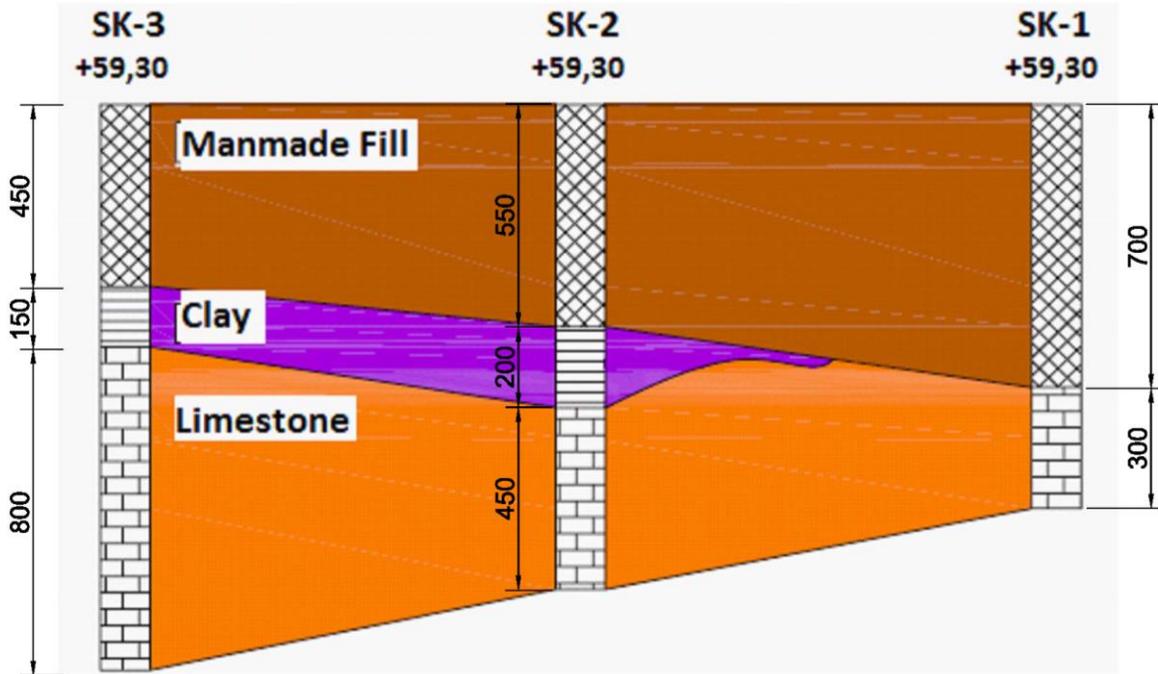
Figure 5: Soil profile at site behind the wall

Layer Definition	Short Description	Thickness	Top Elevation
Uncontrolled Manmade Fill	Clayey soil containing concrete blocks and limestone gravels of loose – middle dense density	1,50 – 7,0 m	0,00 m
Very stiff Clay	Yellowish brown coloured, containing slightly fine gravelly	1,50 – 2,0 m	-1,50 ~ -7,00 m
Slightly weathered Limestone	Gray coloured, medium bedded	> 8,0 m	-1,50 ~ -7,50 m

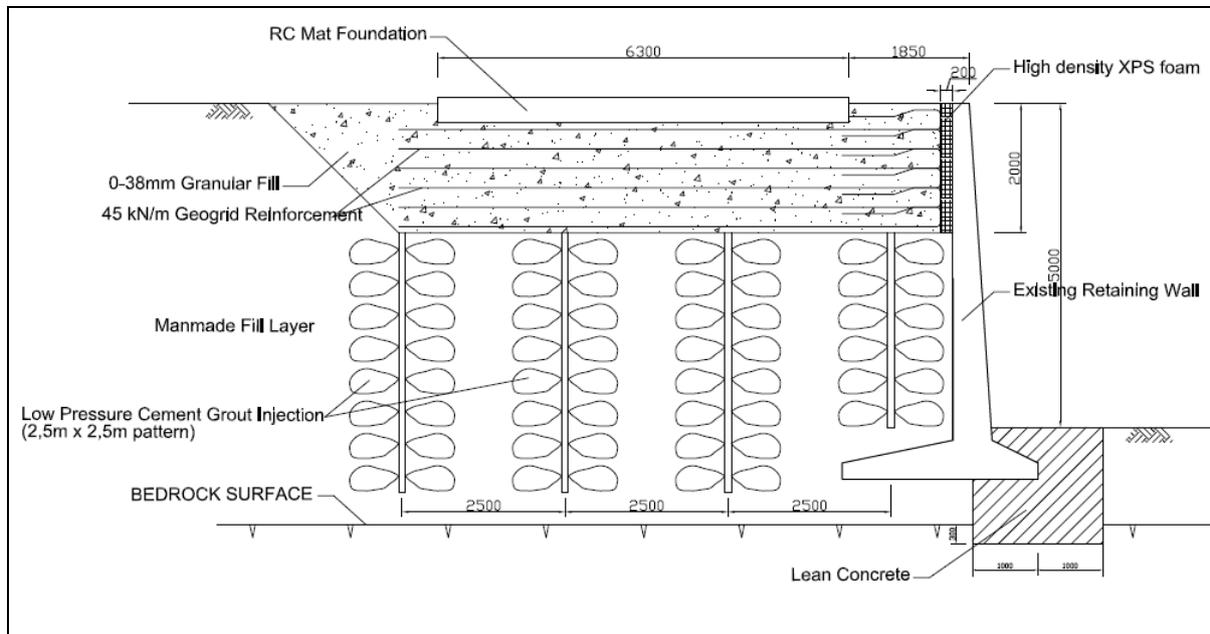
Figure 6: Typical crosssection of the rehabilitation system

As the problematic soil is regarded as the uncontrolled manmade fill layer only, the rehabilitation system design covered only the fill layer. The lower part of the of the fill layer is improved by applying a systematic permeation grouting, in a 2,50 x 2,50m pattern in plan. The vertical spacing between the outflow points on the grouting pipes was 50cm.

The upper 220cm thick layer of manmade fill is excavated and transported outside the plant, as it was not suitable material for the engineering fill. A geogrid reinforced granular fill is placed instead. The granular fill material has been placed as 30cm thick horizontal layers and compacted as to reach minimum and average Proctor Density values of 95% and 98 percent, respectively. 6 layers of uniaxial geogrid reinforcement having an ultimate tensile strength of 45 kN/m have been used. The vertical spacing of the geogrid layers was equal to fill layer thickness which is 30cm.

The section drawing of the rehabilitation system is given below in Figure 6.

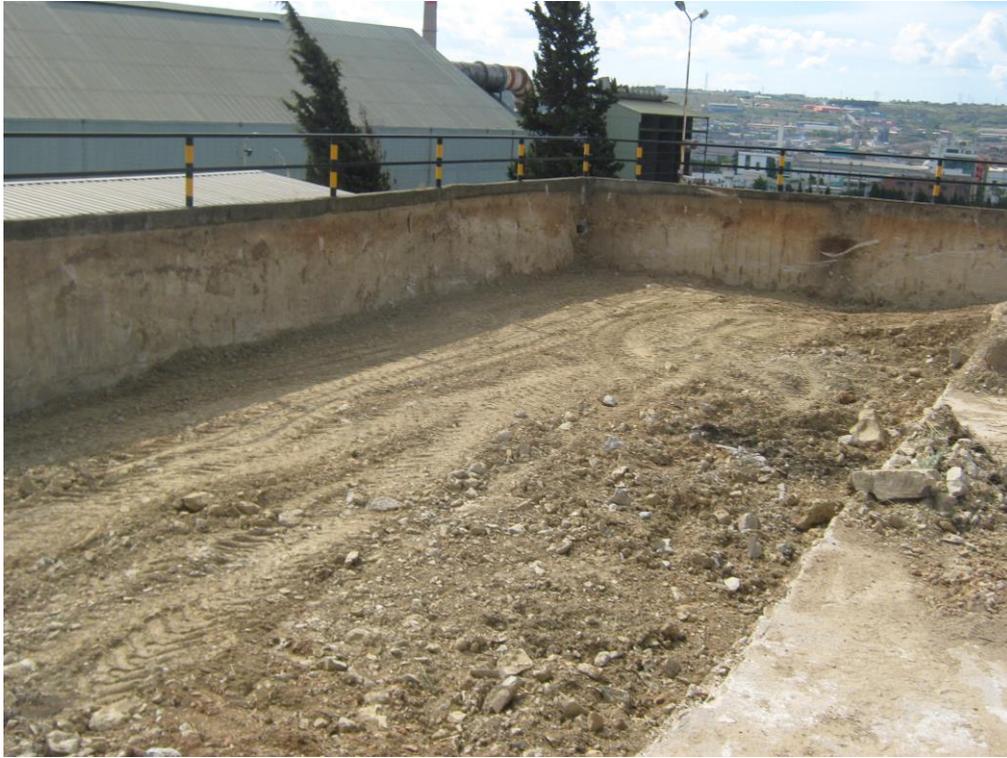
Figure 7: Excavation behind the wall

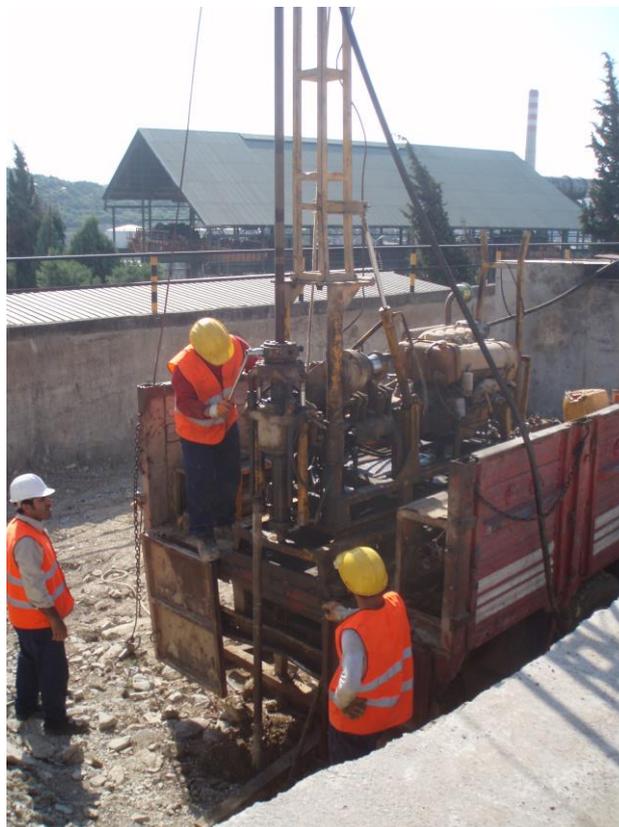
Figure 8: Drilling of boreholes for grouting

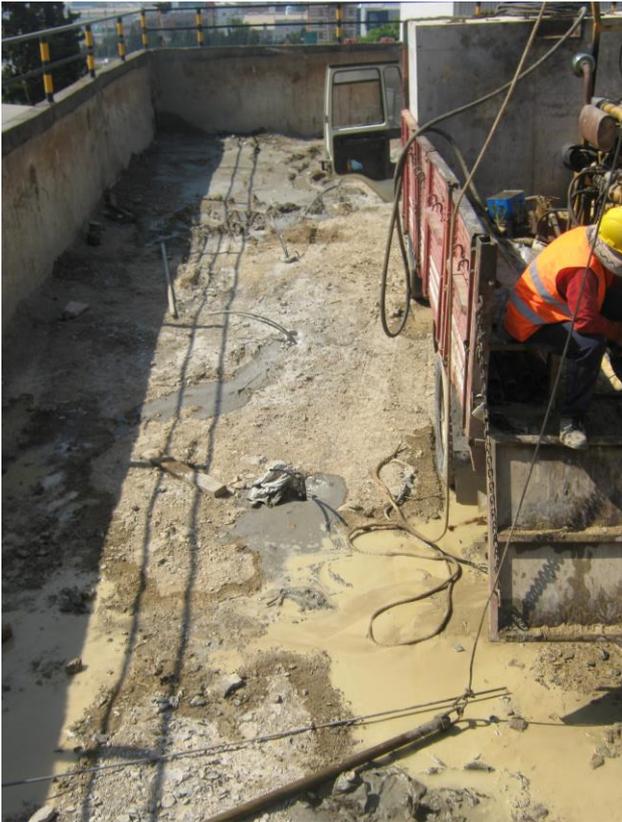
Figure 9: Grout injection

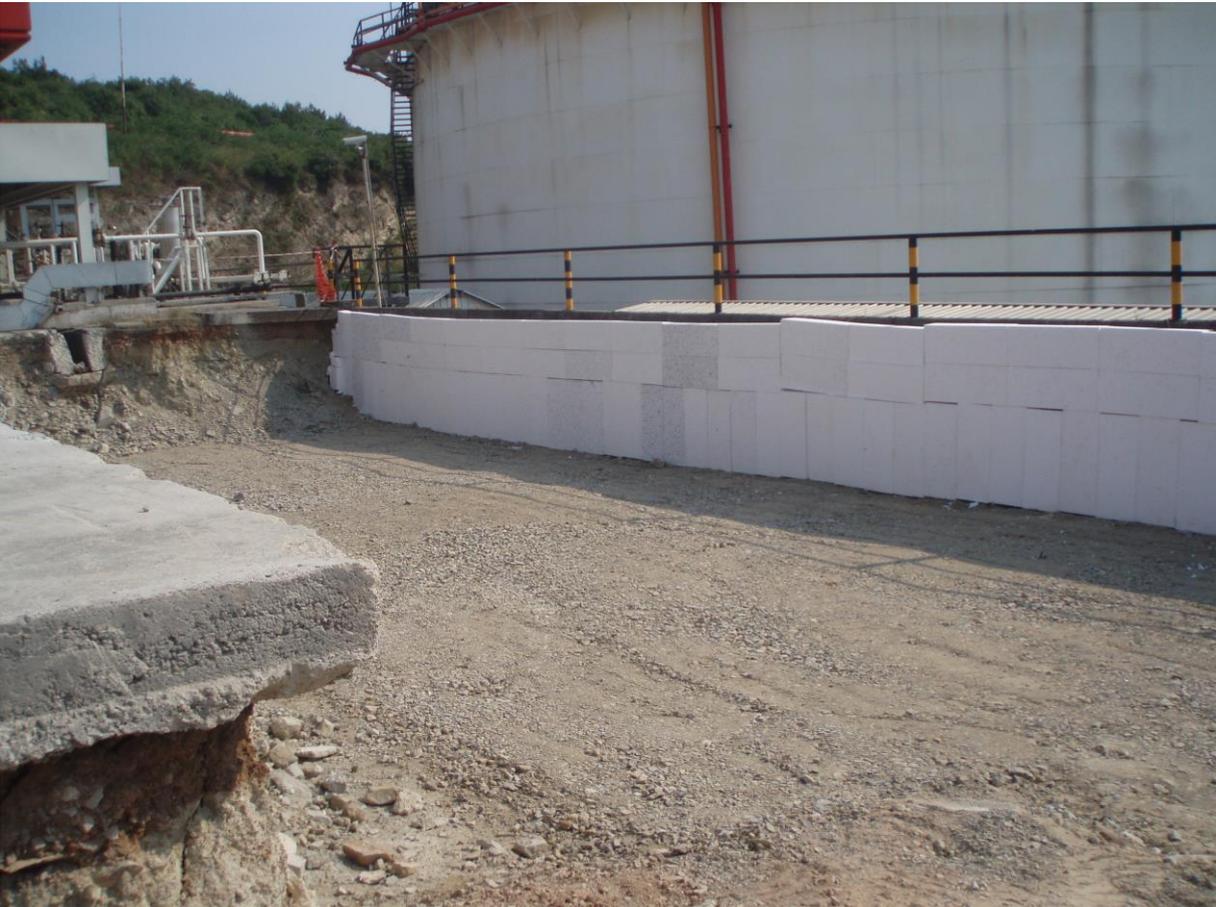
Figure 10: Placement of XPS foam boards after cleaning the site from grout

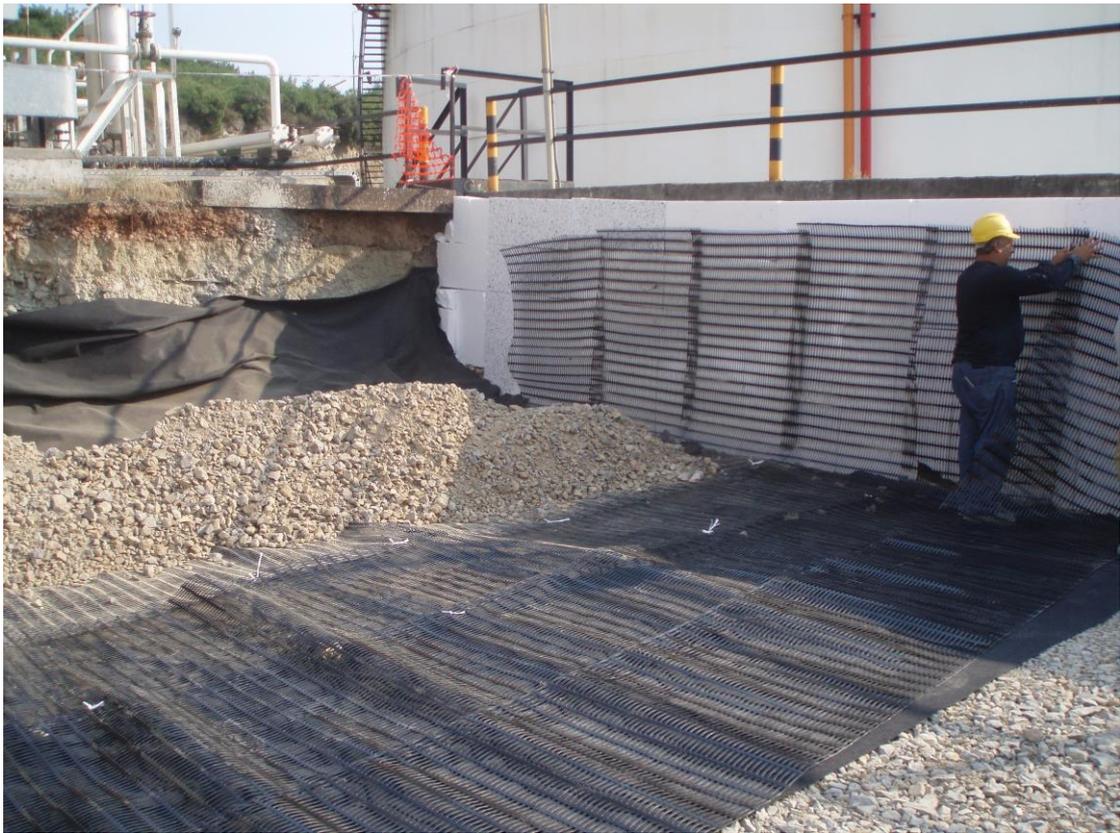
Figure 11: Placement of lowest geogrid layer (and also 1 layer of geotextile)

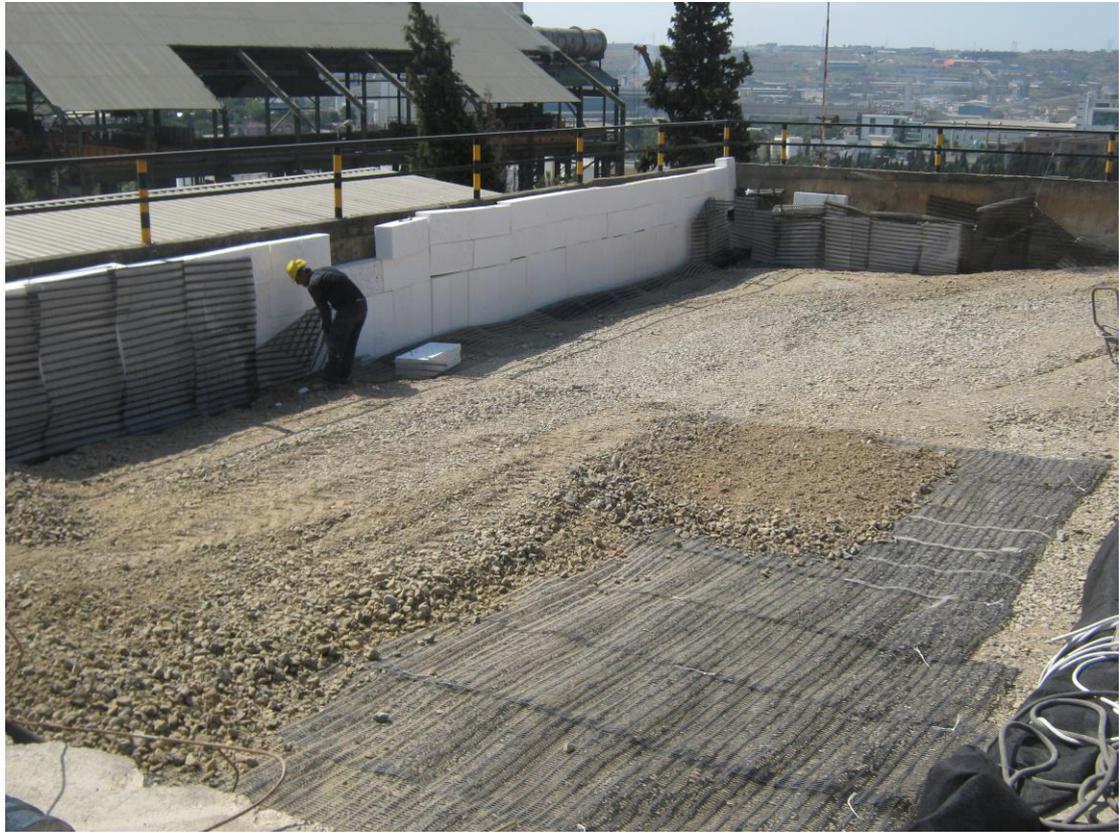
Figure 12: Placement of granular fill over the geogrid

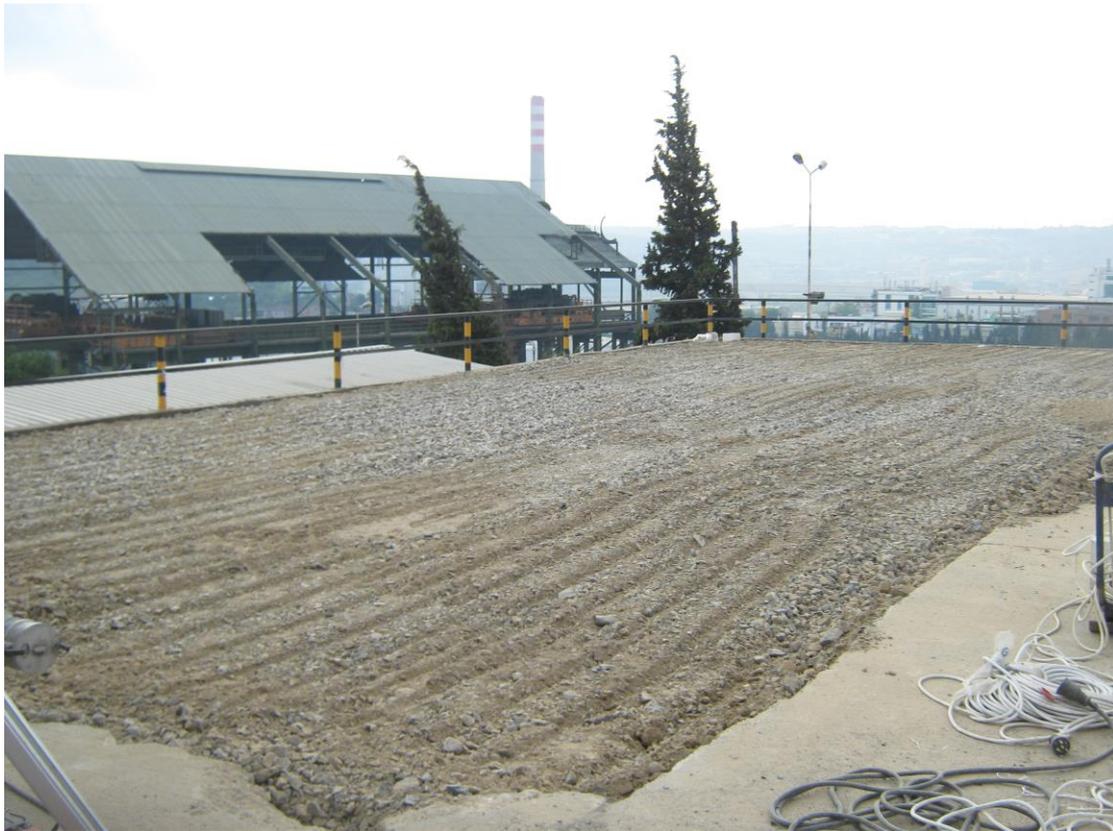
Figure 13: Placement of top layer of granular fill

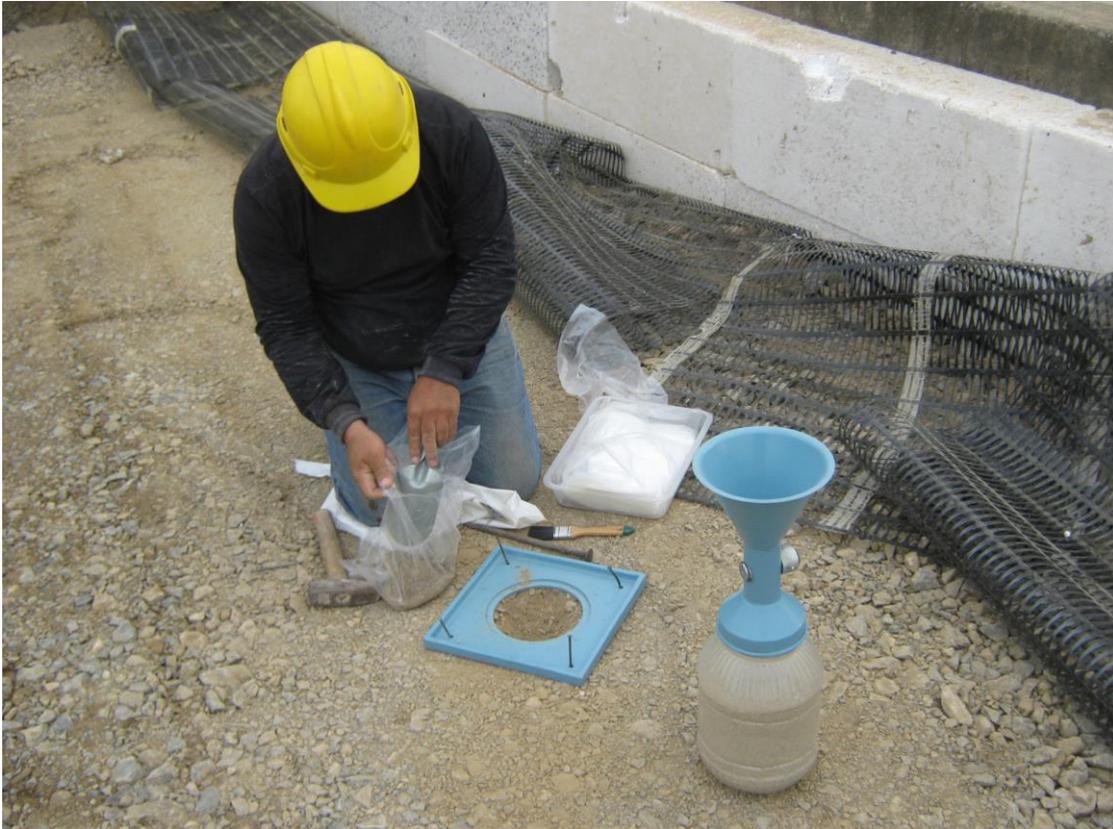
Figure 14: Sand cone test

Compaction has been made by using light electrical table compactors in order not to cause any further deformation in the wall. Sand cone and Proctor tests of adequate amount have been performed at each layer of granular fill after compaction and the above mentioned criteria is fulfilled. Figures 7 to 10 show the different phases of the construction.
