Characteristics of six PVC-P geomembranes installed in reservoirs in Spanish Mediterranean Basin

ABSTRACT: This paper presents the results obtained from six polyvinyl chloride geomembranes (PVC-P) reinforced with a synthetic fabric, installed in irrigation reservoirs for a period between 18-31 years. The geomembranes studied are part of the waterproofing system of the following reservoirs - El Hondon de las Nieves, El Rollo, Pla Aceituna, La Caseta de Mira, El Cid-III y El Rabosero, all of them located on the Spanish Mediterranean County of Alicante.

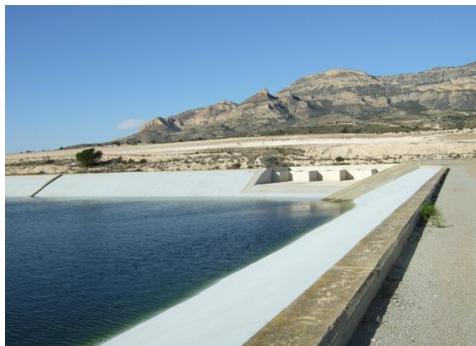
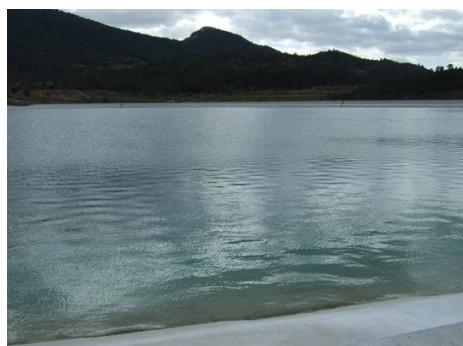
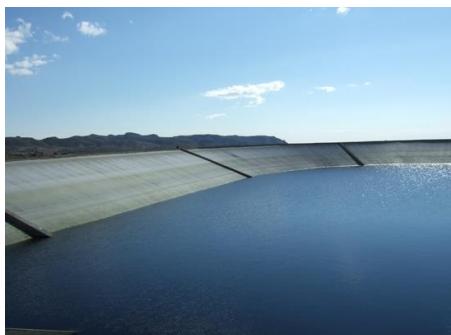
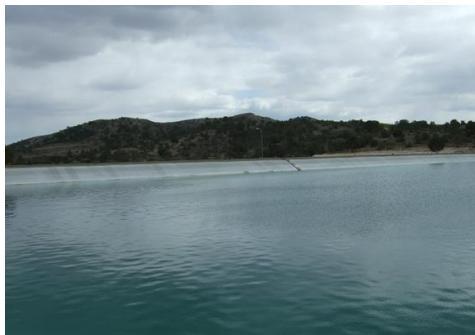
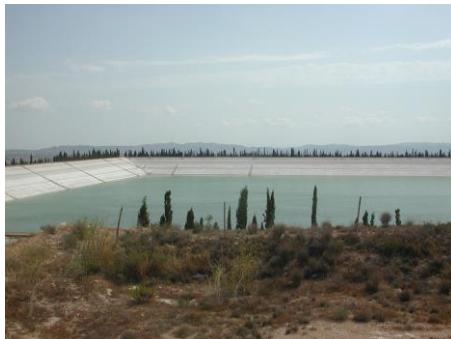
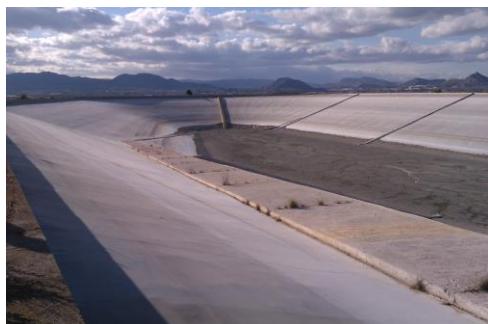
Figure 1: Overview of the reservoirs into study

Meanwhile, Figure 1 shows a partial overview of the water infrastructures. The waterproofing system of all the geomembranes used in the reservoirs into study came from the same commercial company. Also, all of them share a thickness of 1.5 mm being manufactured through the impregnation process.

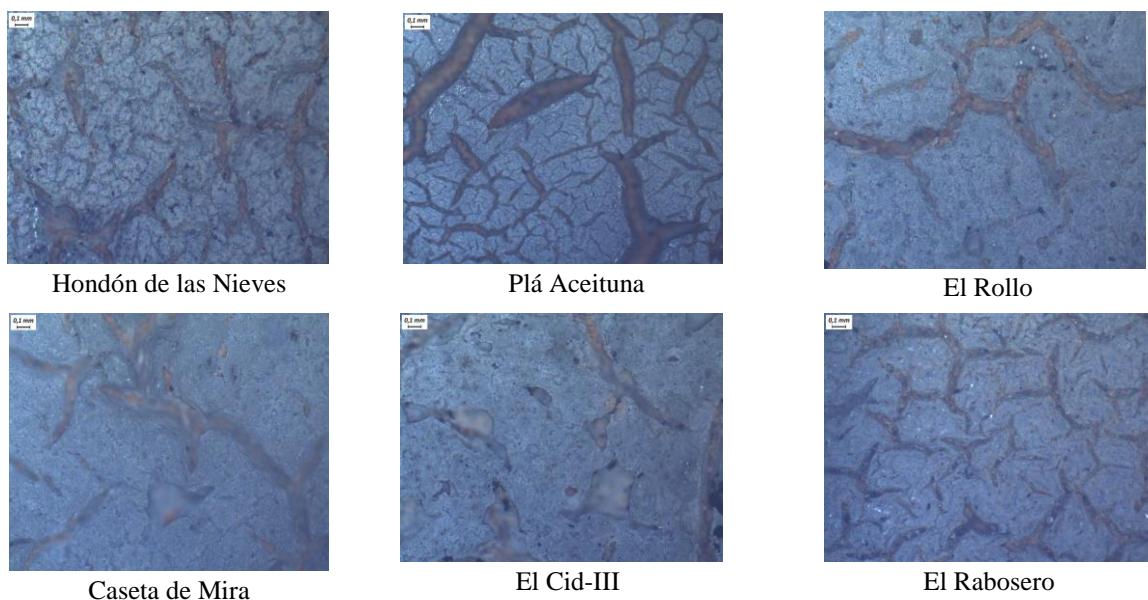
Figure 2 shows the external side at (x60) magnifications for the different geomembranes in 2015. In addition, the condition of the aforementioned geomembranes in 2015 has been tested by scanning electron microscopy (SEM) at (x90) and (x900) magnifications. Figure 3 presents the appearance of the external side of the materials at (x90) magnifications.

Both the ROM and the SEM detect on the external side of each of the geomembranes a significant deterioration with surface cracking.

Figure 2. Microphotograph of the external side by ROM at x60 magnifications

2. The data obtained in the microscopic analysis shows geomembranes whose internal side is in good condition. However, the external side shows severe deterioration, with the presence of surface cracking.

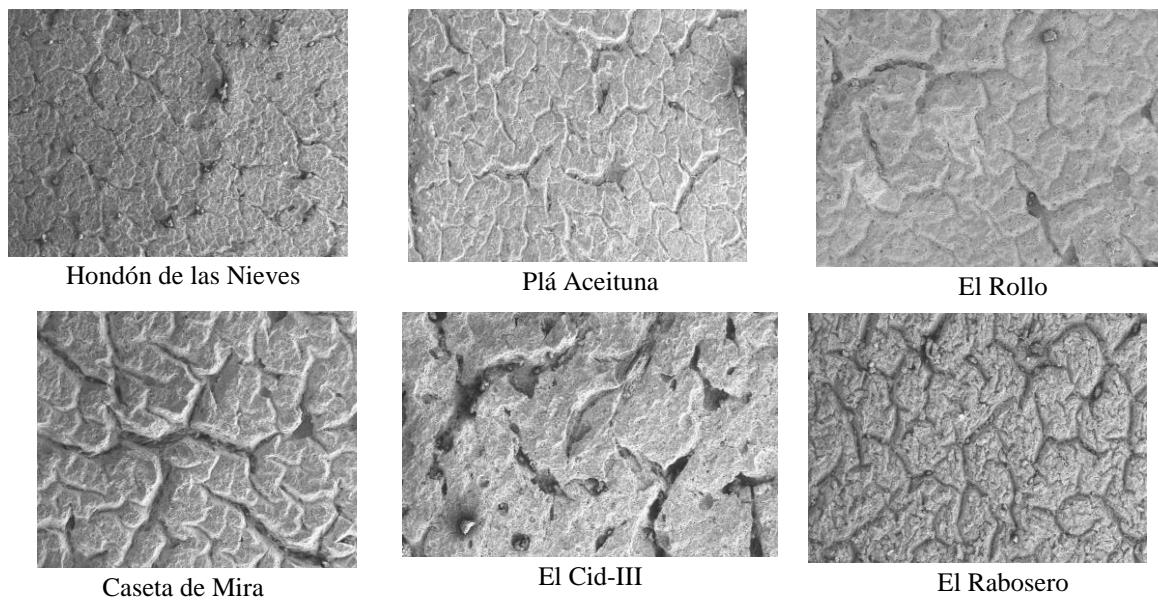
Figure 3. Microphotograph of the external side of the geomembranes by SEM at x90 magnifications

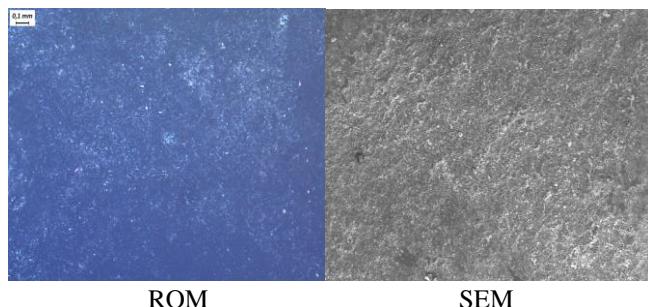
Figure 4. Microphotographs of the internal side of samples from El Cid III reservoir by ROM at x60 magnifications & SEM at x90

Figure 4 shows the microphotographs from the El Cid-III reservoir 31 years after installation, on the internal side, taken using ROM (x60) and SEM (x90) technology. In these, the good condition of the material can be observed. The comparison between the two sides of the tests specimens highlights the effect of UV radiation in the degradation of the organic material.
