The use of geosynthetics in steep side wall capping: A case study

ABSTRACT: A ferrochrome smelter in South Africa is in the process of upgrading its waste management facilities to comply with the requirements of local legislation. As part of this process, a previously decommissioned hazardous waste facility required an upgraded capping design. The facility was originally decommissioned and capped in 1999, with a geomembrane covered by a protective layer of slag fines on the top surface, while the steep outer slopes were capped with concrete filled geocells. Due to settlement of the waste body, the existing concrete cap on the side slopes has cracked, while some areas have been subject to mechanical damage. This paper presents the engineering solution applied to effectively upgrade the cap with particular focus on the steep (1V:1.5H) side slopes and the use of geosynthetics to overcome the associated stability challenges. Given the space constraints at the site, the side slopes had to be capped without significant modification to their shape. This, coupled with the requirement for a geomembrane with appropriate protective cover on the slopes, presented challenging design criteria.

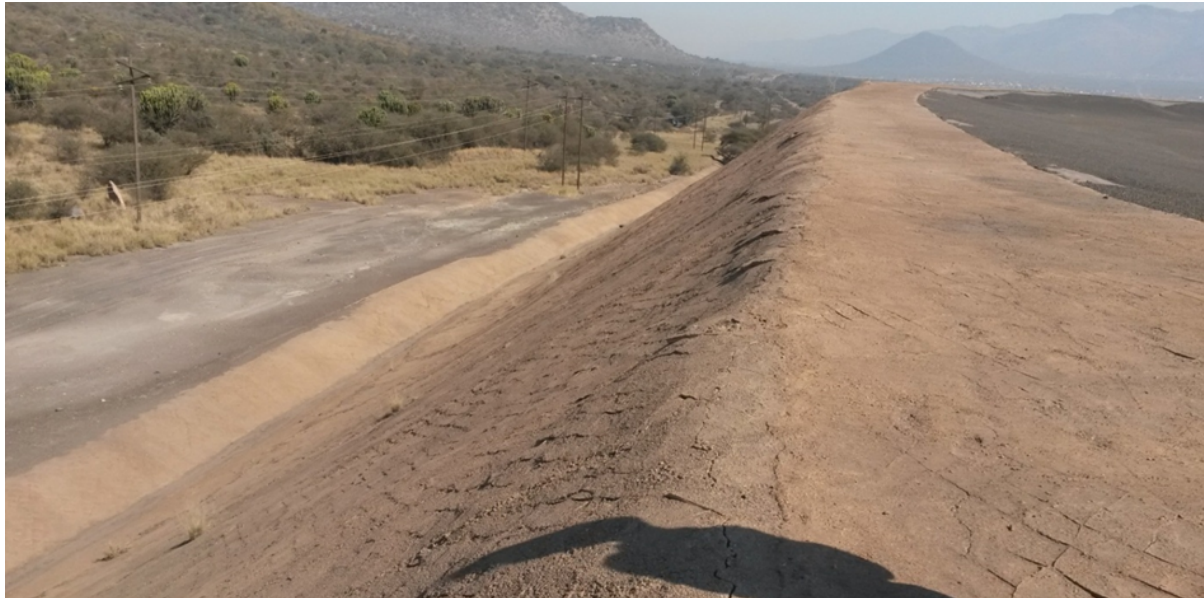
Figure 1. Southern embankment and perimeter drain of existing Capped Facility.

Due to the settlement of the waste body over time, the concrete capping system has cracked or deformed in certain areas. Mechanical damage has also occurred as a result of operational activities at an adjacent slag dump. The existing capping system therefore does not provide a low permeability barrier against water ingress. The need for an upgraded cap to prevent the ingress of stormwater is therefore evident, as depicted in the Figures 1 and 2.

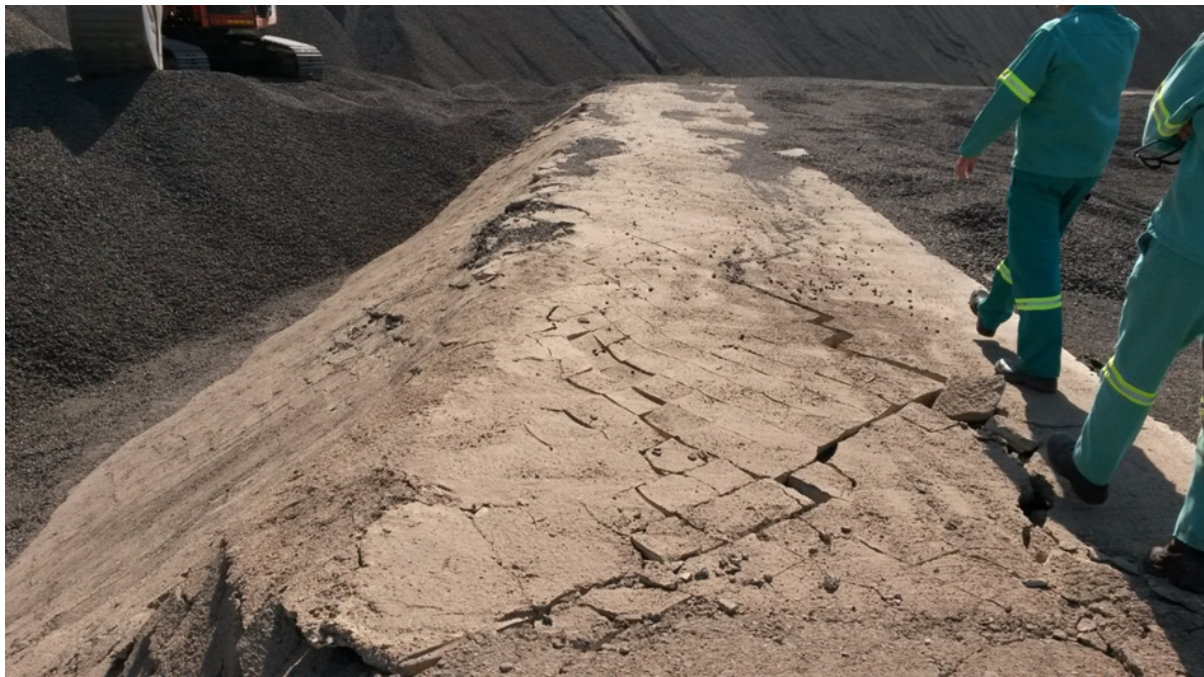
Figure 2. Large cracks in the existing capped side slopes.
