The long term performance of polymeric reinforced walls under static and seismic conditions

ABSTRACT: Data is presented that shows that polyester based reinforcement from two reinforced soil walls, at Elmadag Turkey and at the Transport Research Laboratory (TRL) UK, have lost no strength and have the same load – strain response as the original materials after 22 and 37 years in service respectively. Scanning electron microscope images showed that no degradation on the surface of the polyester fibres had occurred and chemical testing showed that the number average molecular weight and carboxyl end group count were unchanged from that measured in the original fibres. The results presented in this paper extend the data on the insitu performance of polyester based geosynthetics over extended periods of time. Samples exhumed from the TRL wall, at regular intervals, over the past 28 years have shown no change in the load – strain response of the geosynthetic reinforcement. The samples exhumed from the Elmadag wall in Turkey are the second set of samples exhumed and tested from a reinforced soil structure that experienced a seismic event. No change in the load – strain relationship, appe

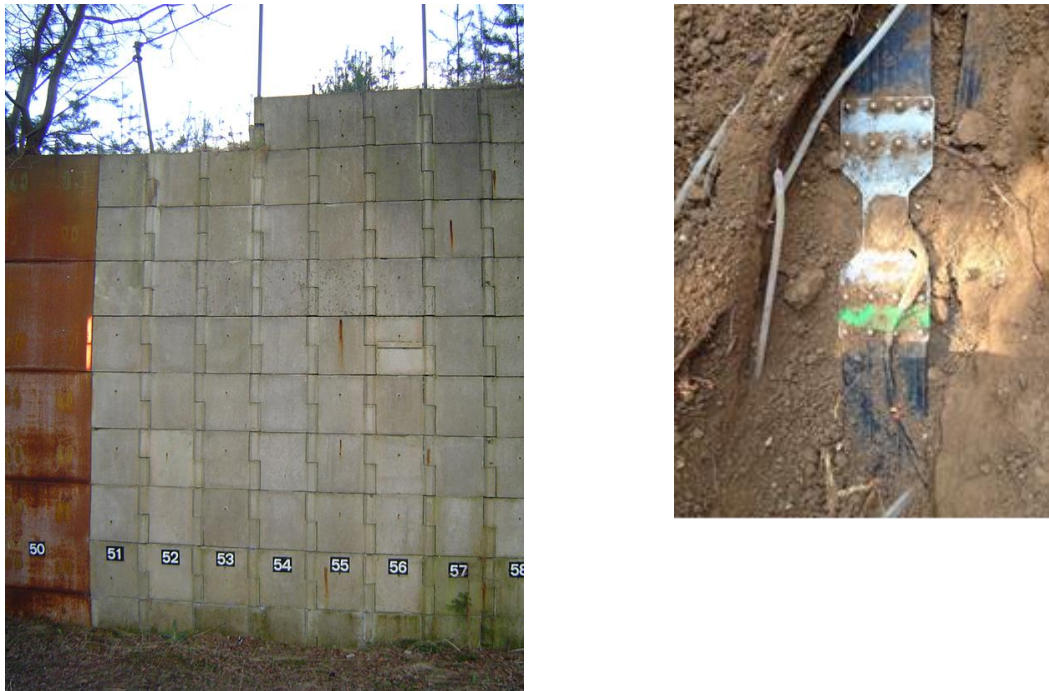
Figure 2: (a) External view of section containing polymeric reinforcement and (b) Exhumed sample from 2014 showing original strain gauge used during TRL monitoring programme

The facing units used with the polymeric reinforcement were reinforced concrete interlocking units with typical dimensions of 450 mm x 450 mm x 80 mm thickness. The units were shaped such that they interlocked with adjacent units using cast in dowels and sockets. A photograph of the polymeric section taken in March 2005, 28 years after construction, is shown in Figure 2(a).

The TRL wall is an early example of a reinforced soil wall constructed using polymeric reinforcement and some aspects of construction are interesting from an historic perspective. Firstly, the facing panels were significantly smaller, at 450mm x 450mm, Figure 2(a), than the typical 1.5m x 1.5m panels commonly used in this type of construction today. Secondly, the connections between the reinforcement and the facing panel were manufactured from stainless steel, Figure 3(a), and were significantly different in size and structure to their modern day equivalent. Finally, the layout of the reinforcement in today's world seems wasteful. The polymeric straps were installed as individual straps which were returned back on themselves, Figure 3(b). This is in contrast to the now customary and more efficient zig-zag pattern commonly used with polymeric reinforcement.

For practical reasons the exhumed samples came from the upper layers of the wall, at depths of approximately 1 m. The backfill soil in this region consisted of silty clay, with a relatively high clay content, Figure 2(b). It can be reasonably assumed that this soil layer was partially saturated and would have a degree of saturation in the range 40 – 70%.

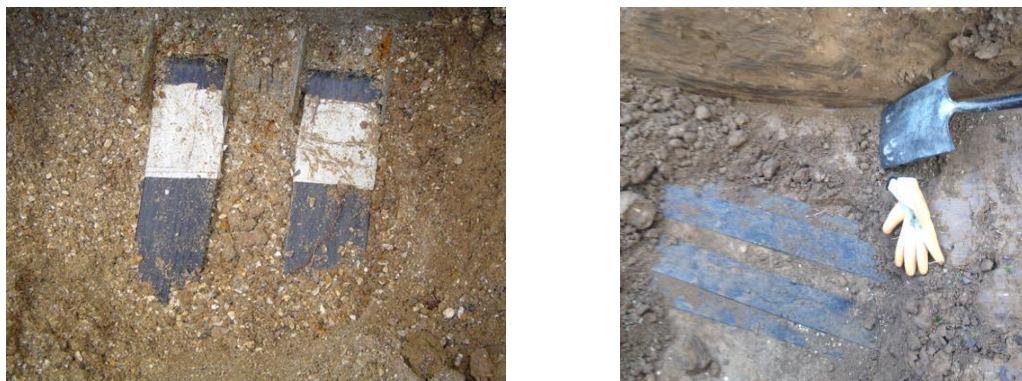
Figure 3: (a) Connection between polymeric reinforcement and concrete facing panel and (b) strap installation

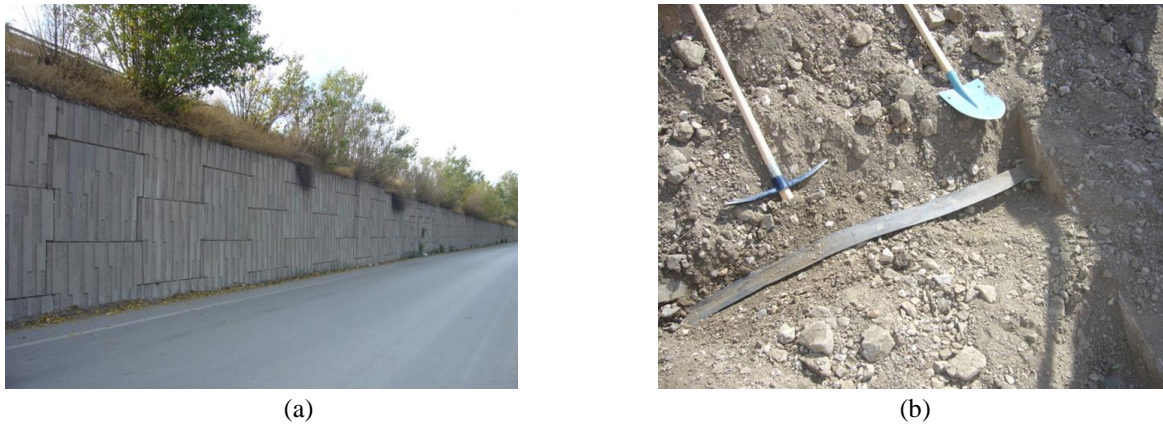
Figure 4: (a) External view of Elmadag wall and (b) exhumation of samples

The reinforced soil wall at Elmadag, Figure 4(a), was constructed between 1986 and 1987 and was both the first reinforced soil wall in Turkey and the first constructed using polymeric reinforcement. The wall is located at the village of Elmadag, approximately 30km east of Ankara on the highway to Samsun. The wall consisted of T shaped panels, nominally 2.0m wide x 1.6m high, with typically four reinforcement connection points per panel. The polymeric reinforcement had a short-term design strength of 50kN (BBA, 1982). The polymeric reinforce-

ment was connected to the panel through a metal connection consisting of two loops and a toggle, Figure 4(b). The metal loops were cast into the facing panel during manufacture. The reinforcement was also installed using the now customary zig-zag pattern. The total area of the facing panels was approximately 4400m², with the wall varying in height to a maximum of 7m. The fill material used in the construction of the wall was river gravel.

Exhumation of samples from the Elmadag wall occurred in 2009, following approximately 22 year of service in the wall. The samples were retrieved from the lower height part of the structure, with the samples located close to the surface. A mechanical excavator was used to remove fill, with hand tools used in close proximity to the samples, Figure 4(b).

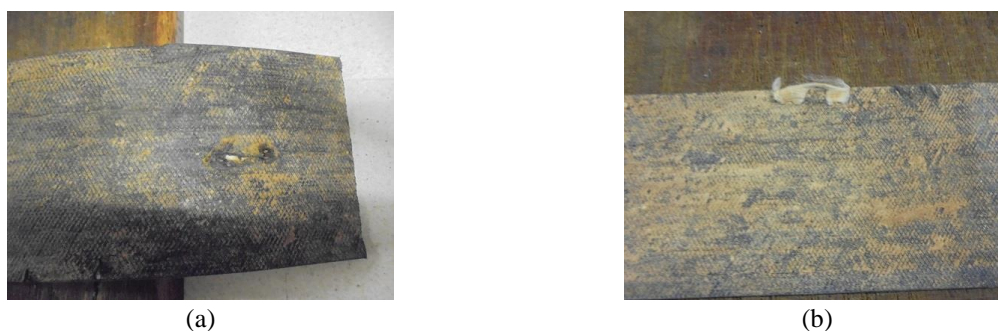
Figure 5: Exhumed samples from the TRL wall showing (a) minor damage (b) some pull through of fibres

Exhumed samples from both sites were examined visually to quantify any damage to the surface of the reinforcement. No significant damage was noted, Figure 5(a). Some minor damage, with pull through of small amounts of fibre, was observed, Figure 5(b), but these were very isolated. It was not possible to attribute this minor damage to original installation, in service use or to the exhumation process.

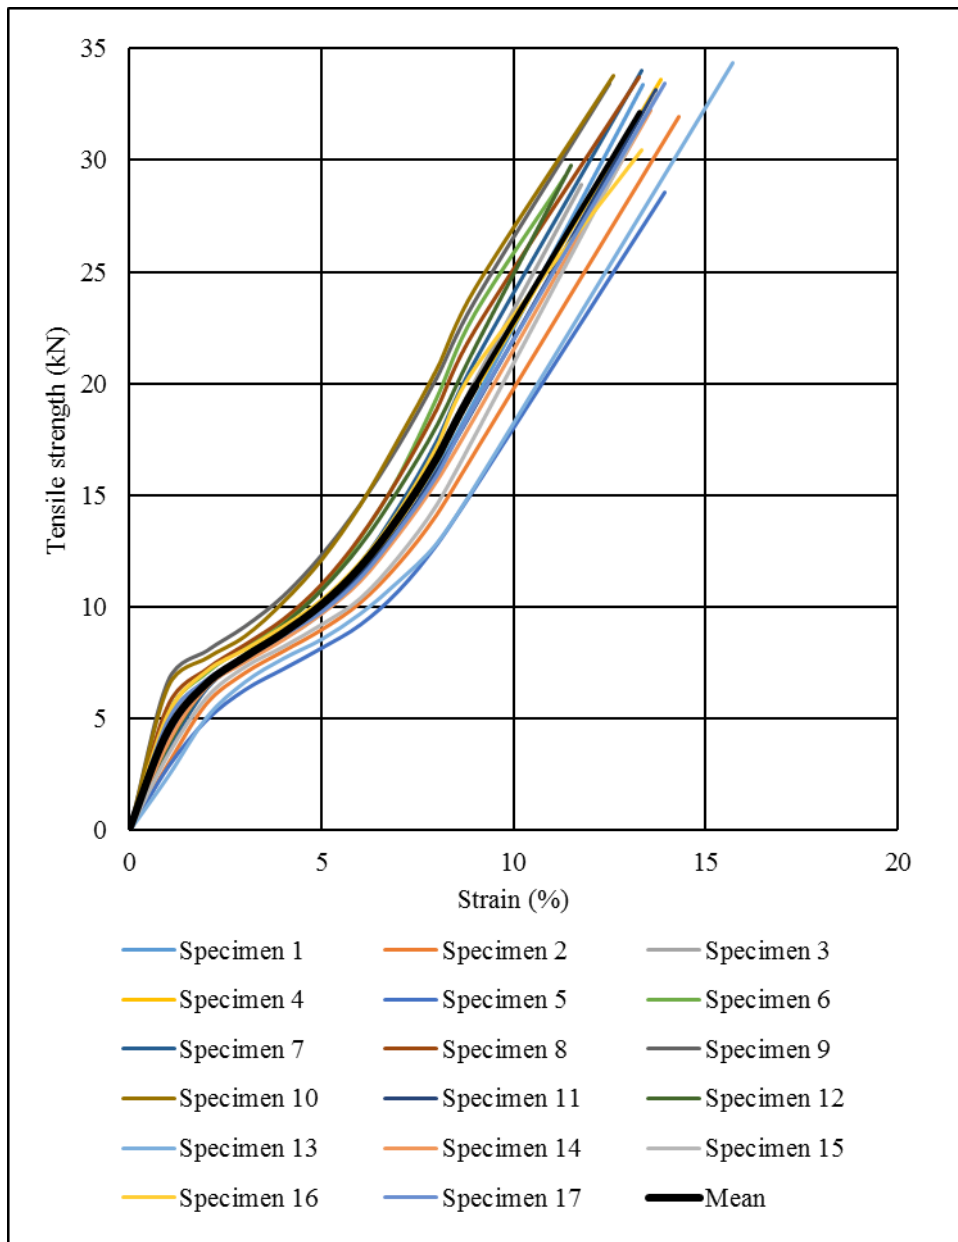
Figure 6: Stress – strain relationship of exhumed samples from the TRL wall

Seventeen tensile strength tests were performed on the samples of polymeric reinforcement exhumed from the TRL wall in 2014. Table 1 presents a summary of the maximum tensile strength of the reinforcement and the corresponding strain at maximum load. Figure 6 presents the load – strain relationship of the exhumed samples, together with the mean load – strain relationship based on all the samples tested. In total, four out of the seventeen samples tested had a tensile strength less than the original short-term design strength of 30kN.

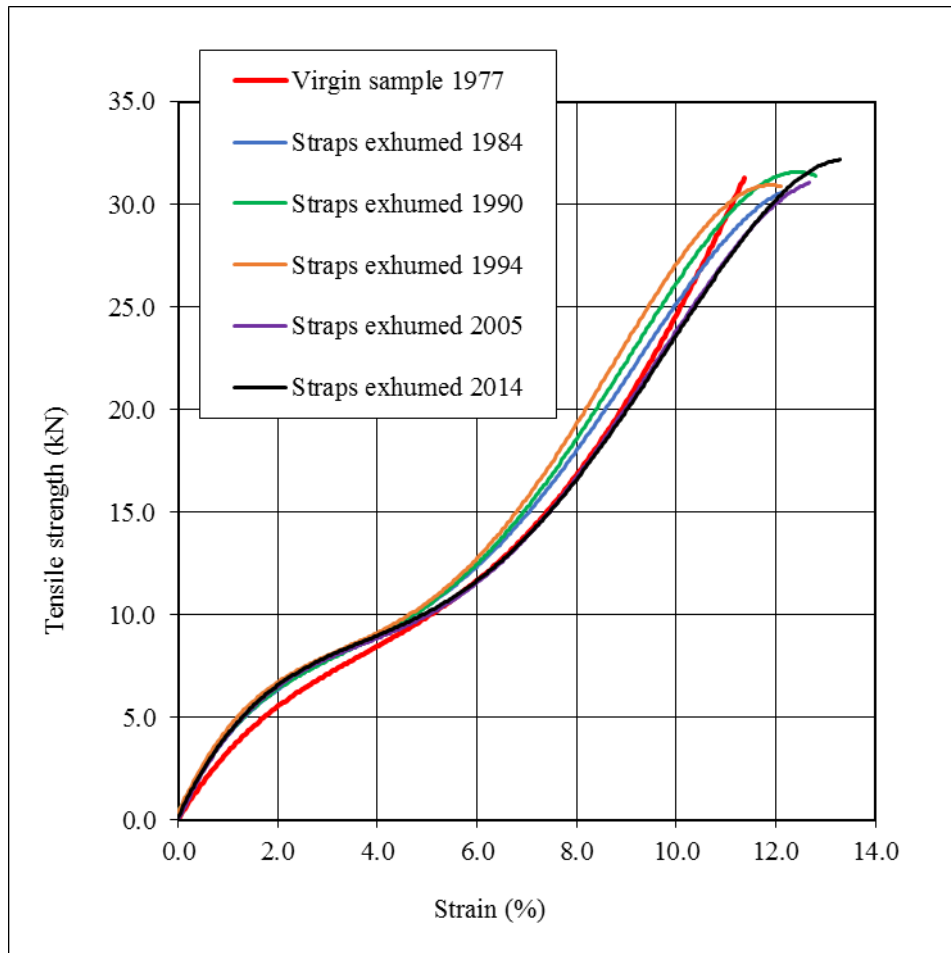
Figure 9: Load – strain relationship for original and exhumed samples from the TRL wall

Samples of reinforcement have been exhumed from the TRL wall in 1984, 1990, 1994, 2005 and 2014 and the load – strain response determined. The load – strain data for the original reinforcement was also available. Figure 9 presents a comparison of mean load – strain relations for both the original material and the exhumed samples over the years. No reduction in maximum tensile strength or change in the load – strain response of the material has occurred since construction. Table 3 presents a comparison of measured strength parameters for the
