BITUMEN GEOMEMBRANES IN IRRIGATION

ABSTRACT: Bitumen was in use 5000 ago for irrigation works that are still in good condition. Today, bituminous geomembranes are providing efficient, durable waterproof linings to irrigation canals, ponds and reservoirs throughout the world. A survey of twenty irrigation dams around 10m high built between 1973 and 1983 in France with unprotected geomembrane facings found them performing well after 10-20 years service. Linings to a reservoir at Goudel in Niger and canals cut in laterite near Niamey have demonstrated their suitability in tropical climates. In North Africa, the gulf states, Singapore, India and New Zealand, 5m-wide bituminous geomembranes have been in use on irrigation canals for some ten years and are still performing satisfactorily. In the USA, leaky areas on a large concrete-lined canal were stopped with an SBS bitumen-based geomembranes available in 4m widths in France.

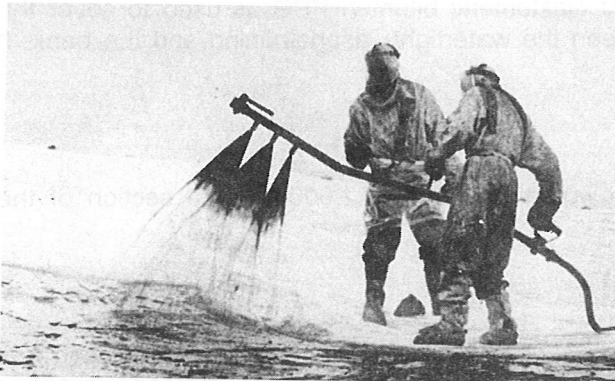
Photo 3. Spraying bitumen by hand

is laid with overlaps of at least 20cm unless the strips are sewn together into panels (Photos 1, 2, 3, 4).

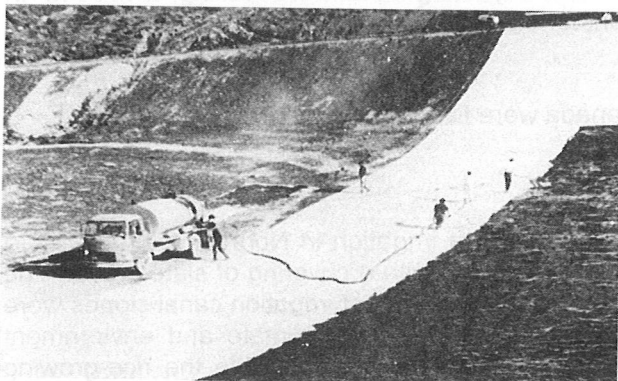
Photo 4. In situ application of bituminous
geomembrane reservoir lining

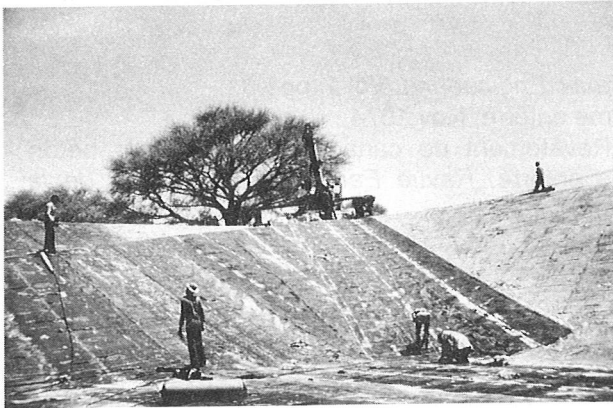
Photo 6. Reservoir lined with Bituminous geomembrane at Goudel, Niger

Prefabricated bituminous geomembranes are suitable for waterproofing large structures in hot climates. At Palma, Majorca, a 22,500 m² lining was applied to an aeration lagoon for wastewater destined for re-use for irrigation. At Goudel, near Niamey in Niger, a storage reservoir for river water was lined with 4500 m² PBG in 1981 and is still in good condition except for some tears at junctions with concrete (Photo 6). At Marrakech and Abu Dhabi, 70,000 m² and 50,000 m² of PBG were applied to irrigation reservoirs.
