WATERPROOFING FREE FLOW CANALS WITH FLEXIBLE SYNTHETIC COMPOSITE MEMBRANE SYSTEMS

A.M. Sciuero¹ and G.L. Vaschetti²

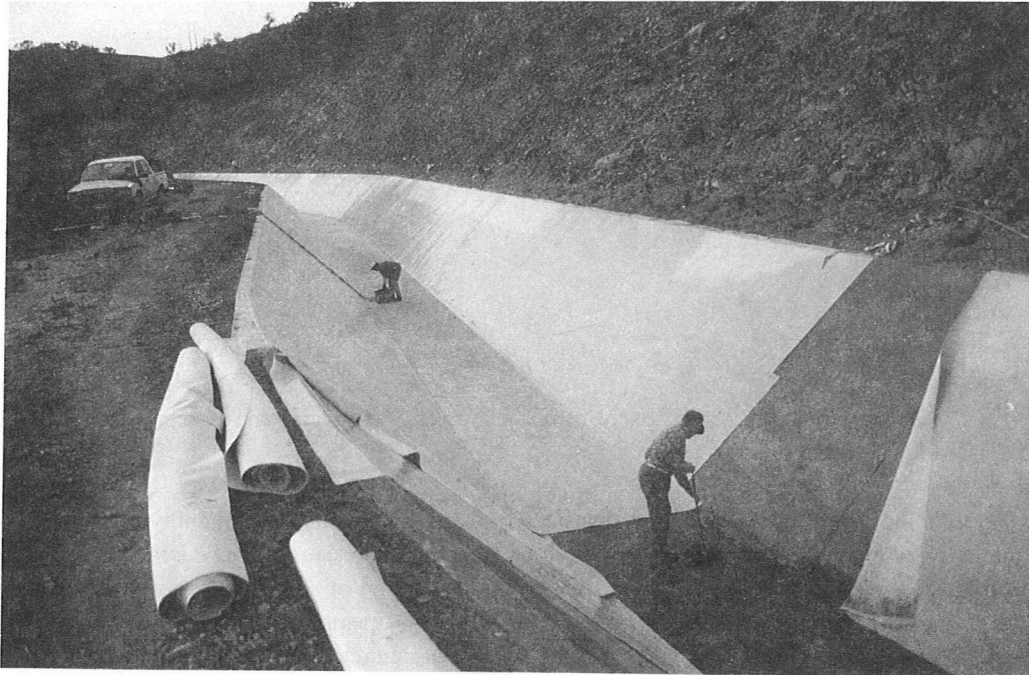
Figure 2. Installation of the PVC waterproofing system at Mira canal

Experience has demonstrated that a composite membrane with coupled geotextile is to be preferred to separate installation of a membrane and of a separate transition geotextile, not only because of shorter installation times: as a separate geotextile does not assure transfer of all stresses to the canal's structure, there is a danger that excessive stresses are transferred to the anchorage system, and that in case of membrane damage the geotextile detaches and accumulates behind the liner. Figure 2 shows an exposed PVC membrane installed on an irrigation canal.

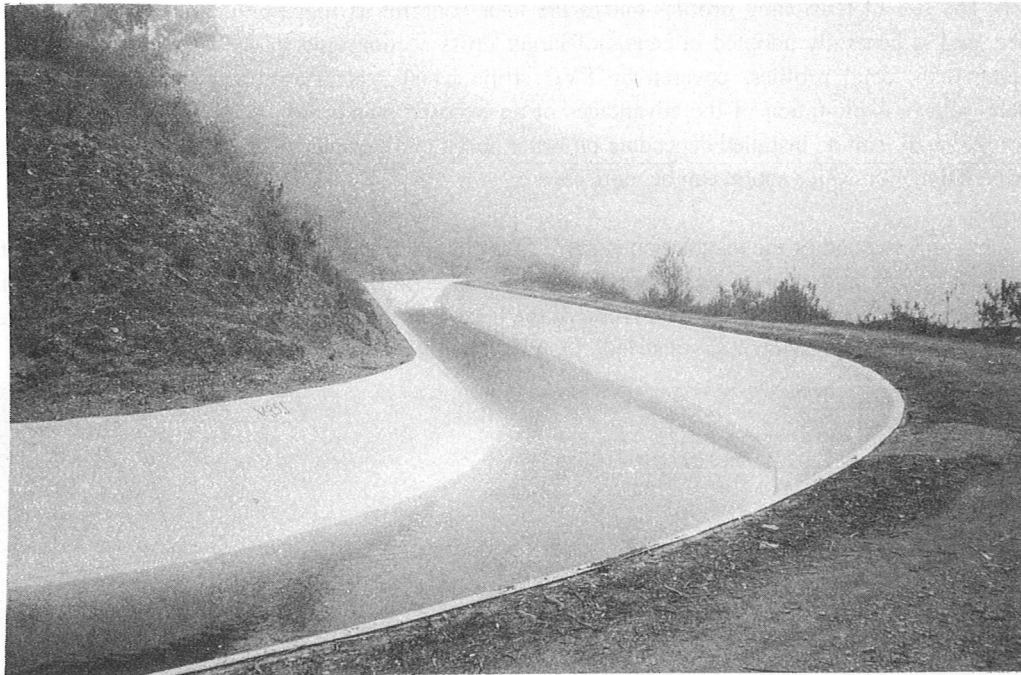
Figure 3. Exposed composite PVC membrane

Whenever possible, the PVC membrane is left exposed, to avoid reduction the canal section and to better exploit the low hydraulic roughness of this material. Figure 3 is an example of exposed membrane system. Leaving the membrane exposed can offer as further advantages elimination of vegetation growth, and the possibility of a quick and easy maintenance, as any damage can be immediately and easily detected and repaired.

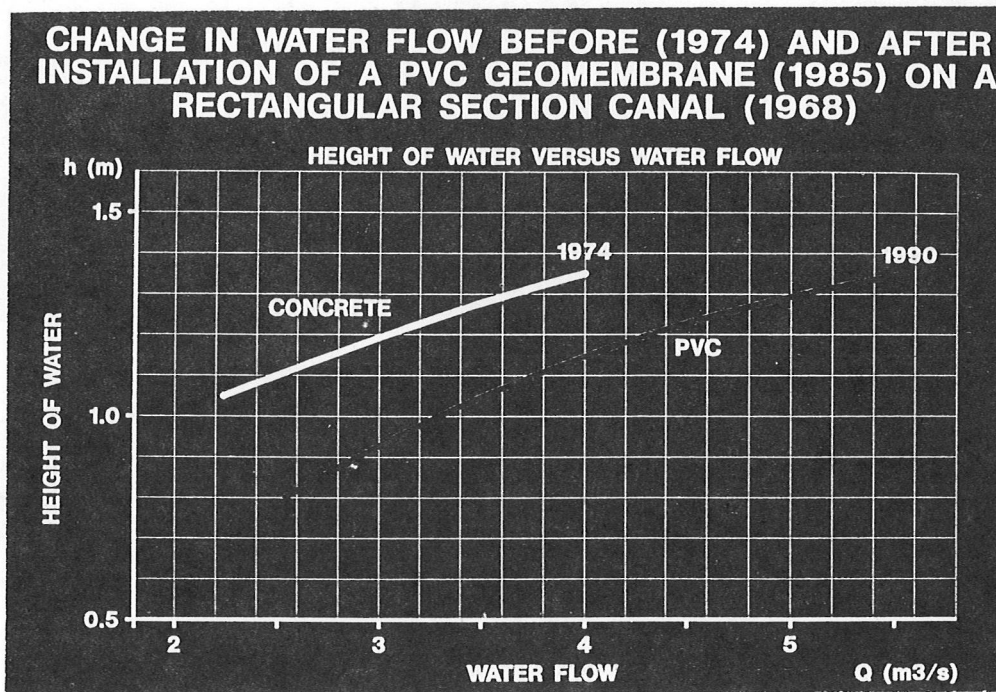
Figure 4. Increase in water flow

Figure 4 refers to a concrete canal built in 1968 and waterproofed with an exposed PVC membrane in 1985. In this case, comparison between water flow values recorded in 1974 (with original concrete liner)

and in 1990 (5 years after installation of the PVC liner) showed an increase in water flow of 35%. Since 1985, improvements in the system have allowed to attain documented increase in water flow up to 90%.

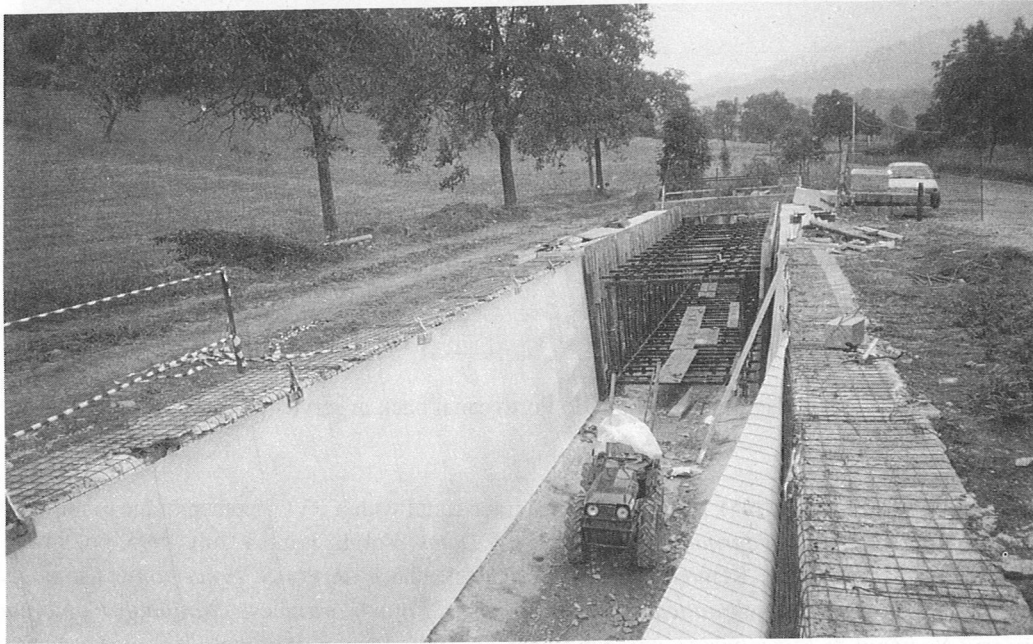
Figure 6. Sibelon CL membrane installed over the Droncro power supply canal

a PVC geomembrane, smooth on one side and corrugated by PVC ribs to be embedded in concrete during casting on the other side, is set on the formworks before construction of the new reinforcement layer. The PVC ribs provide a diffuse and efficient anchorage of the membrane to the new concrete structure. This anchorage is very reliable, as it can withstand very high water speed and turbulence, and it also provides a very effective drainage system for uplifts waters: the elasticity of PVC (more than 300% of elongation at break) allows deformation of the membrane and creates a thin, self-adjusting drainage gap between the liner and the concrete. The low hydraulic roughness of the smooth side of the PVC membrane in direct contact with water allows the increase in water flow which counterbalances the cross section reduction. This solution has already been adopted by ENEL in high mountain canals (Figure 6).

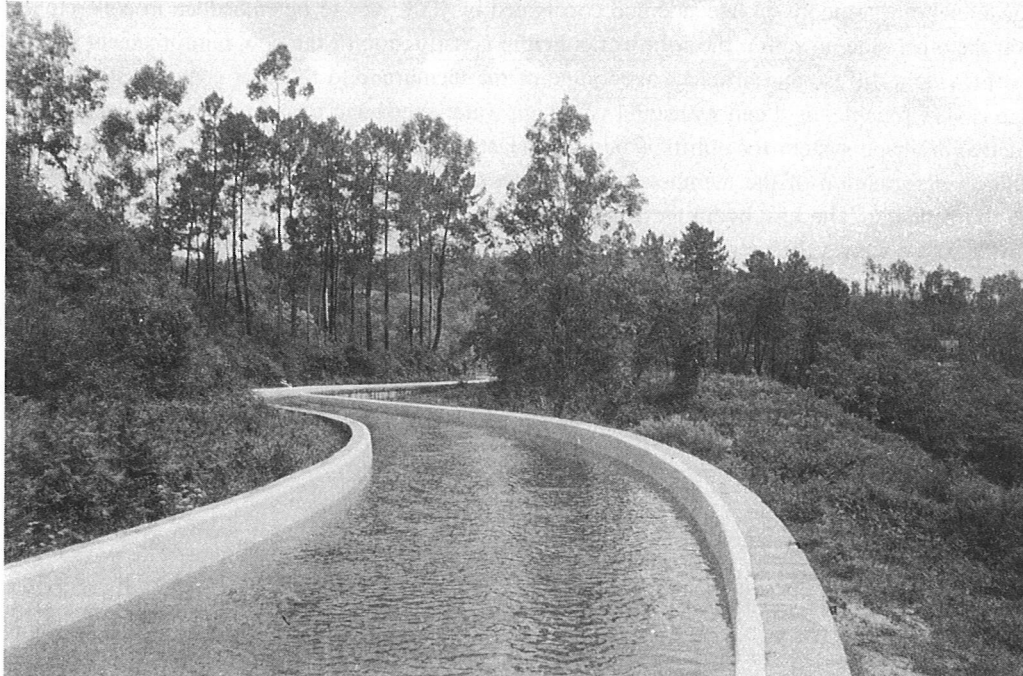
Figure 7. Senhora do Porto canal back in service

Figure 7 illustrates major projects executed in canals with the described state of the art system.
