STABILISATION OF SLOPES IN GARHWAL HIMALAYA

K.G. Garg

Central Building Research Institute, Roorkee-247 667, India

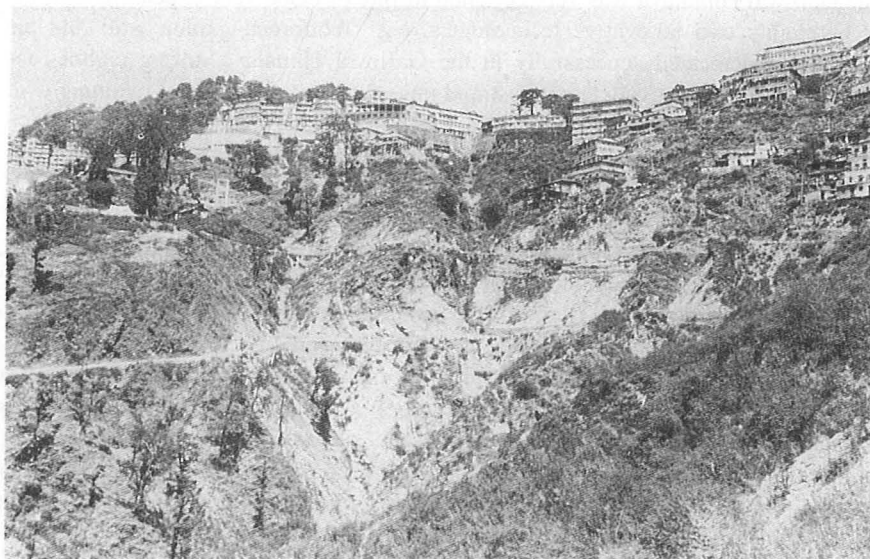
Fig. 1. View of Slope at Km. 5 along Mussoorie Chamba Bye-Pass.

Mussoorie is one of the famous hill stations in north India. It is situated at an altitude varying approximately from 1600 m to 2500 m at a distance of 31 km from Dehradun in the State of Uttar Pradesh. A bye-pass road was built by U.P.P.W.D. in the year 1976-77 connecting Dehradun-Mussoorie road and Mussoorie-Chamba road to bye-pass Mussoorie town and congested Landhour market. In the year 1978-79 a link road was also constructed by U.P.P.W.D. connecting the bye-pass road with Landhour market of Mussoorie town. Both these constructions involved cutting of hill slopes which could be responsible for accelerating instability of the slope in this region. Problem of subsidence of roads by about 60 to 80 cm during rainy season and widening of cracks in a group of buildings, located on the top of slope at km 5 on the bye-pass, was studied by CBRI. This was of great concern as some of the buildings, situated on the slope, had either cracked or even partially damaged due to subsidence and surface movements in the area (Fig. 1 & 2).

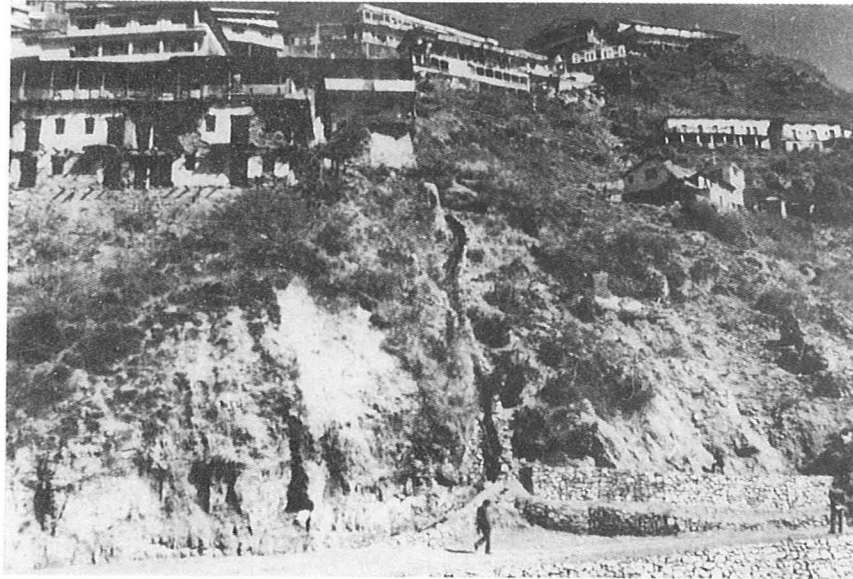
Fig. 2. View of damaged buildings on the slope on Mussoorie-Chamba Bye-pass

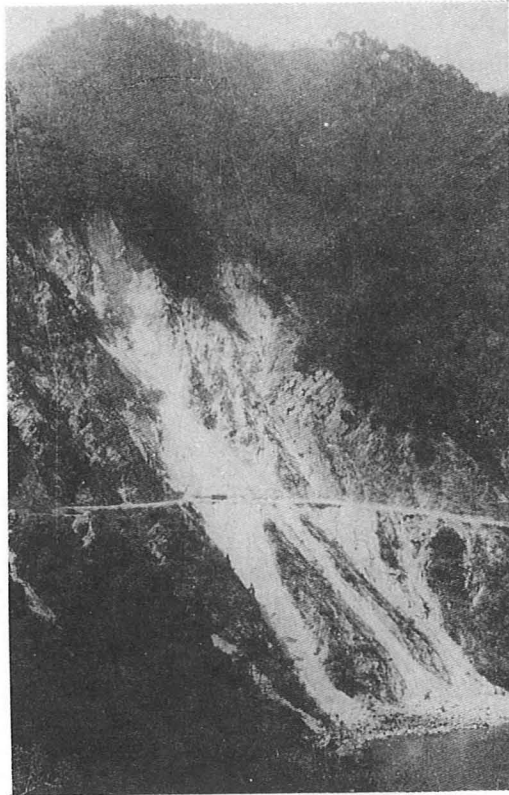
Fig. 5. View of Slope at Kaliasaur landslide

This landslide (Fig. 5) is located at km 147 on Hardwar-Badrinath road, 18 km east of Srinagar (Garhwal) and is situated in a sharp bend on left bank of river Alaknanda. Area suffered a major landslide on 19th September 1969 which had blocked 3/4th of the total width of the river flowing about 100m below road level. Road was damaged badly in a stretch of about 300m. The crown portion of the slide extended upto 120m above the road level. Geologically this landslide is located in the Garhwal group of rocks. The main rocks in this area are purple-white and light green quartzites interbedded with maroon shales. It appears that quartzite with maroon shales pass through the slide zone. These rocks have been pulverized converting the shale into clay which might have caused the sliding and accumulation of debris at the foot of the escarpment. The toe of this accumulated debris is near the river. The uphill slope of the slide zone above the road was highly unstable and caused heavy flow of debris during rainy season. There was an urgent need to restrict the sliding of debris. It was with this reason that the idea of making effective use of landslide debris and slope waste was pursued at the CBRI and the technology of drum diaphragm wall was evolved (CBRI - 1988) through design and field trials. Such a construction technology makes the maximum use of landslide debris and costs only about 60 per cent of the cost of conventional retaining wall.

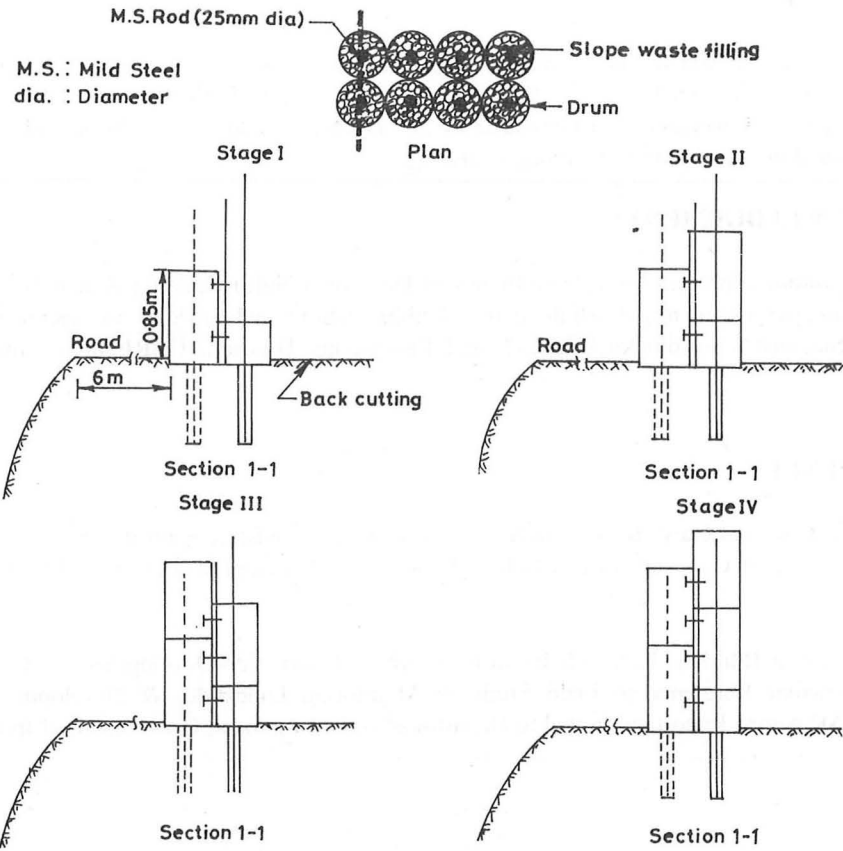
Fig. 7. Sequence of construction of anchored drum diaphragm wall

Location of the wall was marked on the prepared ground. Holes were drilled to a minimum depth of 60cm at predetermined positions 1m apart to accommodate 25cm diameter mild steel rods. The rods were driven into these holes. About 15cm wide and 45cm deep pit was made around these rods. cement slurry was poured into the hole and the pit was filled with 1:3:6 cement concrete. These rods served as vertical anchor at the base and provided additional resistance to sliding. The drums were then assembled and bolted in sequence (Fig. 7) to interconnect them. Alternate vertical rods in the rear row were supported at 1.3m level with the help of 50mm x 6mm mild steel flat which was taken into debris accumulated over the slope. The flats are held in position by two 25mm diameter mild steel bars driven vertically into the debris.

This has helped in preventing tilting of the retaining wall. As the construction proceeded, already completed portion of the wall was filled with debris. The space behind the wall was also filled with debris. 50mm x 6mm flat having a 28mm diameter hole at the centre was held against two drums of the front row. An L-shaped 25mm diameter, 3m long mild steel rod was inserted into the hole and driven inside the debris. This system was provided at 2 meters spacing to keep it in proper alignment and to provide additional stability.

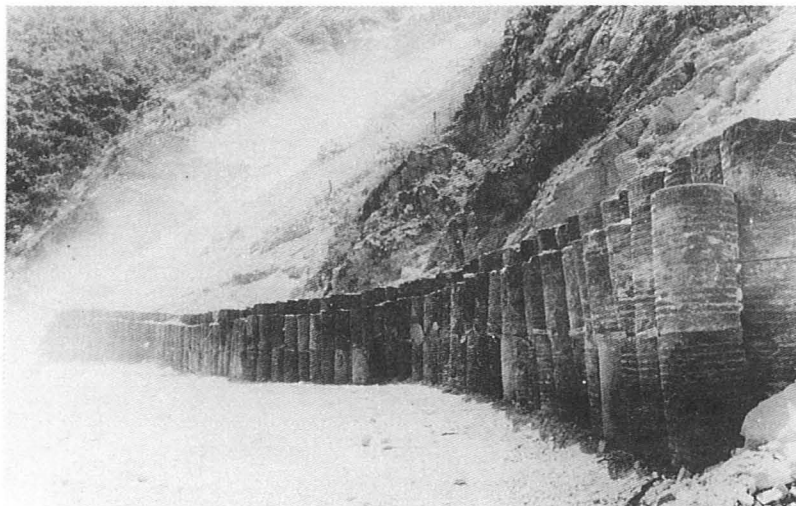
Fig. 8. View of the drum-diaphragm wall built at toe of upper slope

About 100m long and 2.5m high wall was constructed at Kaliasaur landslide location during 1986. Alignment of the wall was monitored in those days which did not show any significant change. Fig. 8 provides the view of the wall constructed at the site.
