Heavy preloading and consolidation of soft soil masses with the use of reinforced embankment and vertical drains

ABSTRACT: A large part of field “B” in the open cast coal mine “Kolubara”, in the Republic of Serbia, was covered by soil masses slid from the disposal area to the active coal excavation area in March-April 2006. A landslide with a length of approximately 2 km and the width of more than 400 m stopped the coal excavation in the field “B”. The already exposed coal stratum was covered by 30 m – 40 m thick very soft soil deposits. An improvement of soft soil deposits at the front part of the field “B” and subsequent open excavation to the roof of the covered coal layer seemed to be the best solution. A heavy pre-loading consisting of a 9.5 m high embankment and an accelerated consolidation by the use of vertical drains was selected. A high tensile strength geosynthetic reinforcement placed at the base of the embankment allowed for a shorter construction time. The pre-loading stage was monitored. After 8 months of consolidation 25 samples were taken away from different locations and depths and a reasonable improvement of the shear strength could be confirmed. Due to the perf

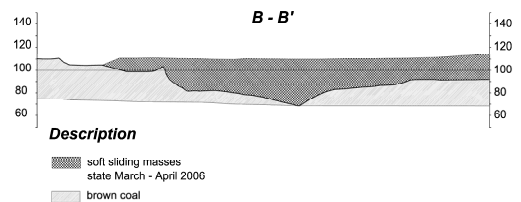
Fig. 1 Cross-section B-B’, March-April 2006, state after of the landslide of soft soil masses

with the thickness of 12 m - 15 m. This situation is schematically presented in cross-section B-B’, in Figure 1.

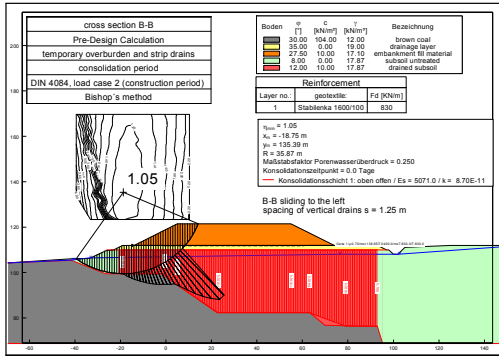
Fig. 2 Cross-section B-B', Stability analysis of embankment, Bishop's method

A high tensile strength woven fabric made from polyester with ultimate tensile strength UTS = 1.600 kN/m was designed as a basal reinforcement. Due to the short time of loading up to 1 year, the design tensile strength of this geotextile was estimated as $F_d = 830$ kN/m. The collection of the achieved results for all sections is presented in table 2. The most critical location was the cross-section B-B' with the safety factor $\eta = 1.05$, which was lower than the value of 1.30 required in DIN 4084 for construction works, see Figure 2.

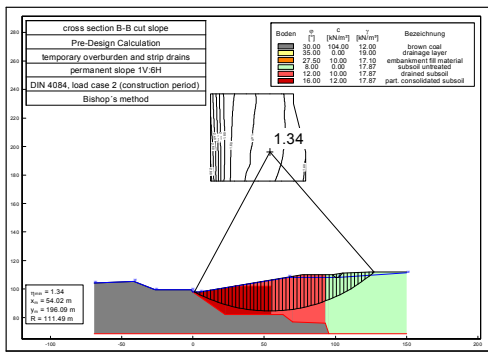
Fig. 3 Cross-section B-B', Stability analysis of excavated slope after pre-loading, Bishop's method

The next stage of design was to estimate the factor of safety during the sloped excavation in the improved area to the roof of the coal stratum. According to the laboratory investigations the stability analysis was performed with the early predicted shear parameters. Figure 3 presents schematically a cross-section of excavated slope under an inclination of 1:6. The results of the stability analysis for the excavated slope are collected in table 3. The min. value of safety factor equal to 1.34 were estimated in

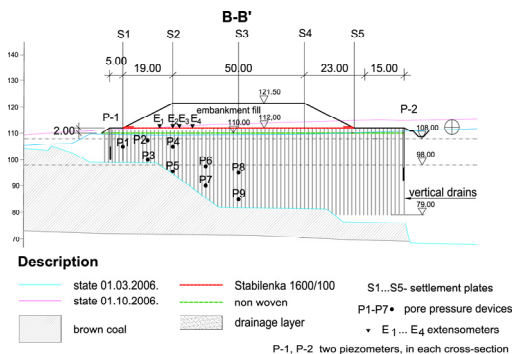
Fig. 4 Cross-section B-B', monitoring plan

Due to the low predicted safety of embankment a monitoring system was installed, consisting of: pore pressure devices, hydrostatic piezometers, extensometers, settlement plates installed on the geotextile reinforcement and markers placed on the ground surface for GPS measurements (control of settlements and horizontal movements in the vicinity of working platform) were installed. Typical location of the monitoring devices is shown in Figure 4, i.e. the cross-section B-B' with the lowest predicted stability reserve, $\eta = 1.05$.

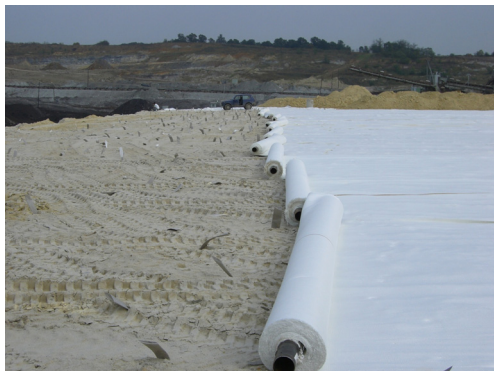
Fig. 5. Installation of geotextile reinforcement on the top of working platform, UTS = 1600 kN/m

The embankment was started after the installation of vertical drains and of the geotextile reinforcement in October 2007. The installation of the geotextile reinforcement at the embankment base is shown exemplarily in Figure 5. Generally, the area to be loaded and the vicinity of the working platform was very unstable showing cracks and steps. In spite of these difficulties the construction works were continued.

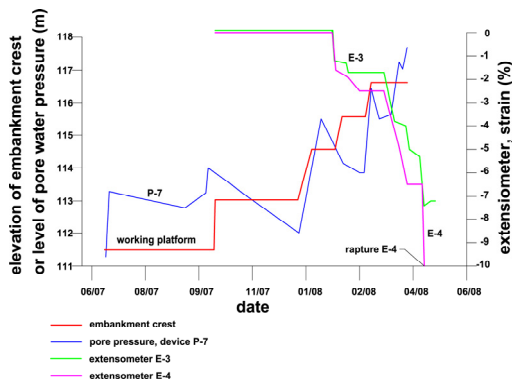
Fig. 6. Monitoring data, cross-section B-B', July 2007 -April 2008

In April 2008 a rupture at the location of the extensometer E-4 was noticed and a rotational sliding of the front part of the embankment observed, see Figure 6.

The slip plane was relatively flat due to the partial extrusion of soft soil at the front of the embankment. It was later confirmed that the flat sliding plane did not affect the improved area, which has an importance for the further excavation. After a removal of 25 samples from 12 different located boreholes laboratory tests were performed in the summer 2008, the results showed out a remarkable improvement of the shear strength after pre-loading. The characteristic values of the main parameters were estimated for the

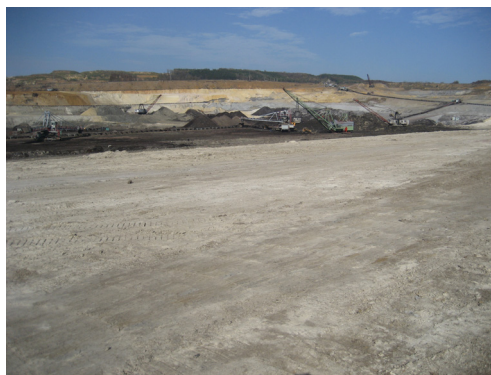
Fig. 7 Excavated slope in the improved soft soil masses, slope inclination 1:6, in the front part uncovered roof of coal layer

In October 2008 the excavation to the coal layer was finished, (see Figure 7) and 2 inclinometers were installed in each of four cross-sections in the central part of slope. A renewed excavation of coal started in November 2008. Initially the slope showed a horizontal movement with a velocity 5 - 20 mm/day. In January 2009 the velocity of the horizontal movement reduced into the range of 0.3 - 0.6 mm/day. Due to the stable situation the monitoring was stopped in February 2009. Up to this day 1.2 Million tons coal were extracted and the excavated slope in the improved area presents a sufficient structural integrity.
