Heavy preloading and consolidation of soft soil masses with the use of reinforced embankment and vertical drains

Sobolewski, J.

HUESKER Synthetic GmbH, Gescher, Germany

ABSTRACT: A large part of field “B” in the open cast coal mine “Kolubara”, in the Republic of Serbia, was covered by soil masses slid from the disposal area to the active coal excavation area in March-April 2006. A landslide with a length of approximately 2 km and the width of more than 400 m stopped the coal excavation in the field “B”. The already exposed coal stratum was covered by 30 m – 40 m thick very soft soil deposits. An improvement of soft soil deposits at the front part of the field “B” and subsequent open excavation to the roof of the covered coal layer seemed to be the best solution. A heavy pre-loading consisting of a 9.5 m high embankment and an accelerated consolidation by the use of vertical drains was selected. A high tensile strength geosynthetic reinforcement placed at the base of the embankment allowed for a shorter construction time. The pre-loading stage was monitored. After 8 months of consolidation 25 samples were taken away from different locations and depths and a reasonably improvement

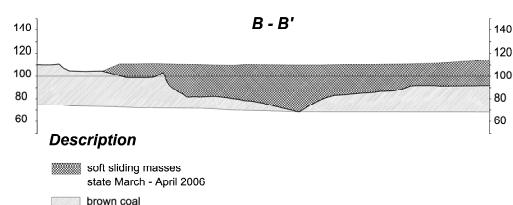
Fig. 1 Cross-section B-B’, March-April 2006, state after of the landslide of soft soil masses

Brown Coal Mine Kolubara is located in the west part of Serbia, ca. 80 km from Belgrade. The coal exploitation in the field “B” started in 1951. From 1951 and up to March 2006 approx. 75 Million tons of brown coal were excavated. Simultaneously, more than 176 Million cubic meters of removing cover soil were deposited behind the steadily moved front of the excavation area. In spring 2006 the first signs of a landslide process could be observed. Due to the very wet winter and spring an acceleration of the movement of deposited soft soil fill was noticed. In March 2006 the velocity of the landslide was estimated with 2 m/day. The movement was observed on the length of 2 km and on the width of more than 450 m. Practically 80 Million m³ moved slowly towards the front of the coal excavation. Due to this extreme landslip risk in April 2006 the whole equipment was removed and the exploitation of coal in the field “B” was stopped. The whole area of the recently opened coal field was completely covered by soft soil masses. A part of the landslide overtopped the unexcavated coal in a form of a tongue

with the thickness of 12 m - 15 m. This situation is schematically presented in cross-section B-B’, in Figure 1.

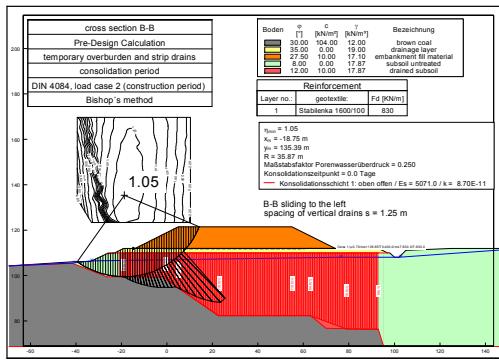
Fig. 2 Cross-section B-B', Stability analysis of embankment, Bishop's method

A high tensile strength woven fabric made from polyester with ultimate tensile strength UTS = 1.600 kN/m was designed as a basal reinforcement. Due to the short time of loading up to 1 year, the design tensile strength of this geotextile was estimated as $F_d = 830$ kN/m. The collection of the achieved results for all sections is presented in table 2. The most critical location was the cross-section B-B' with the safety factor $\eta = 1.05$, which was lower than the value of 1.30 required in DIN 4084 for construction works, see Figure 2.

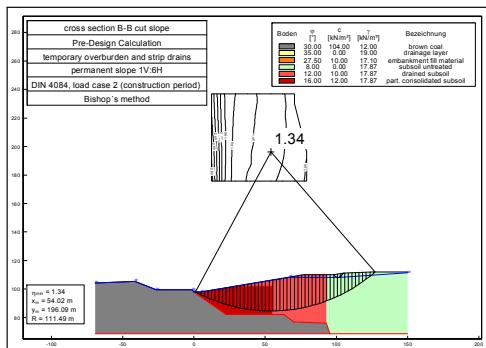
Fig. 3 Cross-section B-B', Stability analysis of excavated slope after pre-loading, Bishiop's method

The next stage of design was to estimate the factor of safety during the sloped excavation in the improved area to the roof of the coal stratum. According to the laboratory investigations the stability analysis was performed with the early predicted shear parameters. Figure 3 presents schematically a cross-section of excavated slope under an inclination of 1:6. The results of the stability analysis for the excavated slope are collected in the table 3. The min. value of safety factor equal to 1.34 were estimated in

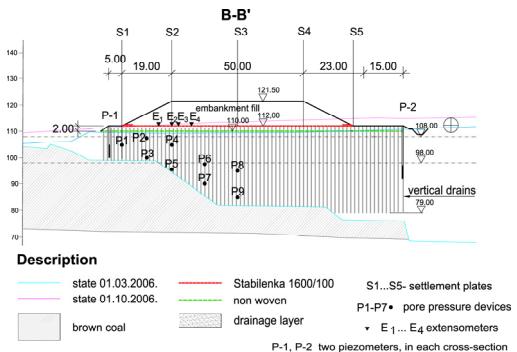
Fig. 4 Cross-section B-B', monitoring plan

Due to the low predicted safety of embankment a monitoring system was installed, consisting of: pore pressure devices, hydrostatic piezometers, extensometers, settlement plates installed on the geotextile reinforcement and markers placed on the ground surface for GPS measurements (control of settlements and horizontal movements in the vicinity of working platform) were installed. Typical location of the monitoring devices is shown in Figure 4, i.e. the cross-section B-B' with the lowest predicted stability reserve, $\eta = 1.05$.

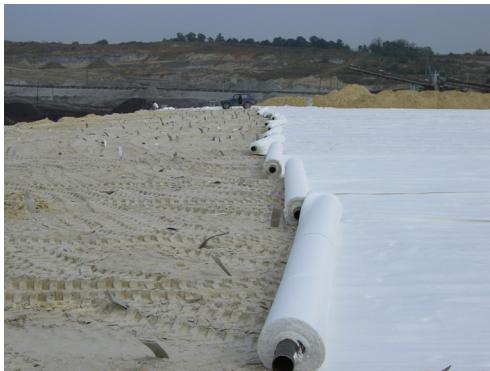
Fig. 5. Installation of geotextile reinforcement on the top of working platform, UTS = 1600 kN/m

The embankment was started after the installation of vertical drains and of the geotextile reinforcement in October 2007. The installation of the geotextile reinforcement at the embankment base is shown exemplary in Figure 5. Generally, the area to be loaded and the vicinity of the working platform was very unstable showing cracks and steps. In spite of these difficulties the construction works were continued.

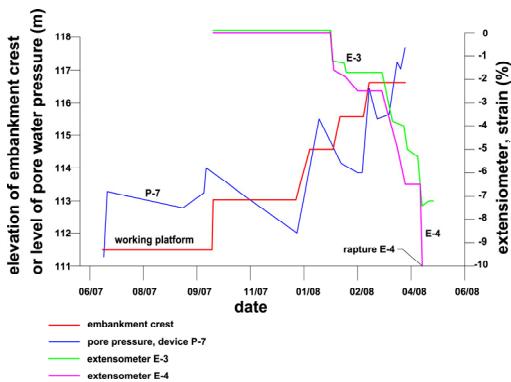
Fig. 6. Monitoring data, cross-section B-B', July 2007 -April 2008

In April 2008 a rupture at the location of the extensometer E-4 was noticed and a rotational sliding of the front part of the embankment observed, see Figure 6.

The slip plane was relatively flat due to the partial extrusion of soft soil at the front of the embankment. It was later confirmed that the flat sliding plane did not affect the improved area, which has an importance for the further excavation. After a removal of 25 samples from 12 different located boreholes laboratory tests were performed in the summer 2008, the results showed out a remarkable improvement of the shear strength after pre-loading. The characteristic values of the main parameters were estimated for the

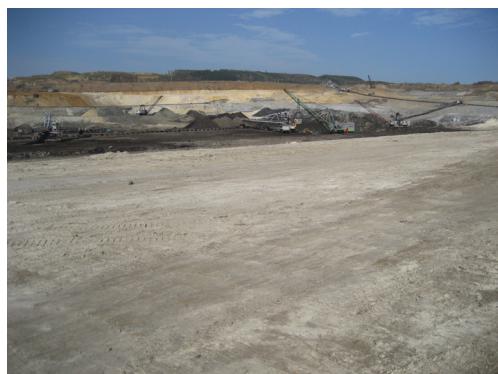
Fig. 7 Excavated slope in the improved soft soil masses, slope inclination 1:6, in the front uncovered roof of coal layer

In October 2008 the excavation to the coal layer was finished, (see Figure 7) and 2 inclinometers were installed in each of four cross-sections in the central part of slope. A renewed excavation of coal started in November 2008. Initially the slope showed a horizontal movement with a velocity 5 - 20 mm/day. In January 2009 the velocity of the horizontal movement reduced into the range of 0.3 – 0.6 mm/day. Due to the stable situation the monitoring was stopped in February 2009. Up to this day 1.2 Million tons coal were extracted and the excavated slope in the improved area presents a sufficient structural integrity.
