Submerged barrier for coastal protection application built with tubes in geosynthetics of big diameter in Tuscany – Italy

In this paper we present an ongoing field study aimed at the detailed monitoring process of a new submerged breakwater built with PET geocomposite geotextile tubes of big diameter, focusing on installation issues and medium term behaviour. Field monitoring confirms that design methods are not sufficiently accurate to predict the final shape of the structure and that hydraulically filled elements have a very limited environmental impact during construction; nevertheless construction technology requires very accurate control during installation. The system performed very well with limited environmental impact during construction and under severe sea storms and colonization by marine flora on the geocomposite surface is very rapid.

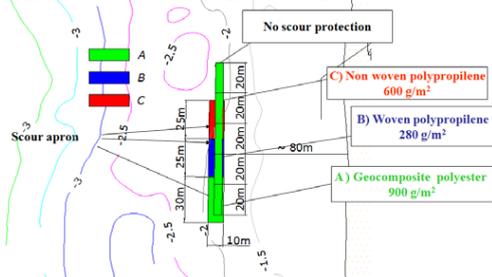
The tube is designed with the hypothesis that the structure made of tubes in geotextile has the same hydraulic response (i.e. protection of the beach), of a rubble mound structure. A structure was therefore designed, of about 0.5 m submergence, 100 m length parallel to the shore and 80 m distance from the beach (Figure 2). Tubes have a nominal diameter of 3.0 m and a final height of 1.6 m installed at the average depth of 2.0 m (Figure 2, Figure 3).

Figure 2 Outline of tubes placement and materials employed

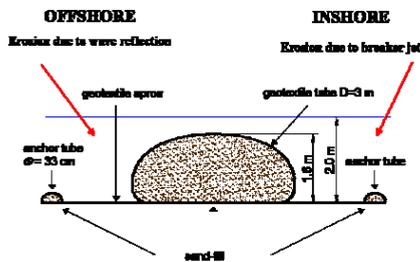
Figure 3 Section of tube and scour apron

Due to the action of currents and waves, structures formed by one or more tubes can lead to local scour, possibly resulting in geotechnical instability. Therefore, for protecting against scouring the design included a filter fabric apron. A filter fabric apron, also known as a scour apron, usually consists of a small tube, called an anchor tube, built into the seaward edge of the apron or around the entire perimeter. The anchor tube is filled with dredged material to stabilise the scour apron. The scour apron should extend for a sufficient distance in front of and be-

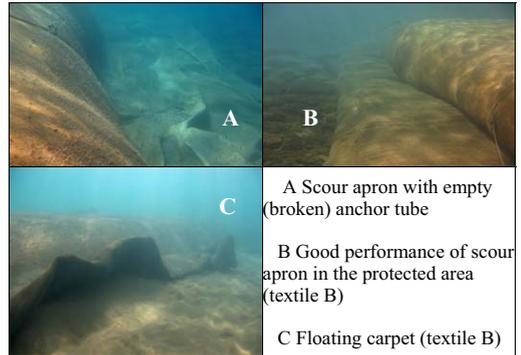
in the right position while installation difficulties have been noticed for the scour apron, and the small anchoring tubes. Furthermore polypropylene aprons (B and C) tend to float, and this leads to an increased stress abrasion of the fabric (Figure 4).

Figure 4 Different performance of scour aprons

Only specific areas being subject to significant mobility of the geotextile, due to wrong positioning, has resulted partially damaged as the PP floating scour apron below the structure that was no longer anchored and around one filling port.(Figure 4).

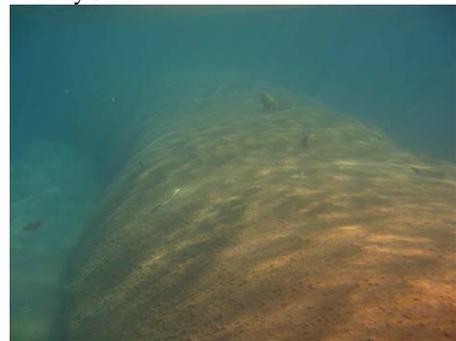
In this site, the sandy bottom has very high mobility, and strong interaction with the tubes was evident from the first surveys- in many cases the scour apron was even covered. An example is shown in Figure 5 and Figure 6 where the tube on the right was installed at 2 m depth and became almost completely covered by sand.

Figure 5 Initial tube shape

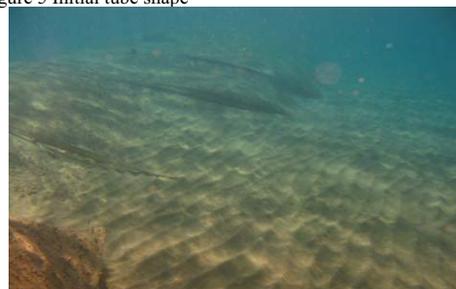
Figure 6 Sand-covered tube

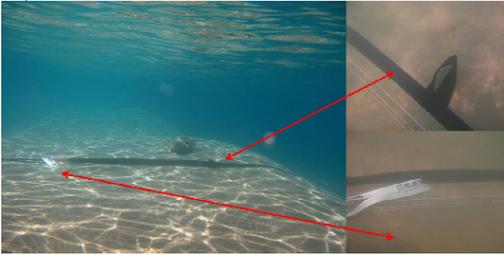
Three measurements of the sea bottom in the surroundings of the tube were carried out using a single-beam echo sounder. Moreover a Differential Global Positioning System (DGPS) measured specific marked points placed on the surface of the tube and on the coastline with 1 cm accuracy. These marks on tubes (Figure 7) were placed in order to have their movements followed over the time: their position is indicated in Figure 8.

Figure 7 Marks on tube surface

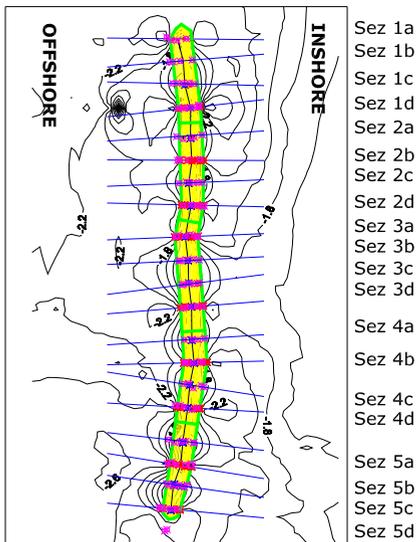
Figure 8 Position of the tubes and sketch of DGPS campaign

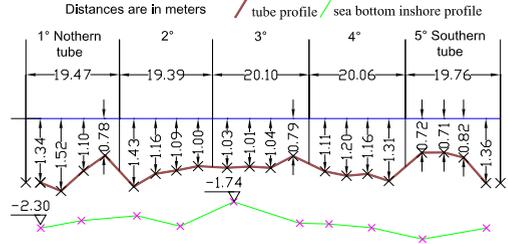
The longitudinal section that was obtained from the survey made immediately after the consolidation of the tubes (Figure 9), shows that the breakwater is few parts is lower than what had been designed; this is due to the natural unevenness of the bathymetry, and in part to a partial filling of the tube.

Figure 9 Longitudinal section of the barrier after consolidation (August 2008)

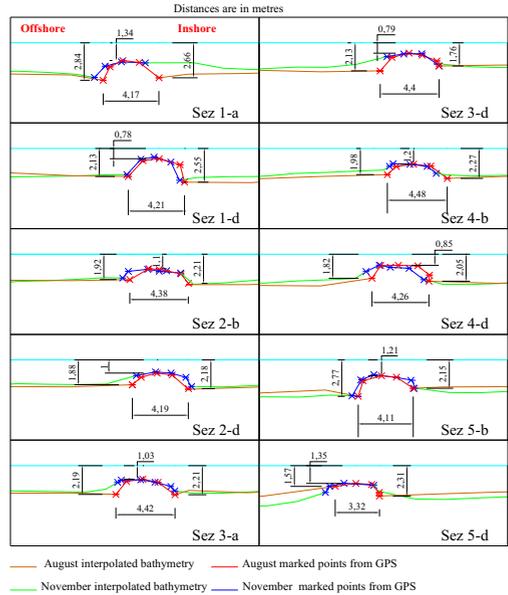
In this way information on changes in the shape of the tube includes a time series of some specific points, and is more accurate than what could be obtained with the echo sounder survey only (Figure 10).

Figure 10 Geometrical evolution of the tube and surrounding sea-bottom - quotes are referred to the first survey.

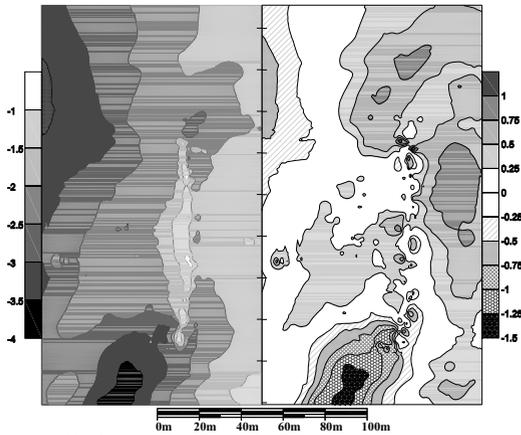
In Figure 11 (left) the latest results on detailed bathymetry are shown. There is an accumulation of sand immediately inshore and offshore the barrier. This means that accreting storms occurred and the tubes interacted with the sand that was moving shoreward; sand accumulated offshore the tubes, and in part overpassed the barrier. Wave and barrier interaction created a tombolo, at one meter below the mean sea level: this indicates that the designed level of protection was achieved.

Figure 11 Bathymetry obtained a few months after construction of defence system (18 November 2008) (left); Comparison of bathymetry surveyed in two occasions after installation: 28 August and 18 November 2008 (right).

Figure 11 (right) shows a comparison between the last survey performed (November 2008) and the survey conducted 1 month after the construction of the tube (August 2008). In the southern area an interaction of the structure with longshore currents can be seen. Between the first and the last survey, this led to an erosion of the sea bottom near the downstream head of the barrier that exceeds one meter. Except for this erosion verified in the offshore area, the bathymetry seems to be in a substantial equilibrium.

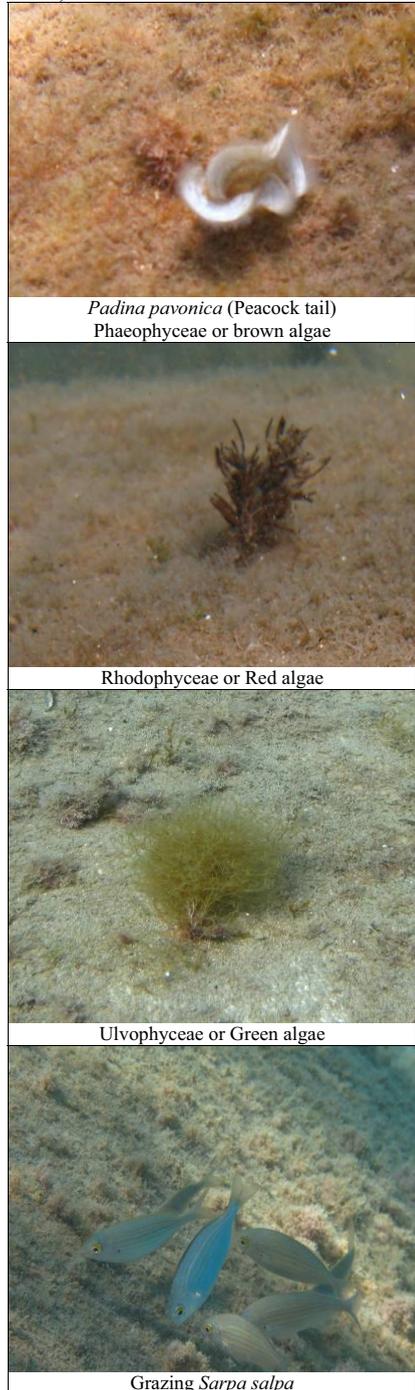
The survey carried out on 31 September 2008 showed that, about three months after its construction had initiated, the geotextile system presented an almost uniform algal cover. There was greater prevalence of algae from the morphological group of Phaeophyceae or brown algae (Figure 12), mainly in areas sheltered from wave action and well lit. In particular, it was possible to detect the presence of species such as *Dictyota dichotoma*, *Stypocaulon sco-*

parium and few *Padina pavonica* (Peacock tail) (Figure 12).

Figure 12 Marine growth on the tube

Even Coralline algae which belong to the group of Rhodophyceae or red algae (Figure 12) were very abundant, such as *Jania rubens*, which covers much of the surface of tubes, with a characteristic yellowish-white colour in areas that are heavily exposed to light and rose-purple in areas receiving less light. The presence of these algal populations, mainly photophilic, attracted several species of fish belonging to the family of Sparidae, such as Seabream or Diplodus, *Oblada melanura* and White salem or *Sarpa salpa*, that browse the substrate for food.
