# Novel geocomposite liner system for the irrigation channels and waterways

**ABSTRACT:** This paper discusses the use of a new and novel liner system for the lining of water channels. The PMC Liner is a polymer-modified cementitious coating impregnated into a reinforced woven geotextile to create an impervious, strong, durable and flexible liner system. The polyester geotextile reinforcement confers the mechanical strength and tear resistance while the impervious polymer modified cement coating is impermeable and protects the geotextile support from UV light and chemical attack. The PMC liner can be installed over aged concrete where it can bridge joints and cracks. The PMC liner prevents seepage through the cracks and joints of aged concrete channels. The PMC liner has the look and texture of concrete but the flexibility and chemical resistance of a polymeric liner.

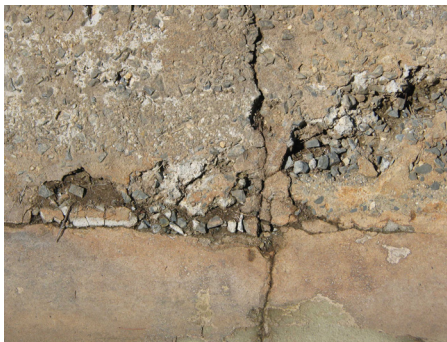
Photograph 1

Many water channels have in the past been lined with reinforced or plain concrete and now require remediation due to leakage problems (see photograph 1 below). Leakage from such channels arises from leaching of calcium ions/erosion, settlement induced cracking, thermal cycle fatigue cracking, deteriorated expansion joints, opened construction joints, deterioration due to chemical attack etc. When a crack occurs in a concrete channel lining the amount of leakage that occurs can be staggering.

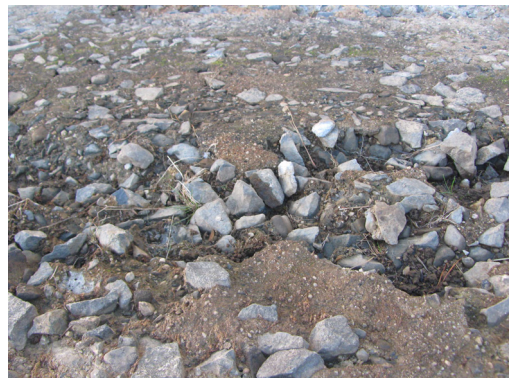
Photograph 2

The leaching out of the calcium from the cement in the concrete has left sharp, angular rocks exposed in the channel wall (see photograph 2 below). In many there are settlement cracks in some instances holes have appeared. As a result water loss by seepage is significant. The water loss can also be accompanied by wash out of the support of the canal wall.

Over time the concrete walls have been weakened by the dissolution of the cement at the surface and has now reached the point where the large aggregate is starting to come loose. The deterioration of the rate at which calcium can be leached out of the concrete and this is in turn dependant on the concentration of calcium in the water and the pH. The less calcium in

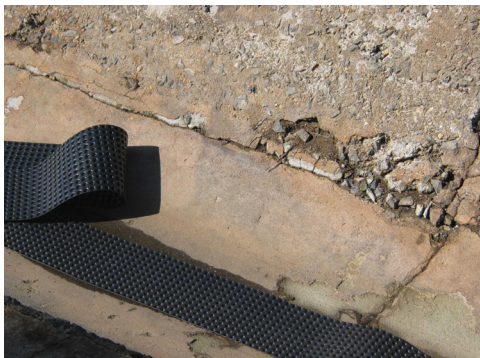
Photograph 4

- (i) The channel is cleared and shaped if required (with limited compaction) for PMC Liner placement and anchoring channel structures. Note: the liner can be installed on damp substrates. A cusped HDPE drainage cell is installed in the base of the channel to allow infiltrated water to be captured and diverted through a channel sump to overflow spillways. (see photograph 4 below).

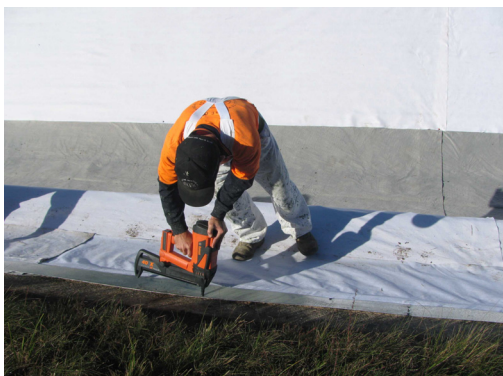
Photograph 5

(ii) For concrete channels the base liner is adhesively bonded with a bituminous adhesion and secured to the channel edges using steel batten strips (see photograph 5 below). Seam-joint overlaps are formed in the downstream direction.

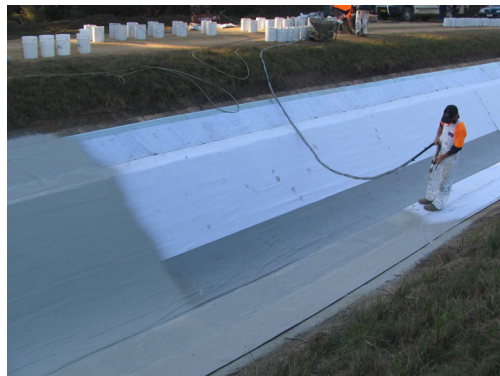
(iii) The PMC Coating is sprayed onto the geotextile (using a textured spray gun) to a 3mm build. The overlaps are also sprayed with the PMC mixture so an integral coating is present over the entire liner. This virtually eliminates leaks due to poor welds. Photograph 6 below shows PMC being applied over the nominated geotextile.

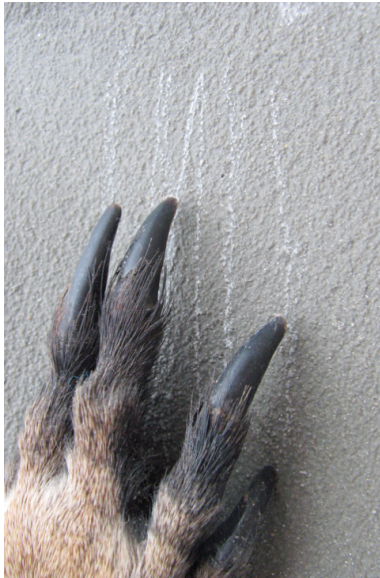
Photograph 7

- the liner construction is substantially thicker (3-6 mm) than other geomembranes (usually 1.5-2.5 mm)
- it has high puncture resistance and hence tolerance to field damage by kangaroos for example (see photograph 7 below)
- it has good frictional characteristics due to the polymer modified cementitious compound that is impregnated into the reinforced woven geotextile (textured surface similar to concrete)
- it has very high grab tensile strength (up to 50 kN/m)

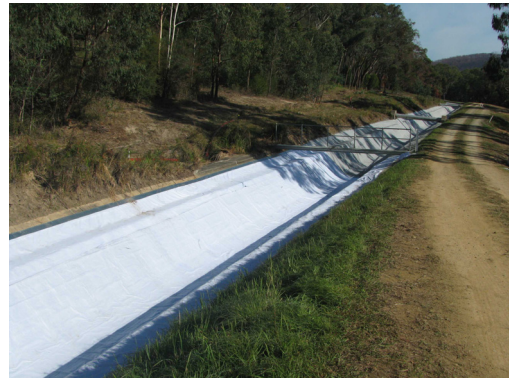
Photograph 8

Flexible & Conformable: The flexibility of the liner allows it to conform to uneven subgrade and integrate into existing channel headwalls and containment structures. The photograph below (photograph 8) shows the base liner installed before the application of the PMC spray coating.

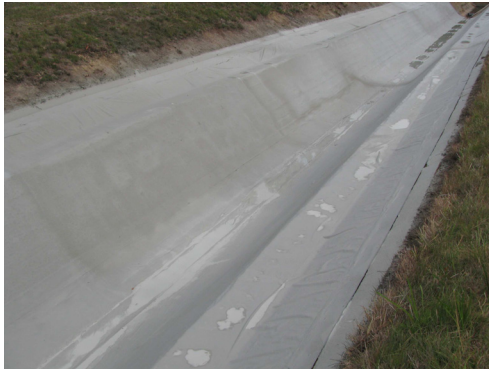
Photograph 9

Hard Wearing Textured Surface: The cementitious coating provides grip and can tolerate mechanical, human and fauna traffic ('walk in walk out' thus no fencing is required) (photograph 9 below shows the finished PMC liner)

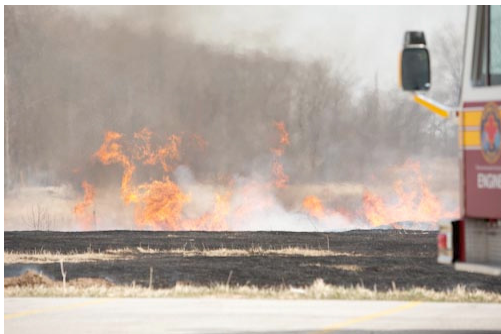
Photograph 10

**Non Flammable:** The thick cementitious coating renders the PMC liner non-flammable making it resistant to bushfires as well as channel fires that propagate in channels by consuming the blow grass or umbrella grass (see photograph 10 below).
