# The design and construction of a noise barrier in reinforced soil at Brussels International Airport

*Keywords:* Airports, Barrier, Geotextiles, Monitoring, Performance evaluation

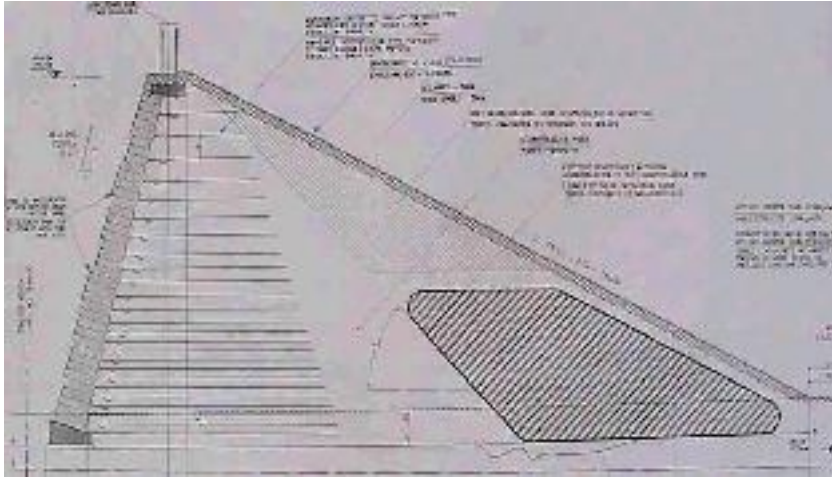
Figure 1. Original conceptual scheme from BIAC

The sound barrier, having slopes on both sides, became narrower towards the top, as shown in Figure 1.

It can be seen that the airport slope is more gentle at 1v:2h and the village slope with the concrete elements is at 1v:4h. This asymmetrical geometry causes problems with both the basic design of the reinforced soil and slip circles, and the specification and supply of the geotextiles.

The original concept was prepared by the Belgium International Airport Company. It was issued as a set of conceptual drawings and minimum specifications for contractors to prepare tender bids. This can be seen in Figure 1.

The following were some of the features of the original concept that needed attention by the design consultant. The original concept drawings showed a non-standard geotextile reinforcement pattern; the foundation structure for the concrete facing elements needed revising; the foundation structure for the surmounted fence needed analysis; the contaminated soil 'sausage' needed careful analysis with alternative locations; there was no basal reinforcement to tie the whole structure together, and there were some potential slip surfaces generated by the geometry of the HDPE contaminated soil liner and the proposed soil block construction on the airport side slope.

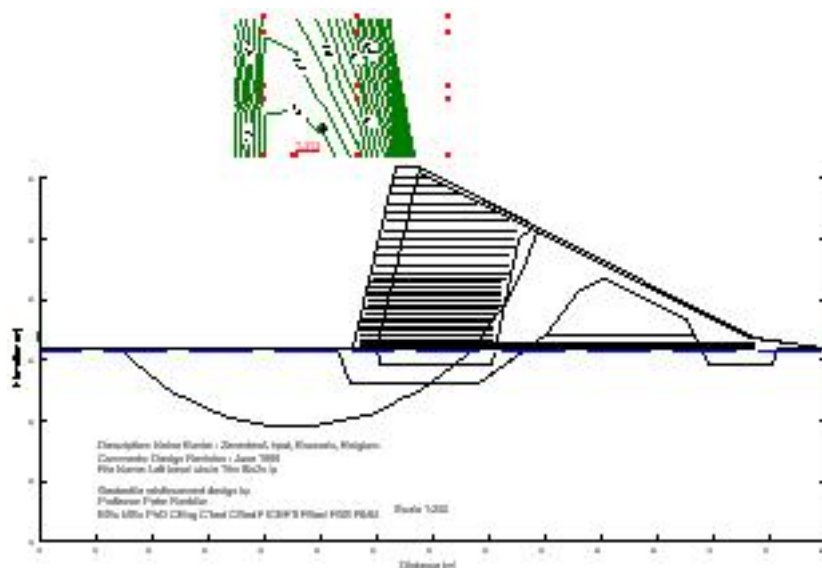
Figure 2. Design cross section similar to final construction.

The final design for the internal reinforced soil block comprised 16 layers of 200 kN/m polyester woven geotextile at 364 mm centres in the 'lower half' of the structure, followed by 5 layers of 200 kN/m polyester at 728 mm centers and finally by 6 layers of 100 kN/m polyester geotextile at 728 mm centers. This arrangement can be seen in Figure 2.

Having assessed the required geotextile configuration, the Slope-W stability computer program was used to calculate the overall stability of the barrier in relation to its real geometry (Figure 2).

Figure 2 shows the Slope-W design finally specified to overcome the potential for slip circle and wedge failure.

The underlying foundation material was deep sand, with failure surfaces predicted within it and requiring long basal reinforcing layers. The final configuration was 4 layers of 200 kN/m woven geotextile contained in a granular drainage blanket.

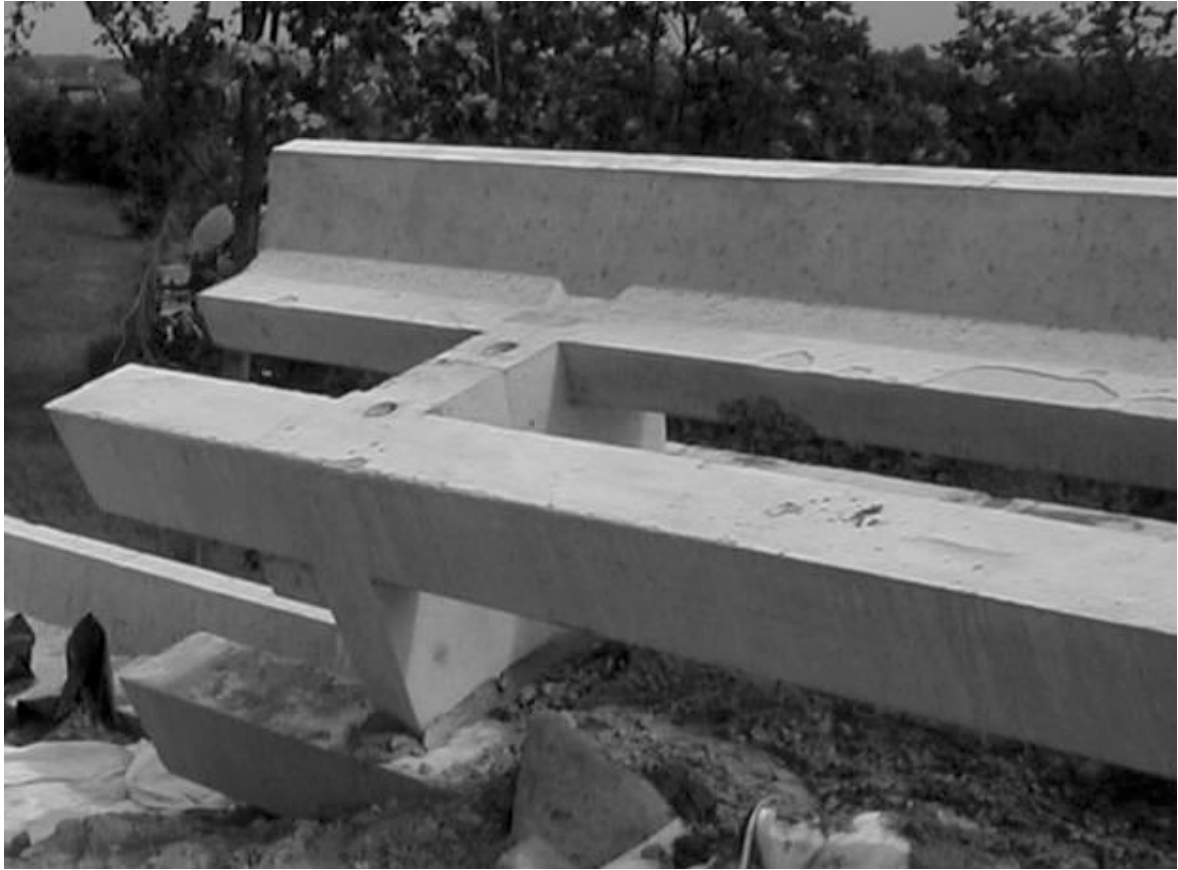
Figure 3. An empty concrete facing element viewed from inside the noise barrier. Note textiles at the base which have been wrapped round the element beneath.

The facing elements were the 'Evergreen' concrete pre-formed type, as shown in Fig.3. There were a number of different sized standard modules used. The lower layers of the sloping face were larger than the upper layers. In general, the elements were about 2000 mm wide and about 750 mm high. They stacked to produce a face with a slope of 4 vertical to 1 horizontal (4v:1h). Where bends in the barrier occurred, every pair of concrete elements had to be designed and constructed individually to fill the changing gap correctly. The concrete elements were pre-cast offsite in Belgium and imported to the site after curing. They were handled and placed by means of a tall crane. The particular features of these facing elements were that they were noise absorbing and that they could support vegetation, thus producing a 'green' effect.

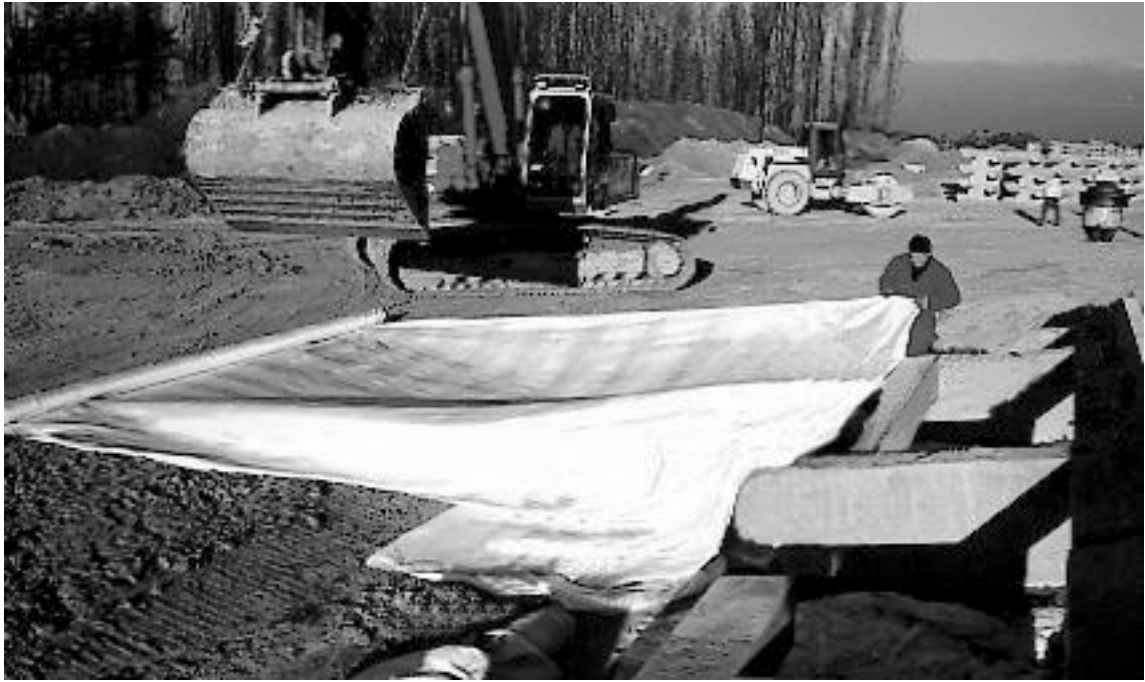
Figure 4. Geotextile being pulled up to the concrete facing element prior to placing beneath the concrete cross beam.

Firstly, the correct roll of geotextile is selected and pulled up to the rear of the given facing element. It is then laid beneath the concrete cross beam, between the legs supporting the beam. It is then dropped out over the face of the slope, whilst sand filling takes place on top of it. The sand is placed and compacted up to and over the concrete beam and the geotextile is then pulled back into the body of the reinforced soil block. It is not placed in direct contact with the concrete element.

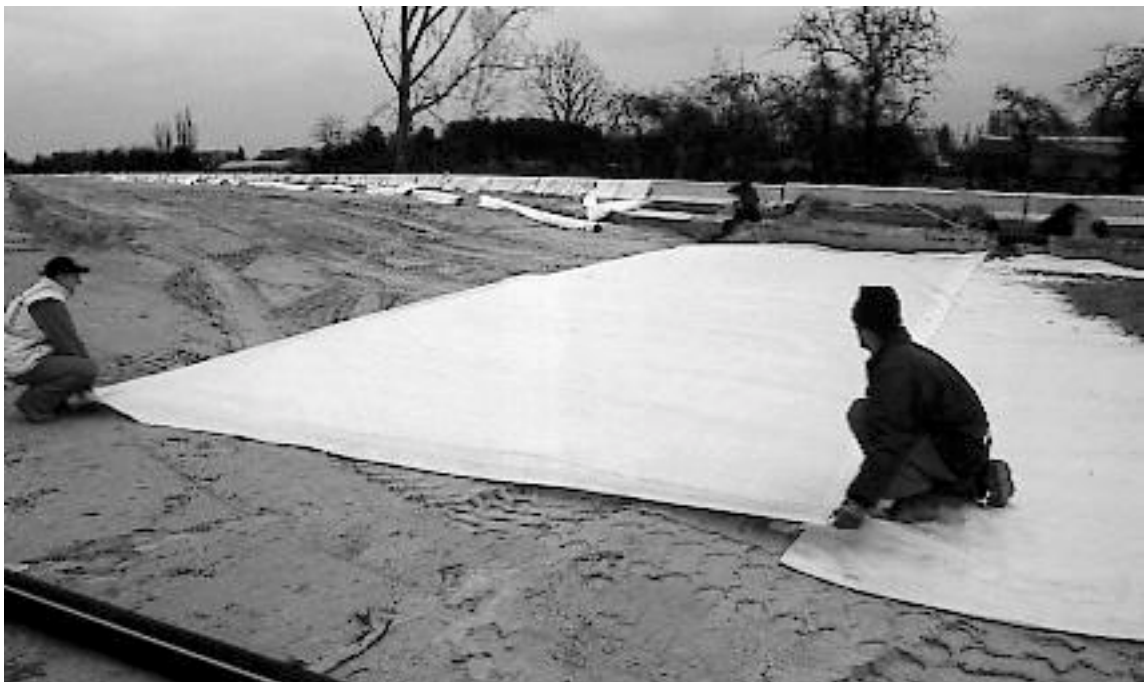
Figure 5. Reinforcing geotextile is pulled out to the precise pre-measured length as supplied to site from the factory.

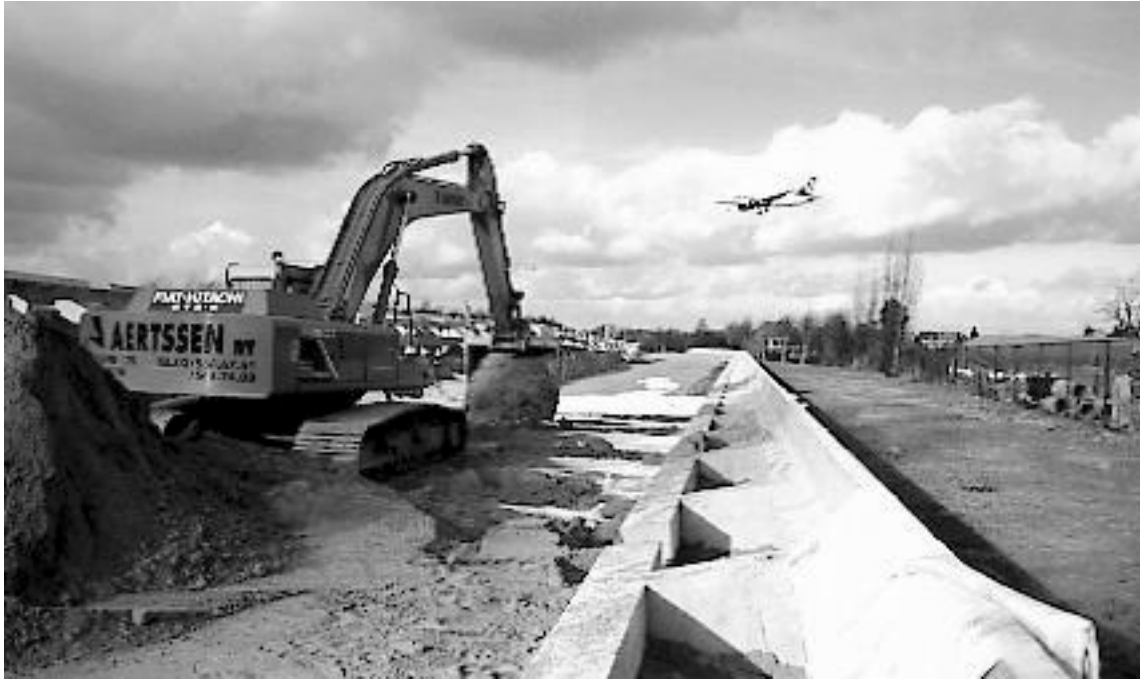
Figure 6. Reinforcing geotextile is hung out over the face of the slope whilst sand is built up within and behind the element.

Finally, the reinforcing textile is pulled over the sand and buried within it to form the wrap-around anchor. The procedure is then repeated for each individual facing element within the structure.

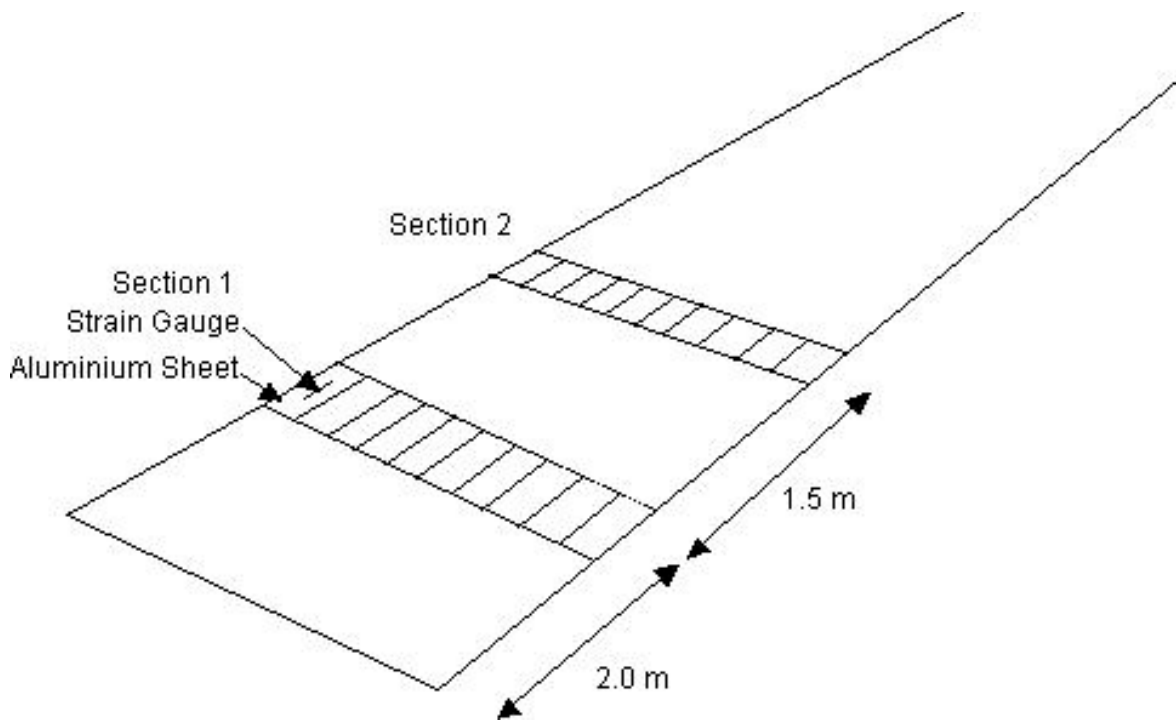
Figure 7. Distribution of aluminium plates in Sections 1 and 2.

The cut sections of the geotextiles were now bonded to strips of aluminium which effectively rejoined the textile into a single long strip. Each cut section was bonded to ten pieces of aluminium of 0.5 m width and on each piece of aluminium were mounted electronic strain gauges. See Figure 7.

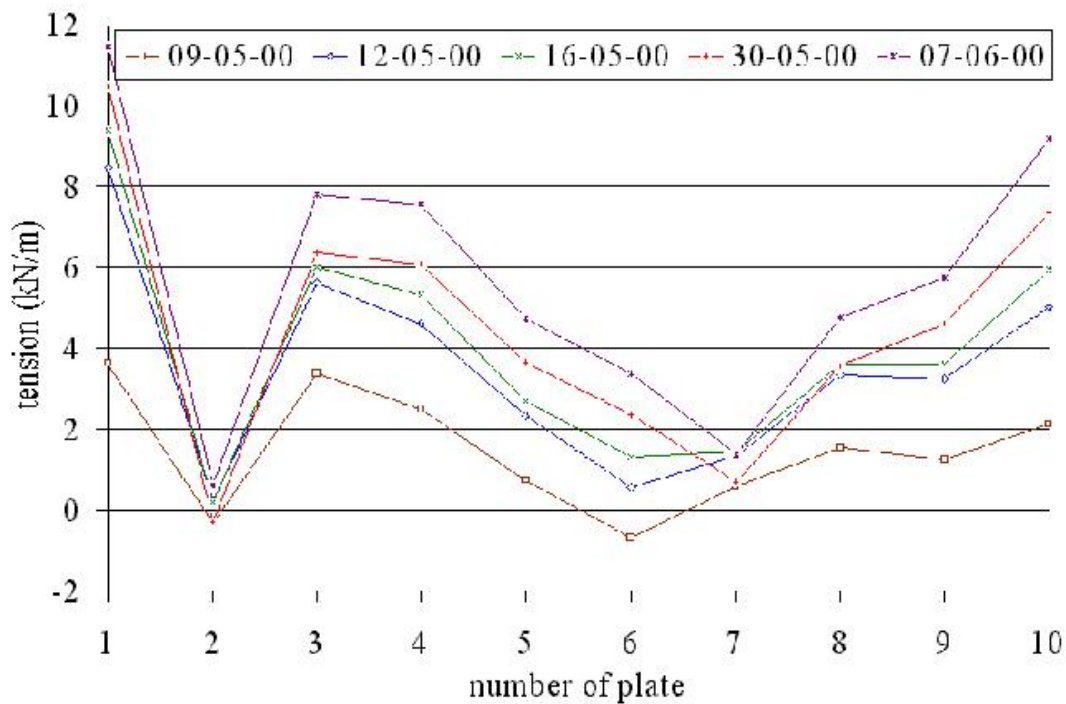
Figure 8. Stresses recorded in Section 1.

64 strain gages were installed, 48 in Section 1 and 16 in section 2. The results of the measurements at Section 1 are given in Figure 8. Instead of using 1 strip of aluminium of 5 m width, 10 pieces were used, each of 0.5 m width, numbered from 1 to 10 (x-axis). The development of the average stress at Section 1 is given in Figure 9, together with the vertical overburden stress on the geotextile (1 layer of sand  $\approx$  0.75 m  $\approx$  13 kN/m<sup>3</sup>). Section 2 produced about the same values as Section 1 (max. 5 % difference). The measured values are considered to be rather low, but it is expected that ultimate stresses will be greater because stresses are still increasing as the structure continues to be built. Furthermore, it is quite possible that the two test sections are not at the point of maximum stress. Also, stress levels increase downwards and at the time of measurement, total overburden was only about 3.5 m. Finally, there would be a small but significant stress imposed between the placing of the geotextile and the taking of the first stress measurement. This stress would not be recorded and is thus not included in the charts below.

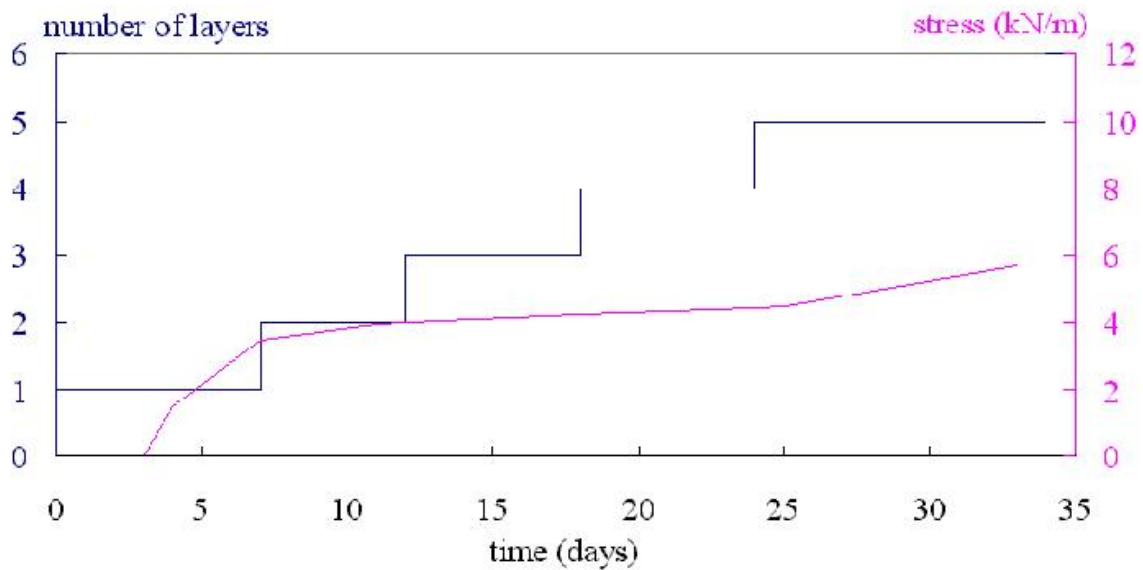
Figure 9. Development of the average stress in Section 1 in relationship to the increased overburden placed during construction works.

It is interesting to compare the measured final average stress of 6 kN/m width with the figures expected from the initial design assessment. In the classical design analysis, the lateral force at any point can be taken to be approximately the density of the soil multiplied by its height above the given horizon and multiplied again by the assessed coefficient of earth pressure. If the density of the soil is say 18 kN/m<sup>3</sup>, the depth is 3.5 m and the coefficient of earth pressure is 0.35, then a peak lateral pressure of 22 kN/m will result. The measured value was 6 kN/m. However, in reality, the stress measured at any given horizon in reinforced soil is not the same as that in design calculations because lateral stresses are absorbed and shared with layers of geotextile above the horizon. It is more important to compare the result with the expected reinforced soil strains. In this case, the total lateral stresses in the block of sand above are being absorbed by 5 layers of 200 kN/m textile. The real stress being imposed on the measuring horizon is thus that from the immediately free 0.75 m of sand above plus a notional small additional stress imposed during the placing of the upper layers. If it is considered that the effective lateral stresses are imposed from a notional 1 m of sand above the measuring horizon, then  $1 \times 18 \times 0.35$  results in a lateral stress of 6 kN/m which is the same as that measured.

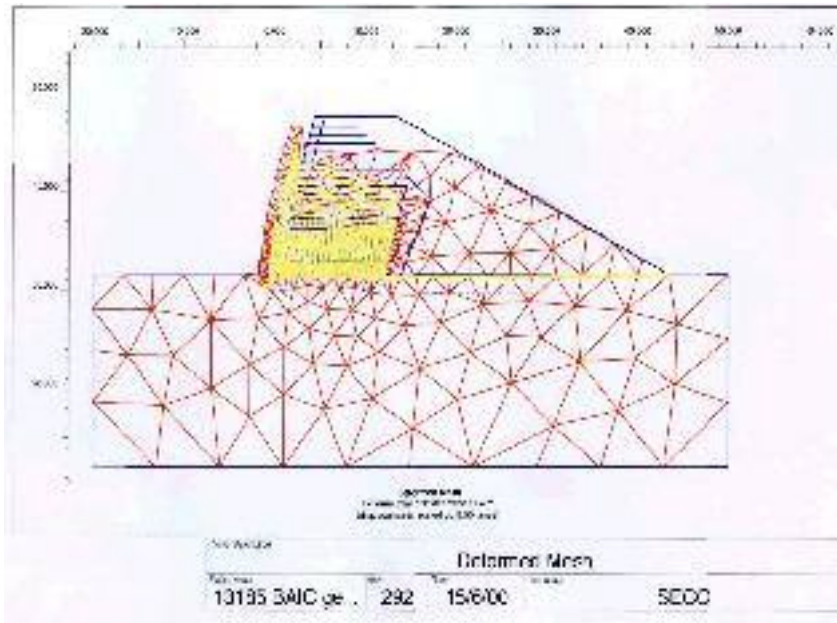
Figure 11. General view of the Plaxis finite element mesh used for calculation purposes.

- Density of the mesh of the model
- Soil parameters ( $\phi$  and E)
- Interface between soil and geotextile (estimated 0.45)
- E modulus of geotextile (tangent – secant)
- Bearing capacity of the soil in front and underneath of the concrete wall since the zone of potential slippage passed through it.

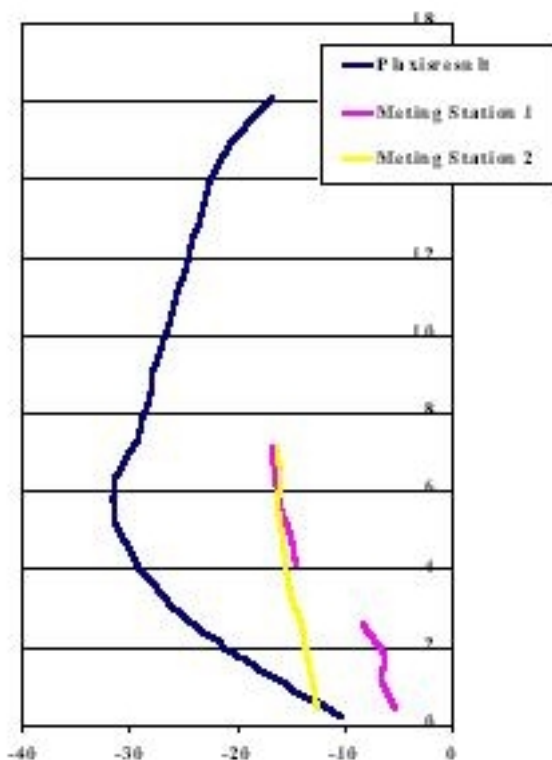
Figure 13. Comparison of the Plaxis calculated stresses with those measured by strain gauges.

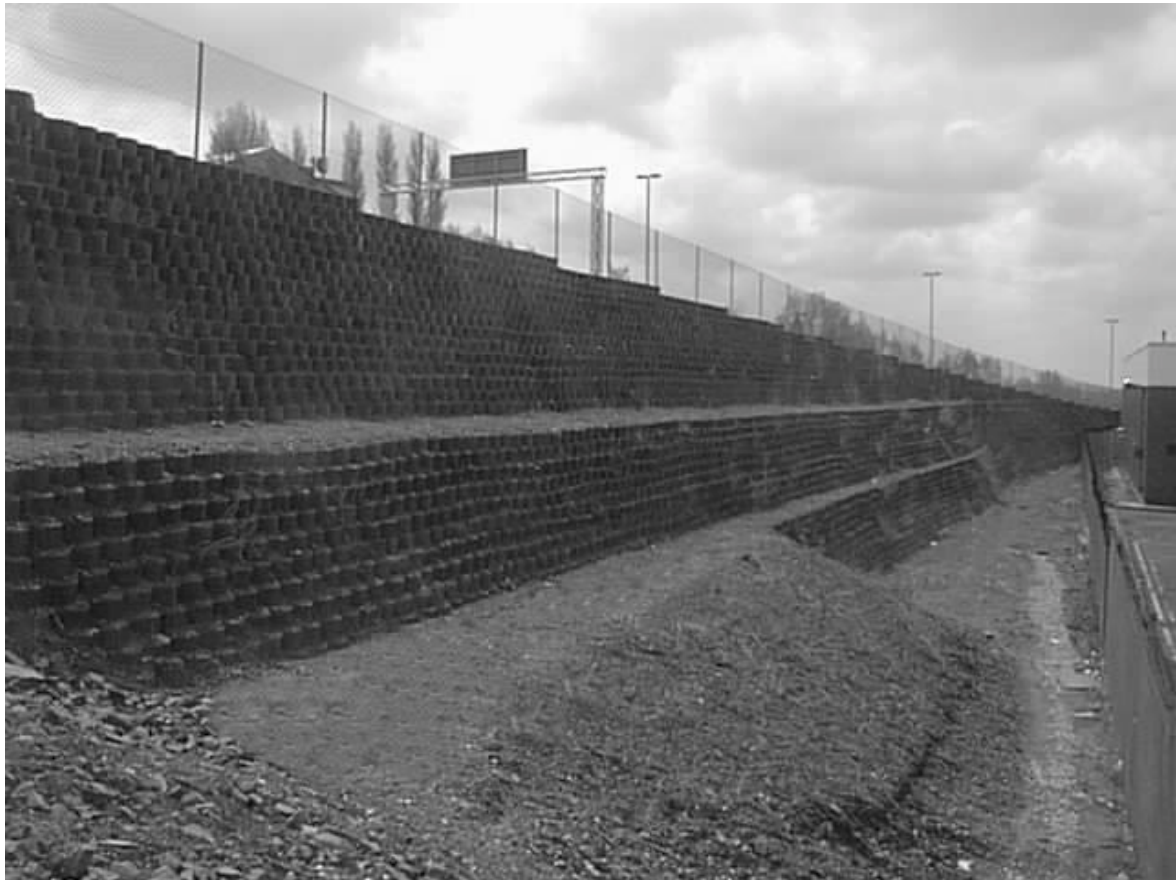
Figure 14. A 7 m high geocell retaining wall from a highway construction site in the U.K. No vegetation soon after construction.

On the airport side of the barrier, the slopes are generally sufficiently flat that they can be topsoiled and grassed without special retaining structures. However, the land space needed for the future road to be constructed at the toe of the barrier, means that at a few locations, the barrier toe has to be steepened and supported by a small retaining wall. Rather than use the concrete facing elements (because of their internal steelwork) the contractor decided to use polyethylene geocells stacked vertically to produce a number of small scale reinforced soil retaining walls. At the time of writing these have not yet been constructed but their appearance will be similar to that shown in Figures 14

and 15 below, which show similar geocell constructions from another site, after construction and showing naturally seeded vegetation.

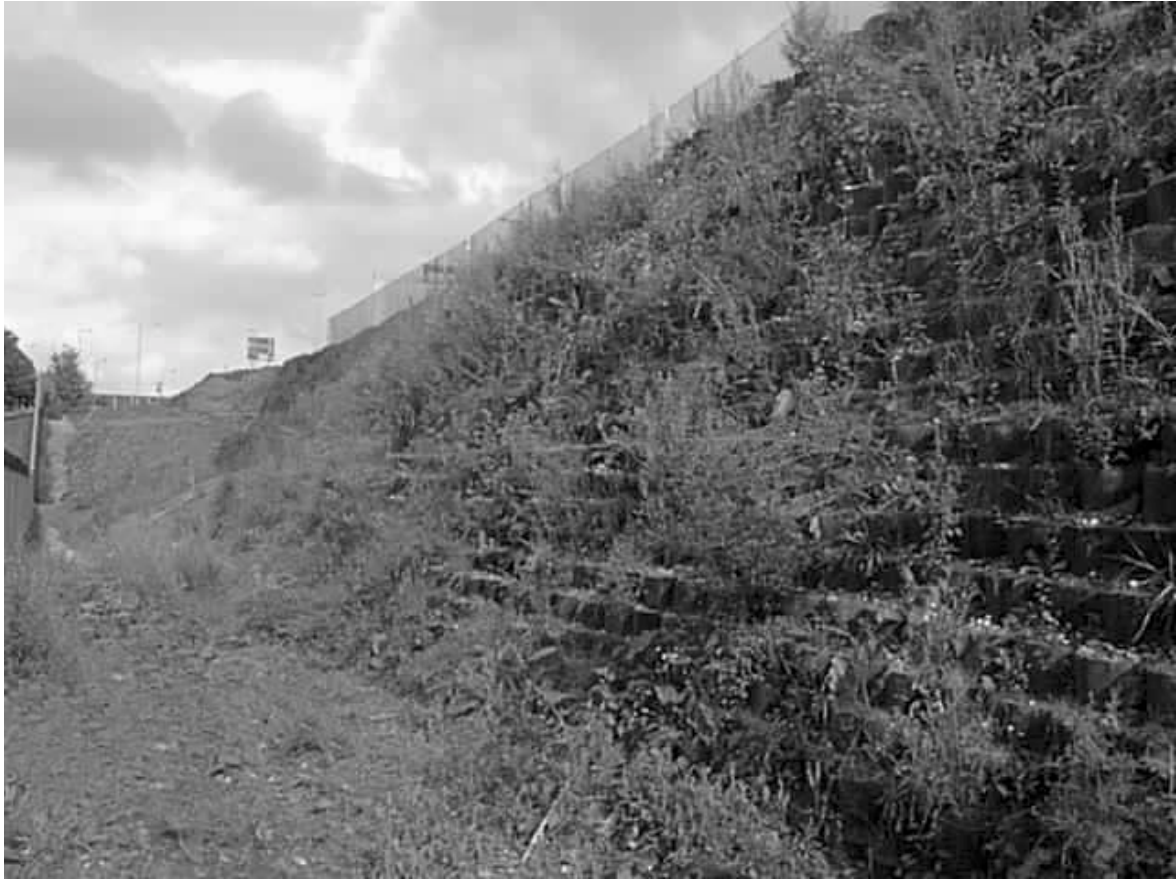
Figure 15. The same 7 m high geocell retaining wall a few weeks after construction. Natural vegetation has established itself to achieve the desired natural appearance.
