Evaluation of an airport pavement after almost 8 years of overlay rehabilitation with a polyester geogrid asphalt reinforcement

Keywords: polyester geogrid, asphalt reinforcement, overlay rehabilitation

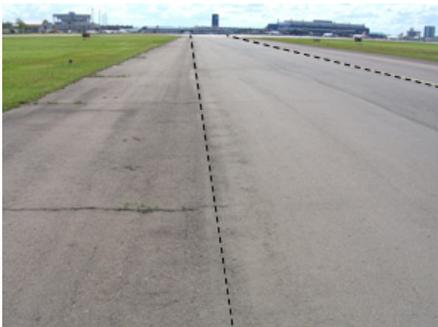
Figure 2. Overview of the studied section: view from the dockyards to the terminal.

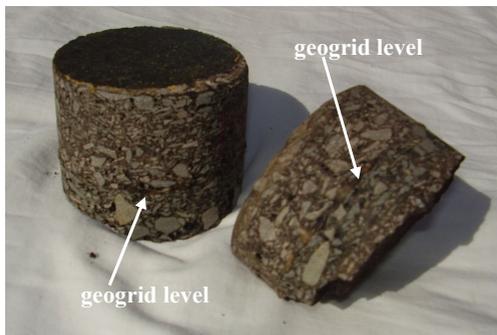
By analyzing those specimens, it was clear the effect of interrupting the crack propagation on the geogrid level (Figure 8). This means that the reinforcement protected the new overlay from stress concentration on that zone on that level, avoiding the reflection of pre-existing crack, or, in the worst cases, producing considerably less aggressive cracks on the new asphalt layer along almost 8 years of traffic loading. It could be also observed good adherence between asphalt layers on the geogrid level.

Figure 8. Specimens taken on reinforced areas: one non cracked (left) and another cracked (right).

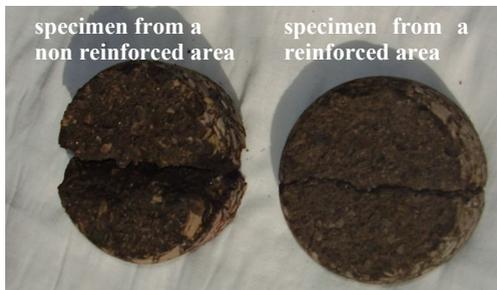
In the case of specimens taken from non reinforced zones, when including cracks, it was not possible to extract an integrate element since the crack took the full thickness and separated at least in two parts these pieces (Figure 9). In some of those cases, adherence between the two asphalt layers was lost during extraction, what was not the case of specimens taken from non cracked areas.

Figure 9. Specimens from areas with (right) and without (left) reinforcement.
