HAVARD, H., Laboratoire Régional Equipement, Les Ponts de Cé, France

## GEOTEXTILE SEEDING FOR EROSION CONTROL

A special geotextile was tested by seeding in laboratory and in the field. Results are interesting for erosion control.

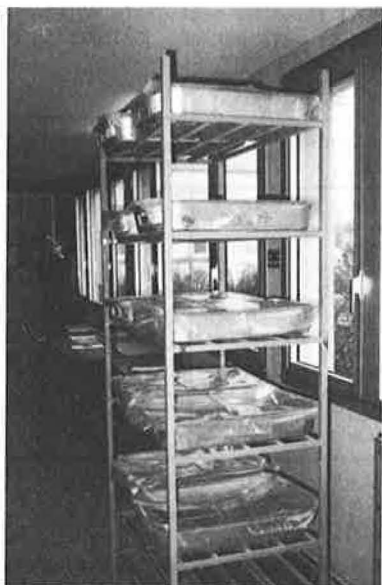
Photo 1 : Seeding receivers stocking covered with a plastics film in a warmed room before a window. Experiment started on 6.1.84.

We seed on the 6.1.84 on several samples of waterlogged geotextile and laid upon very clean Loire sand (coarse sand 0/4 mm with less than 5 % of grains smaller than 80 $\mu$ ) almost barren. Dry Loire sand was spread in a 2-3 cm - thicked layer at the bottom of a 560 x 360 mm (L x B) rectangular, aluminium receiver (photo 1). Above the receiver, a plastics, light-opened, no sealed film was laid to prevent of evaporation drainage. The receiver was stocked in a laboratory-room at an almost constant temperature (18 à 20°C) and before a window.

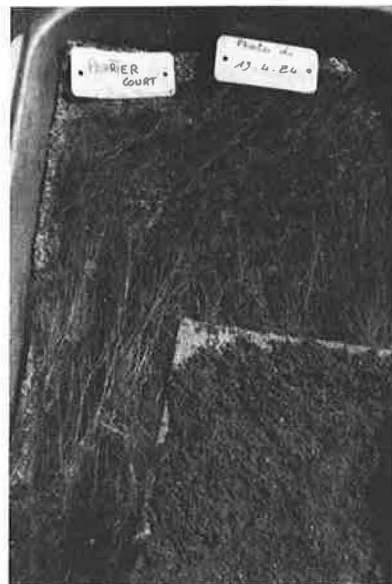
Photo 4 : On 13.4.84. A corner of seeded layer is folded up. Notice the important lot of sand trapped by the roots.

From 30.3.84, plastics film was withdrawn and geotextile exposed to a severe evaporation drainage in the warmed room. On the 13.4.84, experience was stopped. Grass had been dried but roots were largely (about 2-3 cm) introduced in the sand so imprisoned in the roots (photo 4). The dry geotextile was so weighting 2,7 kg for an area of 0,2 m<sup>2</sup> with grass and especially the root-imprisonned sand. Roots were firstly growing across the geotextile, and then very fastly down to the sand. So the layer was tied to the sand about one month later the seeding was realised.

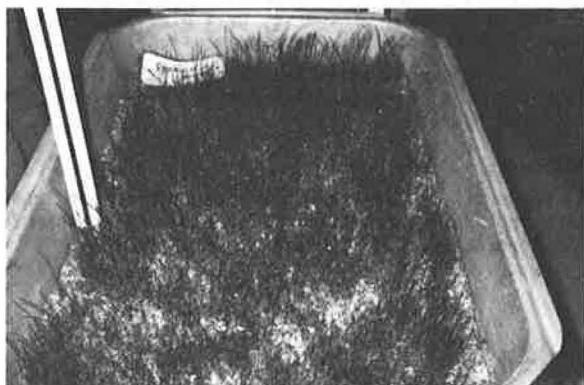
Photo 2 : On 16.1.84, grass is already settled.

Ten days after seeding, grass was raising largely on the normally seeded geotextiles (photo 2). This experience went on to 30.3.84 in the same conditions without any watering between seeding and this date. Photo 3 shows.

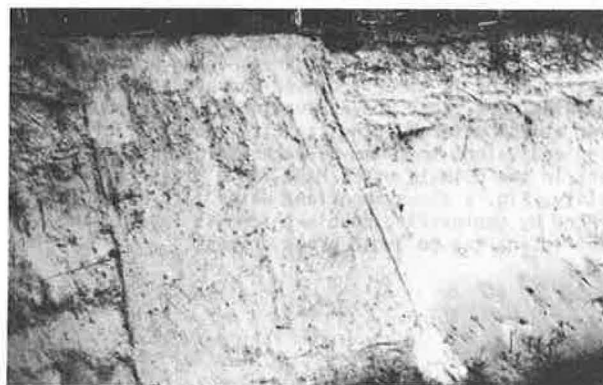
Photo 5 : On 4.4.85. Grass covering is poor and scarcely distinct on the photography. Geotextile is beginning to be destroyed at the top.

A first layer spreading about 4 m<sup>2</sup> of area, was laid on a steep slope ( $\beta \approx 50^\circ$ ) of clean sand 0/2 mm in LE MANS. Two tries of hydroseeding on this slope had been unsuccessful. This slope is looking to west direction. This seeding, realised on 13.9.84, began to raised and vegetated. We tried to seed again with ferti-

lisation in April 85. Unsuccessfully. Photo 5 shows this test plot in April 85 (grass is very poor).

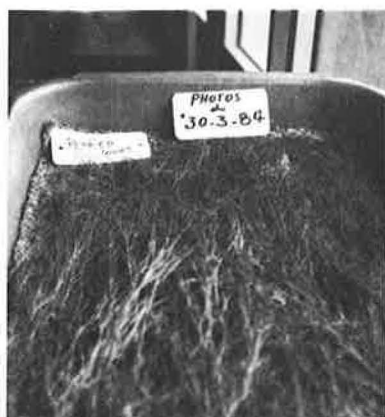
Photo 3 : On 30.3.84. No watering since on 6.1.84. Seeding is effective still, but grass is drying.

a satisfactory grass-quality on this date.

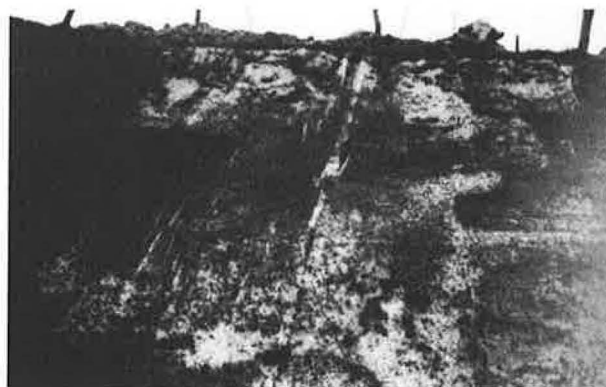
Photo 6 : On 4.4.85. Plot exposed towards East. Grass is poor. On each side, plot is surrounded by a vegetal earth layer.

A second layer (about 10 m<sup>2</sup> of area) was laid in LE MANS too, on a identical sand. Slope ( $\beta = 30^\circ$ ) is looking to east direction. Grass raised fastly enough. Seeding was realised on 13.9.84. Photo 6 shows this test plot on 4.4.85. The grass being poor and too dry, we seeded again with fertilisation. Visiting again on 28.8.85, photo 7 shows a satisfactory covering grass (about 20 % area without grass) for such a slope. Photo 8 taken in the same time and place shows sliding vegetal earth spread on these slopes, while geotextile retained correctly the slope.

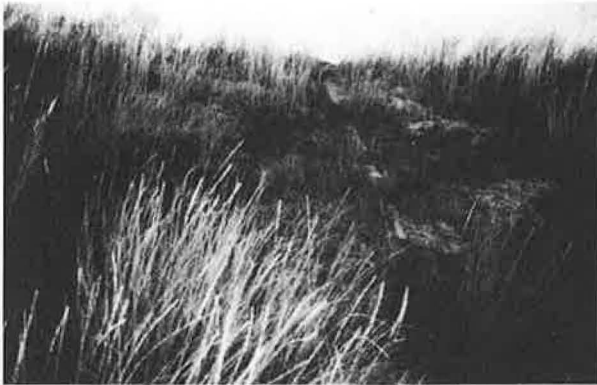
Photo 7 : On 28.8.85. Vegetal covering is satisfactory on geotextile. About 20 % of area without any grass.

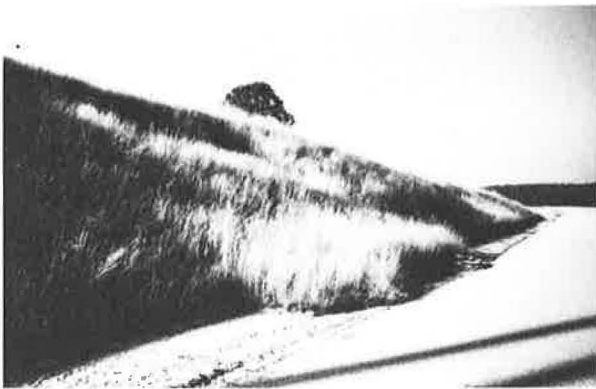
Photo 8 : Vegetal earth layer has a good vegetal covering, but is not tied to the slope and has slid.
