Full scale tests on geogrid reinforced embankments for rock fall protection

D. Peila, C. Castiglia, C. Oggeri
Politecnico di Torino, Torino, Italy

ABSTRACT: Geogrid reinforced embankments can absorb high quantity of dynamic energy, both from cyclic loads and from impulsive loads, with high resiliency and limited deformation. This property finds a positive application as a barrier to rocks fall, for the protection of towns, roads and plants. An experimental program was performed in a specific testing facility, where concrete blocks of up to 9 tons of weight can be driven onto a geogrid reinforced embankment at a speed in excess of 30m/s, producing impacts with more than 4000 kJ of energy. Several instrumented embankments with different geogrid strengths and layout were tested under strictly controlled conditions, allowing to draw a quantitative assessment of the limit impact resistance of these structures. The paper provides a full description of the experimental set up, of the different tests performed, and of the obtained results.

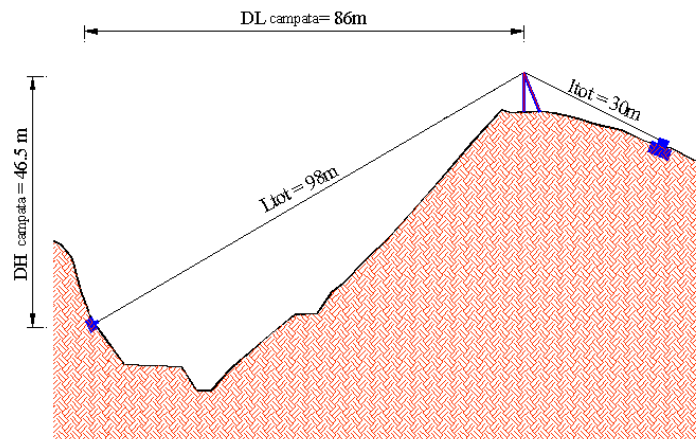
Fig. 2: Scheme of the test site.

The test was performed in the Meano test site (Trento) (Fig.2) which was specifically set up to carry out full-scale tests for rein-forced ground walls (Peila, 1999; Peila et al. 1999; Rimoldi et al. 1999).

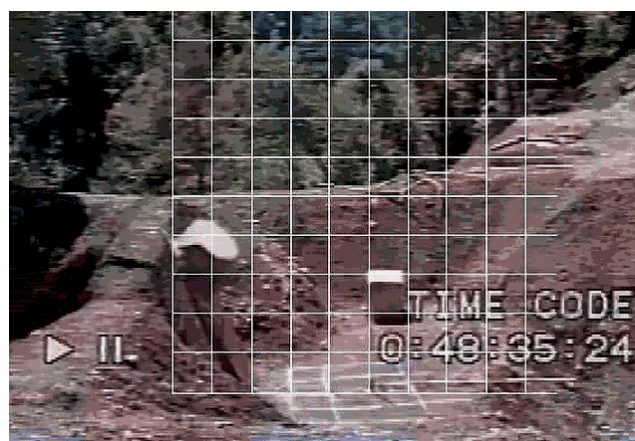
Fig. 3: The block impacting the front face during the first test.

The evaluation of the kinetic impact energy was carried out by analyzing the photographs of the film taken during the event, which were taken from three different angles (as an example Fig 3 shows the moment of impact of the block against the ground wall).

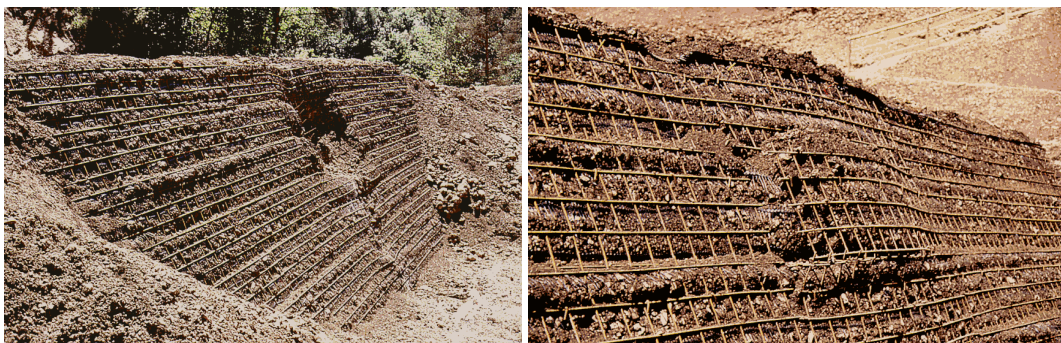
Fig. 6: Deformation of the wall due to the impact.

The ground wall was neither pierced nor damaged in an irreparable way. On the front side a crater formed with a maximum depth of about 0.60 m while on the backside an extrusion of soil could be observed (Fig.6). No significant variations of the geometry of the ground wall could be observed outside the area directly involved in the impact.

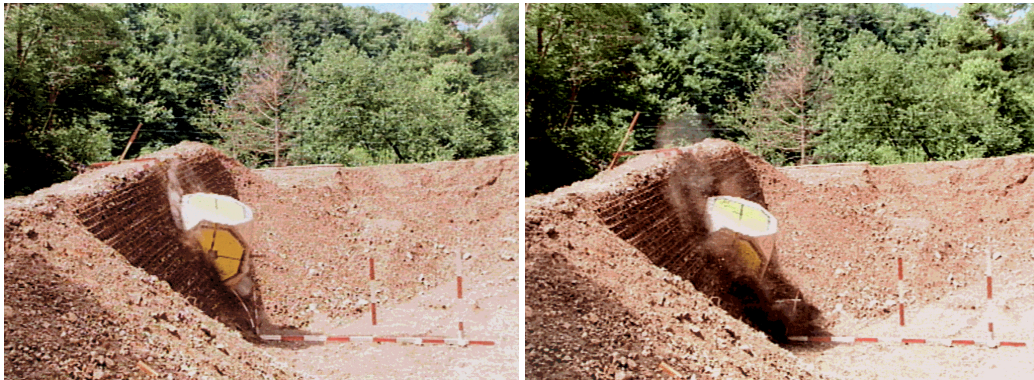
Fig. 7: Two frames showing the 8778 kg block while being arrested by the wall during the second test.

Translational velocity of the boulder at the moment of the impact was estimated as 31.3 m/s, therefore the kinetic energy of the block at the moment of contact is about 4354 kJ (Fig.7).

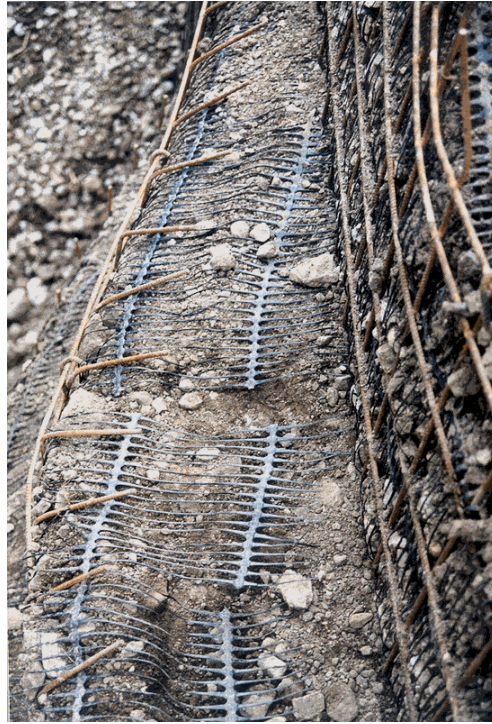
Fig. 8: Thorn grids in the second test.

The ground wall not pierced and the occurred deformations did not cause any structural collapse. On the front side a crater formed with a maximum depth of about 1 m while on the back-side a large displacement of soil (about 0.90 m) could be observed. The geogrids have occasionally been thorn, as shown in fig.8, but the global stability of the structure appeared to be assured anyway.

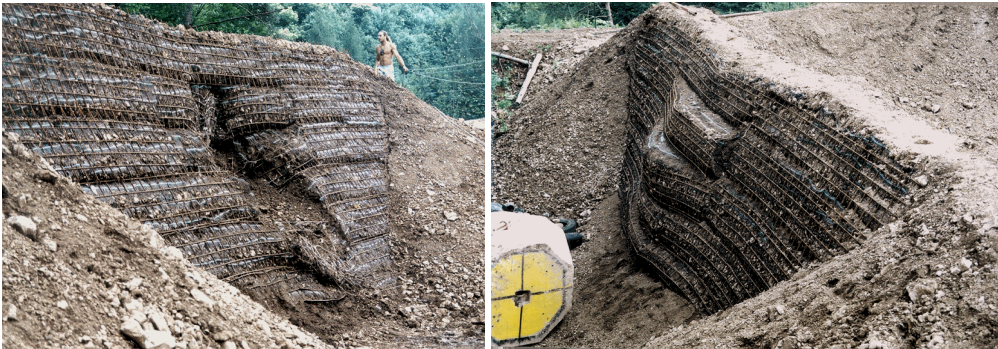
Fig. 9: Views of front and back deformations after the first impact in the 4354 kJ test.

The global behavior of the earth wall showed a major influence of the geogrid interfaces, which allowed a relative sliding of the levels solicited by the impact (Fig.9).
