Use of geotextiles in concrete pavement construction

P. Sulten

Federal Highway Research Institute, Bergisch Gladbach, Germany

Keywords: Geotextiles, Erosion control, Pavement systems, Separation of hydraulically bonded layers

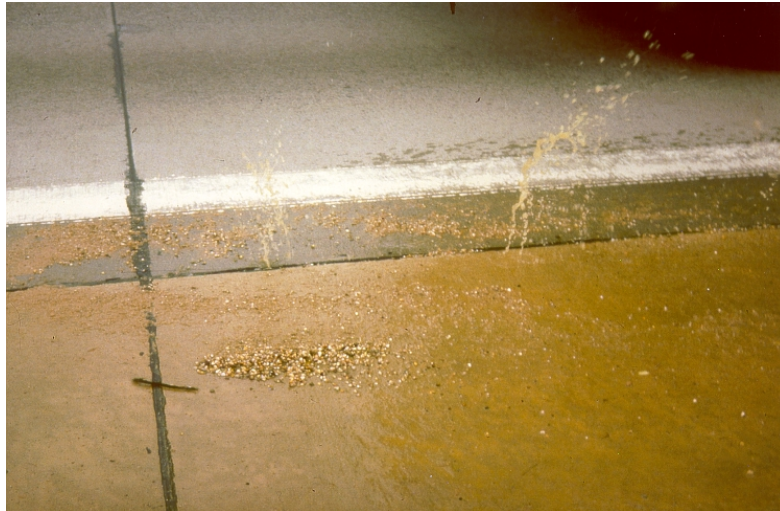
Fig. 1: Water being ejected from the longitudinal joint between roadway and hard shoulder together with fine particles and sand from the THB

This results in the base course surface becoming eroded in the areas of the motorway which are driven over by heavy vehicles and may even lead to water being and fine particles from the base courses being expelled, particularly through the longitudinal joints between the right lane and the lower-lying hard shoulder or first overtaking lane (if there is a cross slope towards the middle of the roadway) as the bond which holds for longer in this area prevents the water from being discharged (fig. 1).

This state can be recognised by dirt stripes, which may range from light to dark depending on the bond and the composition of the base, near the longitudinal joint and by the water fountains which are expelled from the joint when a lorry drives over it.

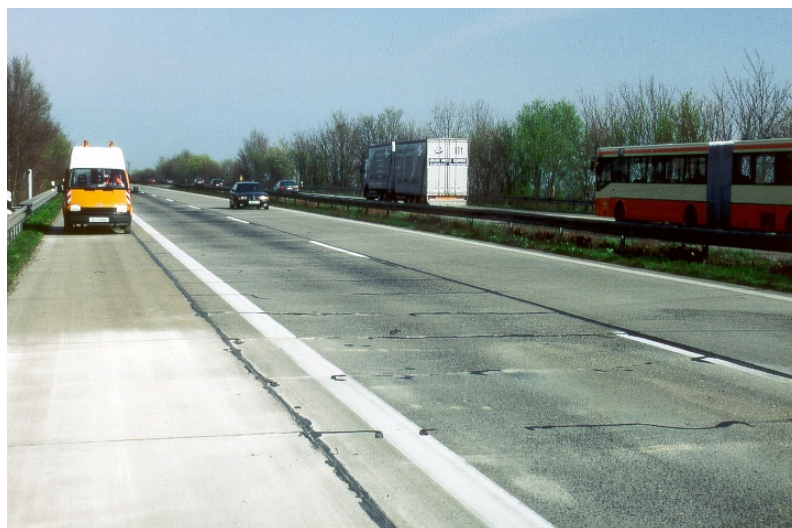
Fig. 2: Concrete surfaces on a federal motorway shortly before being renewed

The erosion of the base leads unavoidably to the bearing conditions deteriorating and increased loading of the concrete surface. Cracks may occur and, later, stepping-off and tilting of the plates and plate components. This significantly deteriorates the evenness and consequently the service value of the pavement. This leads finally to a reduction in the service life of the concrete surface (fig. 2).

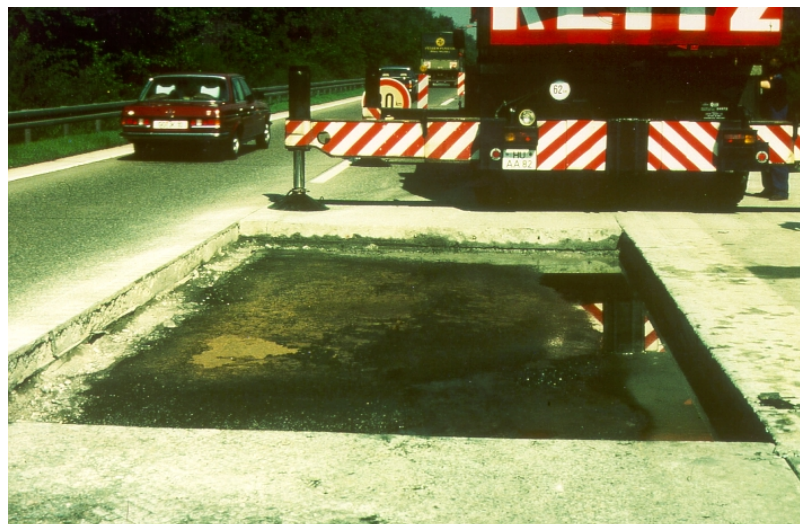
Fig. 3: Water build-up and erosion of the ATS in front of a marginal strip

Applying nonwoven fabrics to the whole area of the bound base has proved to be a promising method for enabling water which has penetrated to beneath the concrete base to be discharged harmlessly. Investigations into the draining of concrete surfaces started at the Federal Highway Research Institute in 1980 initially concentrated on the installation of a longitudinal drainage system in the vicinity of the critical joint between the right-hand lane and the hard shoulder. This was the correct approach for cases where, as discovered for instance on the A 67 near Darmstadt, the water was able to be discharged as far as the hard shoulder down the cross slope on the ATS which was separated from the concrete surface by bearing paper and which only built up there on account of a 30 cm-thick marginal strip (fig. 3).

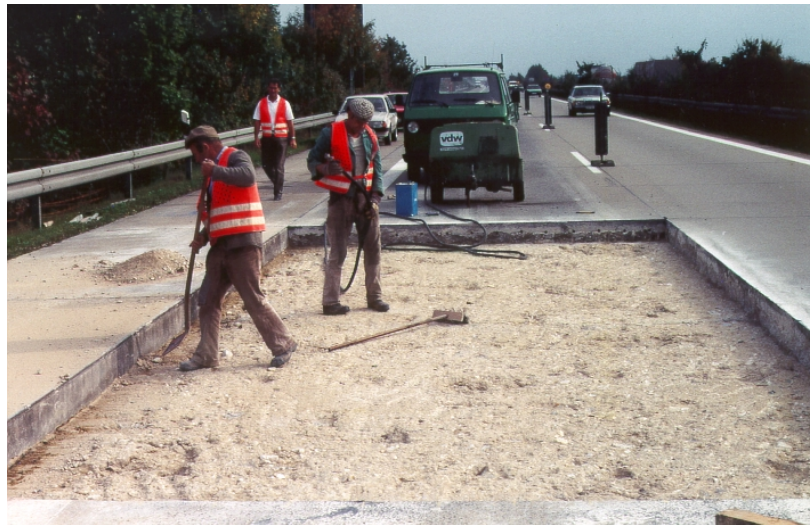
Fig. 4: Large-area erosion of a THB

When large-area erosion is possible under the entire roadway (this must always be assumed for construction methods using binders), installing a longitudinal drainage system will reduce the erosion but will not prevent it (fig. 4).

The good permanent elasticity of the nonwoven fabric means that the concrete surface retains good bearing qualities, even under different deformations. In contrast to concrete surfaces on a rigid undelay the construction is similar to a plate on elastic bedding. The brief impulses caused by the dynamic loading of the moving traffic are evenly cushioned when nonwoven fabric is used and transferred to the whole surface of the base. Rigid unbound underlays with an eroded surface, on the other hand, are extremely unfavourable for the lasting quality of concrete surfaces (fig. 4).

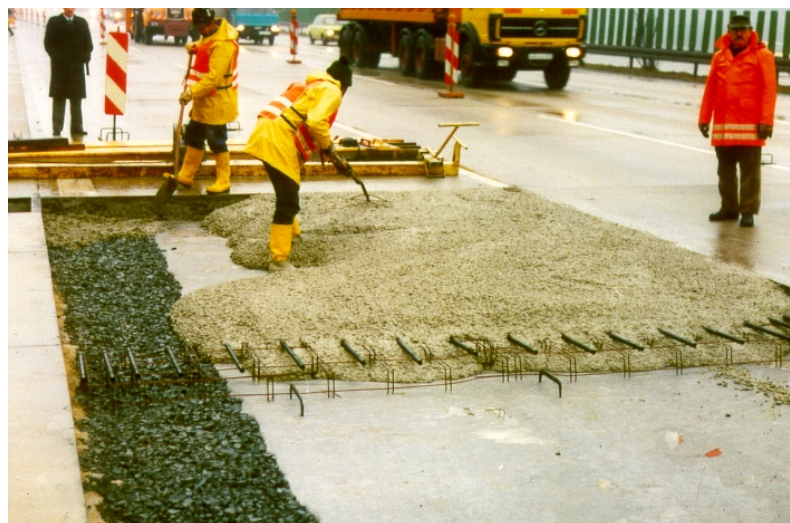
Fig. 5: Installation of the concrete on nonwoven fabric with longitudinal drainage

For this reason, prior to the laying of the concrete, nonwoven fabrics were laid on the whole area of the eroded base right into the longitudinal drainage system which consisted of a slotted tube in a crushed-stone bed (fig. 5).

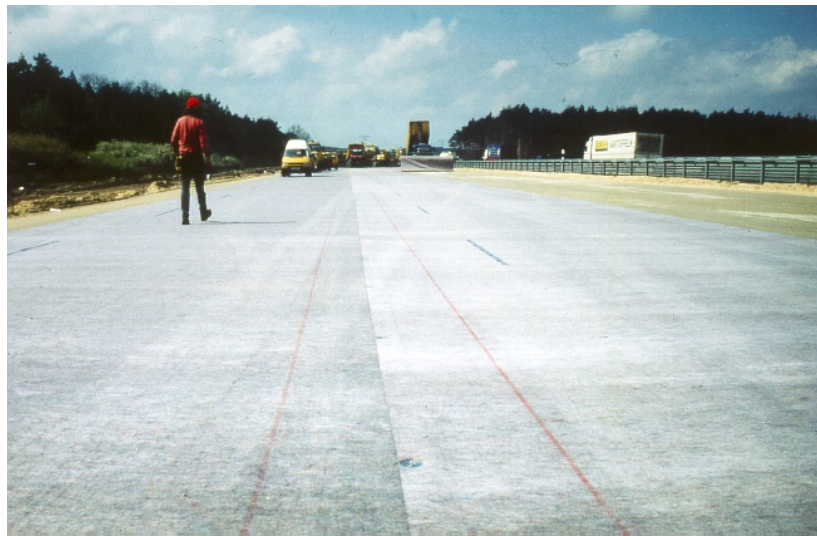
Fig. 6: Nonwoven fabric laid over the entire area

Using nonwoven fabrics means that the concrete plate and the base are completely separated by the bond from the very start (fig. 6).

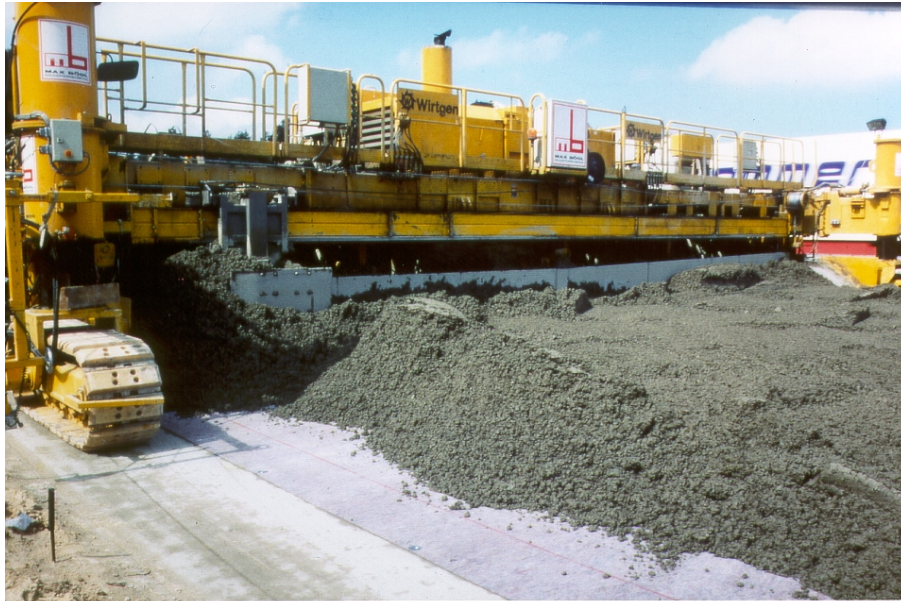
Fig. 7: Installation of the concrete surface on nonwoven fabric

The long-term behaviour of concrete pavement systems with nonwoven fabric inlays are currently being tested on BASt's test road sections which were installed in the 80s; these tests are being carried out as part of a research project commissioned by the Federal Ministry of Transport, Building and Housing. It is intended that the results should be used as a basis for elaborating further requirements and recommendations for the use of nonwoven fabric inlays. The good experiences made so far with this pavement system have already led to this method of construction being used to a greater extent. Eight large motorway sections in eastern Germany have for example been built with a nonwoven fabric inlay between concrete surface and THB (fig. 7).

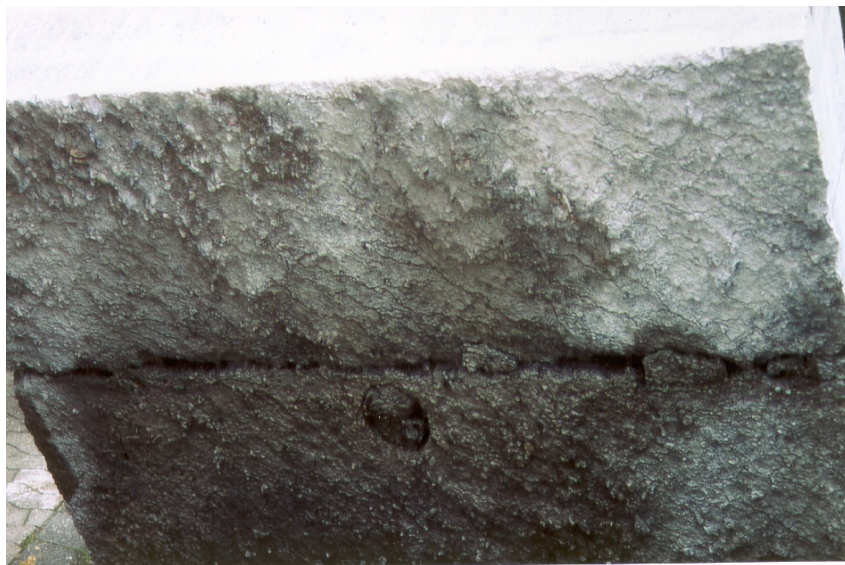
Fig. 8: View under a lifted concrete plate with partially attached THB

The fact that the behaviour of the structure involving THB was comparatively worse was due to a large extent to the horizontal cracks in the upper zone within the base and accompanying erosion and loss of substance – despite the high strengths recorded for the THB. This erosion is supported by impulse radar readings, core investigations and plate components which were removed for investigation (fig. 8).
