## A series of trial embankments of reinforced earth

H.OHTA, Tokyo Institute of Technology, Tokyo, Japan  
 Y.MAEDA, Maeda Kosen, Fukui, Japan  
 T.NISHIMOTO, Century Consultants, Toyama, Japan  
 K.OHMORI, Research Institute of Geo-Environment, Kanazawa, Japan  
 T.YAMAKAMI, Kanazawa University, Kanazawa, Japan  
 A.IIZUKA, Kobe University, Kobe, Japan  
 I.KOBAYASHI, Tokyo Institute of Technology, Tokyo, Japan  
 M.HIRATA, Toyo Construction, Tokyo, Japan

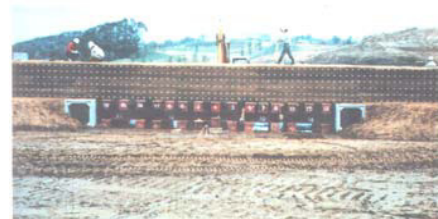
Photo 1 Overall view of the bridge made of soil, 1992

After carrying a series of preliminary model tests in the laboratory, the authors constructed a bridge of reinforced earth shown in Photo 1 and Figs. 1(a) and (b) during a period from 20<sup>th</sup> July through 8<sup>th</sup> August, 1992. On top of the three layers of H-section steel beams, three layers of a geogrid were placed at a vertical interval of 500 mm with the compacted fine sand sandwiched between geogrid. The reinforced earth bridge was 1500 mm thick, 4500 mm wide. The span of the bridge was widened by removing the H-section steel beams one by one. To avoid the direct contact between the lowermost (third from the top) geogrid and H-section steel beams, sheets of plywood were placed under the lowermost geogrid. The side surfaces of the bridge were exposed to the air so that people could see and feel that the bridge was really made of compacted sand. To keep the side surfaces of the bridge intact, 500 mm wide sheets of

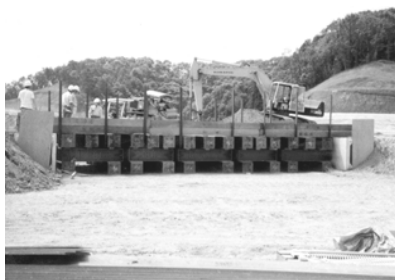
Photo2 Placement of H-section steel beams

non-woven fabric were placed along the side surfaces at a vertical interval of 100 mm, see Fig. 1(b). A typical result of tensile test on geogrid is shown in Fig. 2. The cross sectional area and Young's modulus of the geogrid were  $5.25 \times 10^{-4} \text{ m}^2/\text{m}$  and  $2.55 \times 10^6 \text{ kN/m}^2/\text{m}$ . Table 1 shows the physical properties of the sand. The compaction tests on the sand are summarized in Fig. 3 while the performance of the field compaction is summarized in Table 2. The construction sequence is seen in Photos 2 and 3.

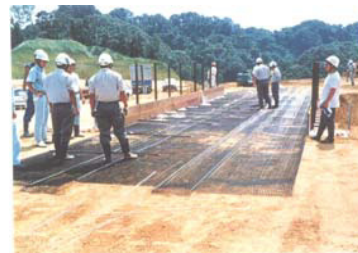
Photo 3. Placement of the geogrid

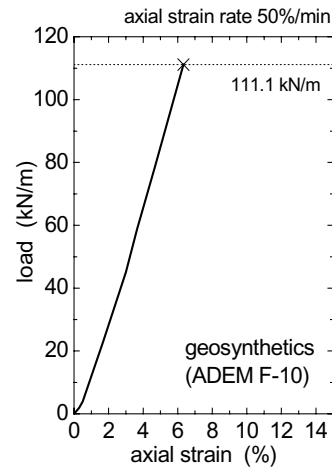
Fig. 5 Tensile test of the geogrid, 1993

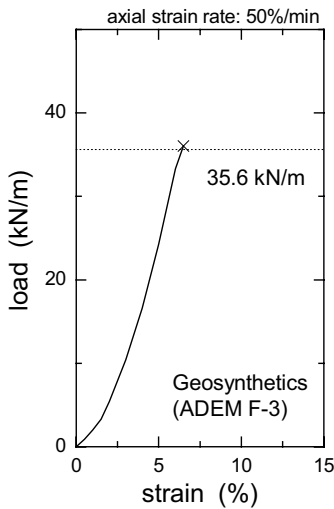
Fig. 7 Tensile test on the geogrid

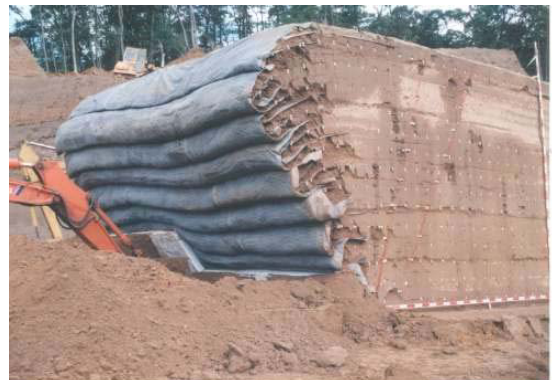
Photo 7 Excessive deformation of the third embankment in 1994

The test started by removing the supporting fill shown in the left end of Fig. 8. Loading of the overhanging cliff was performed by stepwise removal of the supporting fill to depths of 0.7 m, 1.5 m and 2.4 m from the top. Large deformation of the overhanging cliff was observed during this process of loading. After leaving the fill for 5 days at this stage of loading, further loading went on by removing the supporting fill to depths of 3.3 m, 4.1 m and 5.0 m. Excessive deformation such as seen in Photo 7 eventually resulted in falling down of the overhanging part of the reinforced fill (Photo 8). After having the unexpected partial collapse, the intended collapse was initiated by cutting the geogrid. Firstly the cutters began to cut the geogrid at their embedded positions along the line inclined 60 degrees from the original ground surface (see Fig. 8). Cutting of all the geogrid at 9 levels resulted in the cracks along the line of 60 degrees. However the overall collapse did not take place at this stage. After spending 1 hour to make sure that the fill did not show any sign of progressive overall collapse, second series of cutting the geogrid along the line inclined at an angle of 70 degrees to the ground surface. Cutting went on from the 10<sup>th</sup> layer of geogrid at the top of the reinforced fill gradually downward, 9<sup>th</sup>, 8<sup>th</sup> and 7<sup>th</sup>. At the stage of cutting the 7<sup>th</sup> layer of geogrid, the overall collapse took place as seen in Photo 9.

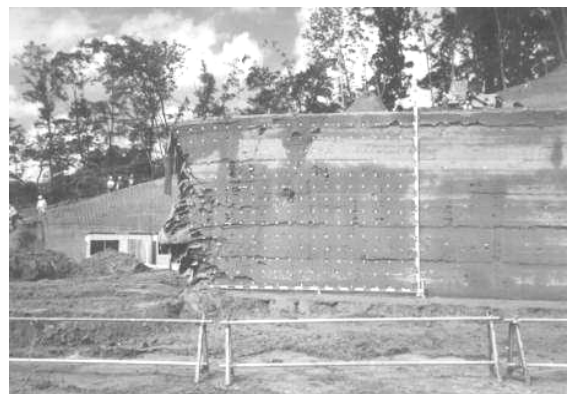
Photo 8 Falling down of the overhanging part of the reinforced fill

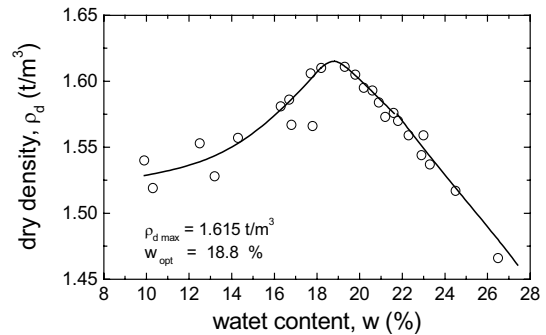
Fig.10 Compaction tests on Onma sand (sampled from Taiyogaoka, Kanazawa, 1996)

The 1996 project was planned as the final of a series of field tests on reinforced earth and performed during a period from 8<sup>th</sup> July through 5<sup>th</sup> October, 1996. The physical properties and the compaction test results of the sand used in the experiment are summarized in Table 7 and in Fig. 10. The mechanical properties of the geogrid (cross sectional area:  $3.20 \times 10^{-4} \text{ m}^2/\text{m}$ , Young's modulus  $E: 4.86 \times 10^6 \text{ kN/m}^2/\text{m}$ ) are summarized in Fig. 11. The dimensions of the fill are shown in Figs. 12. The left hand side of the fill is an overhanging cliff as in the previous field tests while the right hand side of the fill is designed in such a way that the performances of a soil bridge and a soil cantilever are to be tested. The soil bridge and the soil cantilever are initially supported by blocks of expanded polystyrene and steel beams and then loaded by eliminating the supporting members during the experiment. To avoid the ill success that the authors had experienced in the first 1992 project in which a soil bridge collapsed, the authors decided to apply pre-stressing to the reinforced earth. The use of pre-stressing was suggested to the first author by Prof. F. Tatsuoka who had successfully established a new technique of pre-stressed reinforced earth (Uchimura, Tatsuoka, Sato & Tateyama, 1995, Uchimura, Tatsuoka, Koseki, Sato, Kodaka & Tateyama, 1995, Muramoto, Tateyama, Uchimura & Tatsuoka, 1996). Pre-stressing was applied in two ways as shown in Fig. 12 (b) where a half of the fill is densely pre-stressed while the remaining half is sparsely pre-stressed. Pre-stress was applied vertically through a steel bar sleeved by a chloroethylene pipe eliminating the friction between the soil and the steel bar.

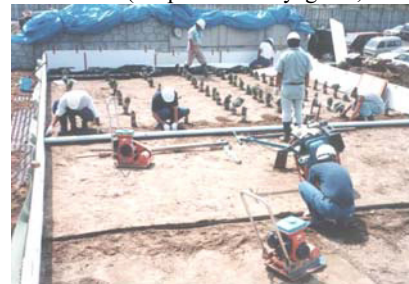
Photo 10. Construction works going on, 1996

Performance of the compaction work is summarized in Table 8. Photo 10 shows the ongoing compaction work while pre-stressing is seen in Photo 11. Photo 12 shows the appearance of the completed reinforced earth ready to undergo the various kinds of test. A series of test started by eliminating the supporting fill seen at the left end of Fig. 12(a). Photo 13 shows the completion of the removal of the supporting fill. At this stage the top edge of the overhanging cliff moved 320 mm downwards. Then the supporting members under the soil bridge were removed resulting in the maximum deflection of 110 mm as seen in Photo 14. The right hand side of the fill were planned to form a cantilever, but this was not achieved due to an excessive compression of the supporting members during the process of eliminating them one by one. Then the geogrid was cut along a vertical line at the center of the fill (Fig. 12 (a)) aiming at mechanical separation of the fill at the centre. The final stage of the test was to cut the geogrid along a line shown in the left side of Fig. 12 (a). Cutting proceeded from the geogrid placed at the highest level and went down layer by layer. The overall collapse took place at the stage when the geogrid at a height of 3,000 mm from the bottom of the fill (ie the ground surface) was cut as seen in Photos 15.

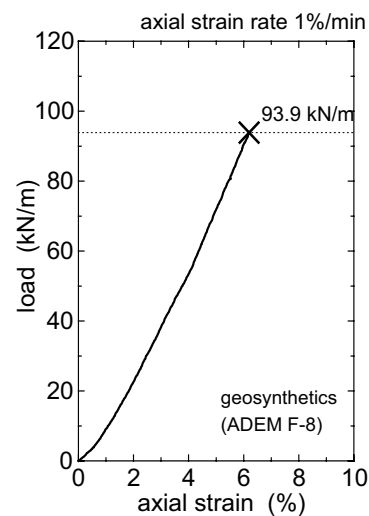
Fig.11 Tensile test on the geogrid, 1996
