Case Studies: The Design And Construction Elements That Arise When Hazardous Waste Lagoons Incorporate Steep Sideslopes.

C. Cilliers. Jones & Wagener, Johannesburg, South Africa. cilliers@jaws.co.za

J. Msiza. Jones & Wagener, Johannesburg, South Africa. jabulile@jaws.co.za

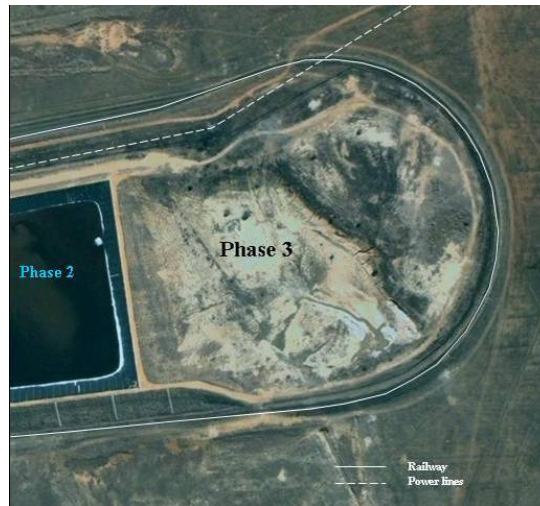
The site is surrounded by a railway loop that forms the northern, southern and eastern boundary (refer to Figure 1). Powerlines are also located on these boundaries, their servitudes overlapping the edges of the site. There are two phases constructed within the facility with Phase 2 forming the western boundary for Phase 3.

Figure 1. Plan view of Phase 3 of the slurry disposal facility at Site A in Kwa-Zulu Natal

The railway loop prevents a fourth phase from being added to the facility. The external toe of the embankment of Phase 3 was extended to be parallel within the railway embankment leaving only the width required for the storm water trench and access road in between. This allowed the remaining area within the loop to be used for Phase 3.

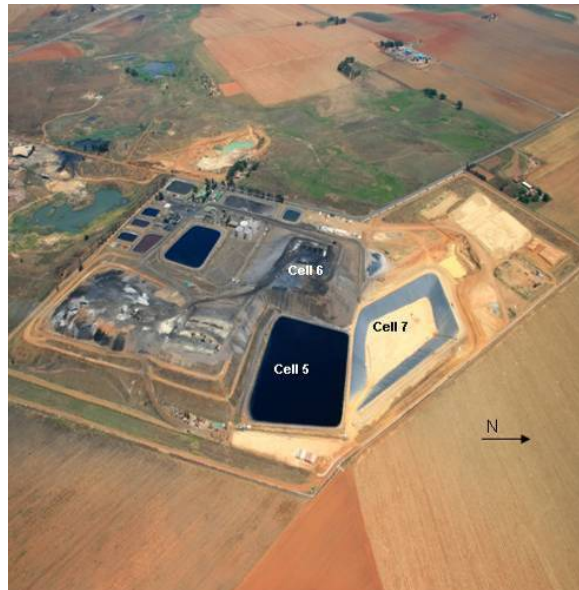
The new leachate dam (Cell 7) is bordered on the south by an existing leachate dam (Cell 5) and an existing landfill cell (Cell 6), see Figure 3 showing the site layout. Future cells will be developed on the western and northern sides of Cell 7 within the permitted boundary as the landfill progresses.

Figure 3. Plan view of Cell 7 of the landfill site at Site B in Gauteng.
