Determining the Remaining Lifetime of Exposed HDPE Geomembrane Liners

I.D. Peggs. I-Corp International, Inc., United States of America, icorp@geosynthetic.com

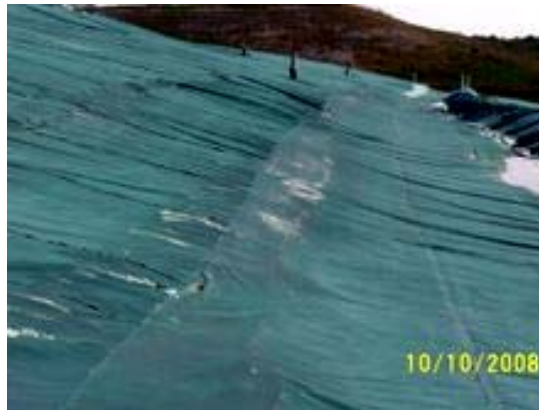
Figure 3. Exposed reinforcement (white) on sunny side (Courtesy DSWA)

An exposed reinforced polypropylene (RPP) geomembrane cap (EGC) on an 18 ha landfill was evaluated after almost 10 years of service prior to application for an operating permit for a further ten years. Conventional mechanical property tests (grab tensile, wide width tensile, puncture, tear) were performed on samples removed from the cap and all were essentially found to be acceptable. Some increased monitoring was proposed on the south facing (sun exposed) side due to a larger, but not unacceptable, reduction in properties. However, not long after the permit application was submitted, but before it was issued, significant degradation of the liner became visually apparent. Reinforcing yarns were exposed on the sunny side as the exposed PP layer cracked and spalled (Figure 3), and as the other sides were found to have become powdery or “chalked” on the surface (Figure 4). Even with good surface cleaning it was not possible to thermally weld a patch of RPP to the surface to make a repair. The surface of the FPP had become oxidized and would not melt to facilitate a repair.

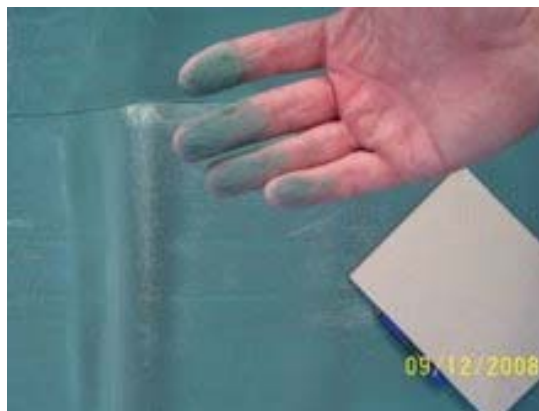
Figure 4. Chalking on surface (Courtesy DSWA)

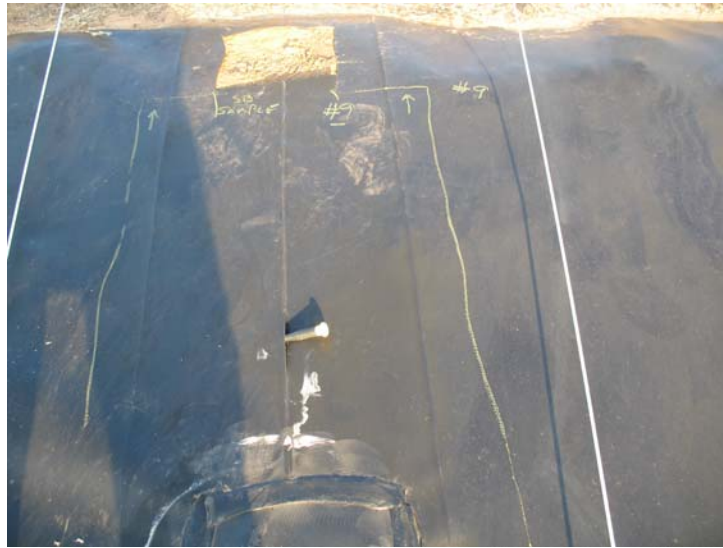
Figure 6. Stress cracking (screwdriver) along apex-down manufacturing fold. Anomalous apex-up folds (arrowed) are not cracked.

The cracking was initiated on the exposed surface. The fold failures only occurred in the few folds with the apex down (a V cross section). No SC occurred in the majority of folds with the apex up (an inverted V). The stresses that induced cracking were those due to thermal contraction at low temperatures. Thus, the surface conditions on the exposed and unexposed surfaces of the geomembrane at the folds are shown in Table 1.

This shows that only the apex-down creases have both tensile stresses and oxidation on the surface, both being needed to initiate SC. Similarly the stone protrusions generate a tensile stress on the oxidized surface and SC is initiated at the stress concentrating surface die marks. These stresses are exacerbated at low ambient temperatures. SC was also seen along the edges of both extrusion welds (added oxidation and grinding gouge stress concentrations) and fusion welds (added oxidation). Thus, there was more cracking, as expected, at extrusion welds.

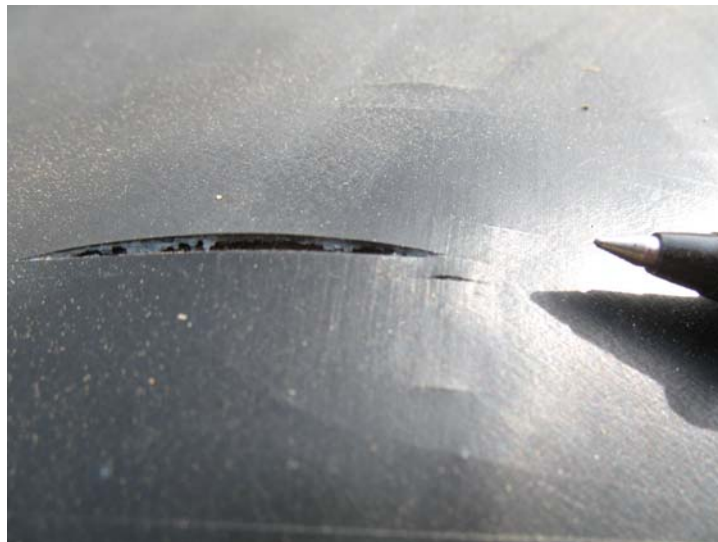
Figure 7. Stress cracking along extrusion die lines at subgrade stone protrusion.

Another example is a single exposed HDPE liner in a pond in a hot/cold environment in the Midwest USA. It was installed in 1993. It failed in late 2008 (Peggs 2009). Material from the anchor trench, unaffected by high temperatures and UV exposure still met 1993 geomembrane specifications (National Sanitation Foundation International standard NSF 54). It also met the Geosynthetic Research Institute (GRI) GM13 stress cracking resistance (SCR) specification of >200 hr (ASTM D 5397) introduced a few years later. In fact, the conventional mechanical properties of the exposed material still met those specifications. However, the SCR had decreased, and both Standard Oxidative Induction Time (S-OIT) and High Pressure Oxidative Induction Time (HP-OIT) fell by about 50%. Failure was by SC along some, but not all, of the round die extrusion manufacturing fold marks at the quarter and three-quarter roll width locations of the sheet (Figure 4), and at subgrade stone protrusions (Figure 7).

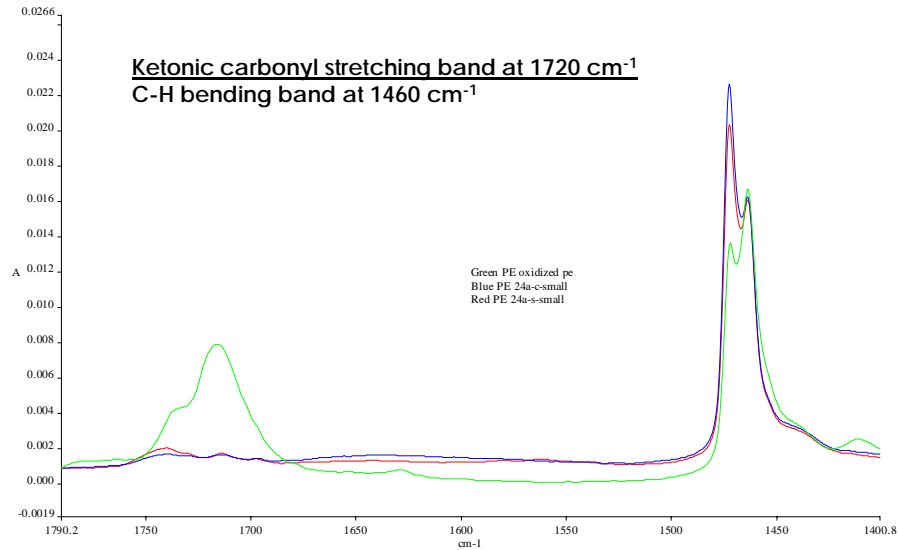
Figure 9. FTIR-ATR spectral peaks (carbonyl left, PE right) and definition of CI.

However, none of these tests indicate definitively whether or not actual oxidation of the surface has occurred. Clearly such knowledge is important. This information can fairly simply be obtained by measurement of the carbonyl index (CI) using the attenuated total reflectance (ATR) technique of Fourier Transform Infrared spectroscopy (FTIR) on the exposed surface. The CI is derived as shown in Figure 9. It represents a measure of the degree of oxidation by monitoring the increase in the products of oxidation (carbonyl groups) as a function of a reference PE spectral peak.

In HDPE natural gas distribution pipe failure investigations Broutman and Duval, (1989) and Duval (2002) have proposed that if CI exceeds 0.1 there is a high probability of SC being initiated. It is proposed that this also be used in the evaluation of HDPE geomembranes.
