INSTRUMENTATION AND LONG-TERM MONITORING OF IN-PLANE STRAINS WITHIN GEOMEMBRANES TO LANDFILL STEEPWALL LINING SYSTEMS

Eugene Gallagher¹, Mao Nguyen² & Derek Smith³

This paper describes the design of an instrumentation unit that measures directly the strains (and temperatures) in a steepwall geomembrane liner. The unit, which is based upon a series of linear variable displacement transducers (LVDTs), each monitoring 2m lengths of geomembrane, was designed to do this without being adversely affected by the lateral and vertical pressures and environmental conditions of a working landfill. Results were collected by automatic datalogger and interrogated remotely by modem link. Data are presented on the first four years of live loading in an operational landfill from construction of the steepwall system.

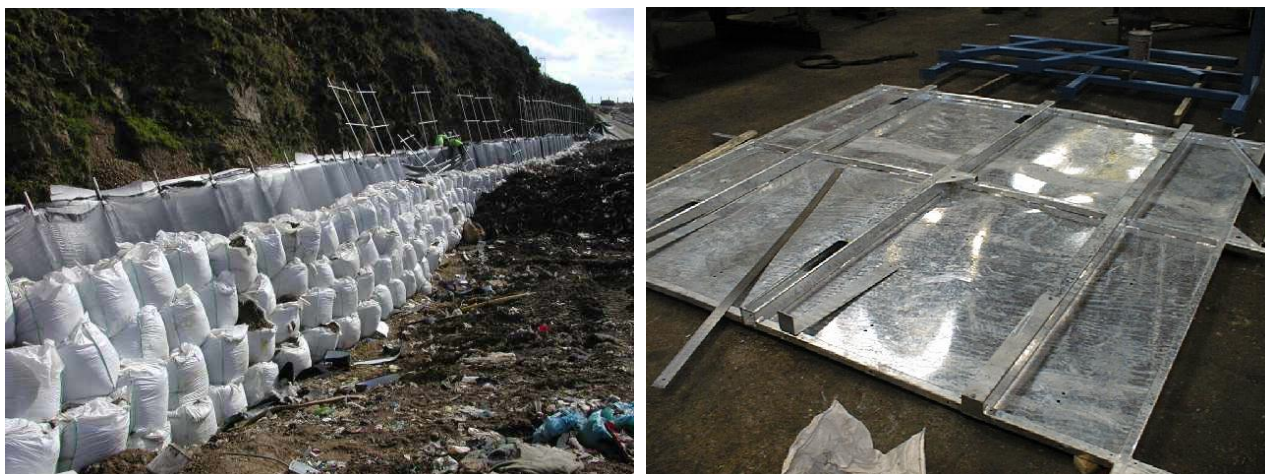
Figure 3: 3a on left is a general view of the revetment system showing bulk sacks and waste in front of steepwall. 3b on right is a rear view of instrumentation panel prior to installation. Three SHS are shown welded to rear face with access slots for installation of the transducers from rear. 'Top' of panel shown in foreground of image.

To allow these objectives to be met, the instrumentation panel was conceived as a replacement to a section of revetment framework. In practice a 3m x 3m section of standard revetment framework was replaced by a specially constructed galvanised steel panel. Each instrument body was 500mm in length and 30mm in diameter. The instruments, including their fibreglass extension rods, were each housed in 80x80x6.3 square hollow section (SHS) members. The three SHSs were welded vertically to the rear of the steel panel separated by 1m horizontally (see Figure 3b). The panel had three sets of two vertically oriented slots of 200mm length and 60mm width cut through both facing panel and SHS (see Figure 4a). The SHS and indeed the steel facing plate added to the strength, and mass, of the 3m x 3m instrumentation panel which was therefore significantly more robust compared to a similar area of standard revetment framework. This increased rigidity was the main difference between the instrumentation panel and surrounding revetment framework. Although in principle this might have made the instrumentation panel less representative, this difference was balanced by the need to ensure the instruments were safely and robustly housed and not influenced by lateral waste body pressure (say) deforming the framework and influencing the readings obtained. The steel facing panel had wire mesh spot welded to its waste-side to simulate the surface texture of the surrounding revetment framework system.

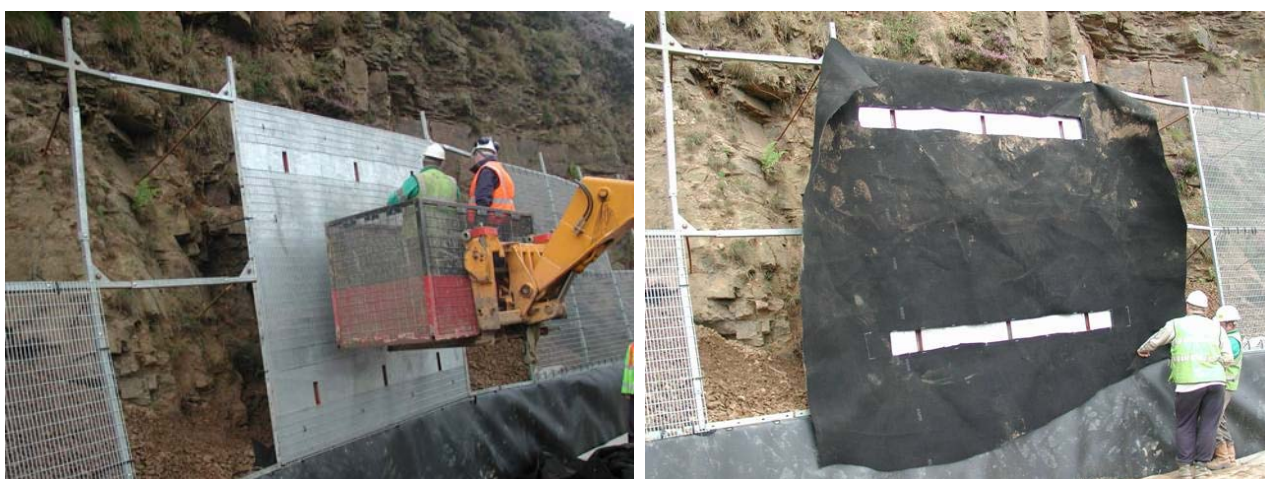
Figure 4: 4a on left shows 3m x 3m instrumentation panel being installed within revetment steepwall. Lower lift of geomembrane visible below. Vertical slots in front face for instrumentation visible. Gap in mesh shown at level of slots. 4b on right shows placement of quarry-side NPNW geotextile protection. Horizontal gaps in NPNW and mesh designed to allow movement in HDPE bars welded to rear face of the geomembrane (see text for further explanation).

To allow HDPE blocks (each 50 x 70 x 50mm) to be fitted to the rear of the 2mm thick geomembrane as anchorage points for the instruments, two strips, each 2500mm long and 10 x 50mm in cross section of HDPE were welded horizontally to the rear of the geomembrane. The anchor blocks were fixed to these. To ensure the two strips did not restrain the movement of the geomembrane, appropriate gaps were left in the wire mesh and quarry-side geomembrane protection layers. See Figure 4a & 4b.

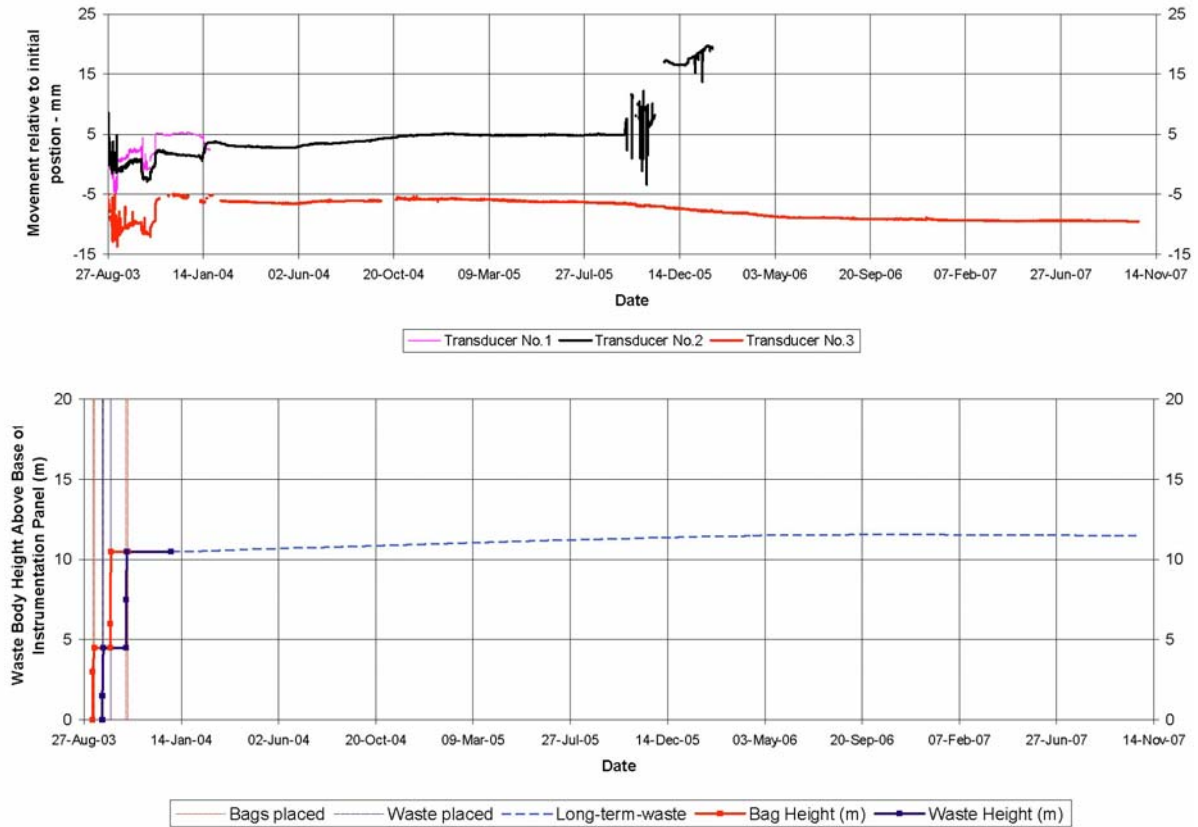
Figure 6: Displacement data and indicative waste body position vs. time

Figure 6 presents the changes in displacement of all three transducers relative to their initial setup positions corroborated with some records of waste filling with time. It should be noted that large displacements clearly beyond those which may reasonably be expected were not included in the derived data set. The purpose of this graph is to demonstrate the continuity in monitoring and indicate the degree of functionality of all three transducers over the project life. Only transducer No. 3 remained functional until the end of the project. Figure 6 also gives an indication of the elevation of the waste body surface with time, particularly during the first half year of monitoring. In the absence of actual survey data, later elevations of the waste body surface were postulated, noting that additional waste placements occurred from time to time, also that settlement of the waste body occurred continually.

Transient spurious data (i.e. outside the transducer measurement range) have not been included in graphs. The discontinuities shown in the graphs of all three transducers in Figure 6 indicate periods of erratic readings.

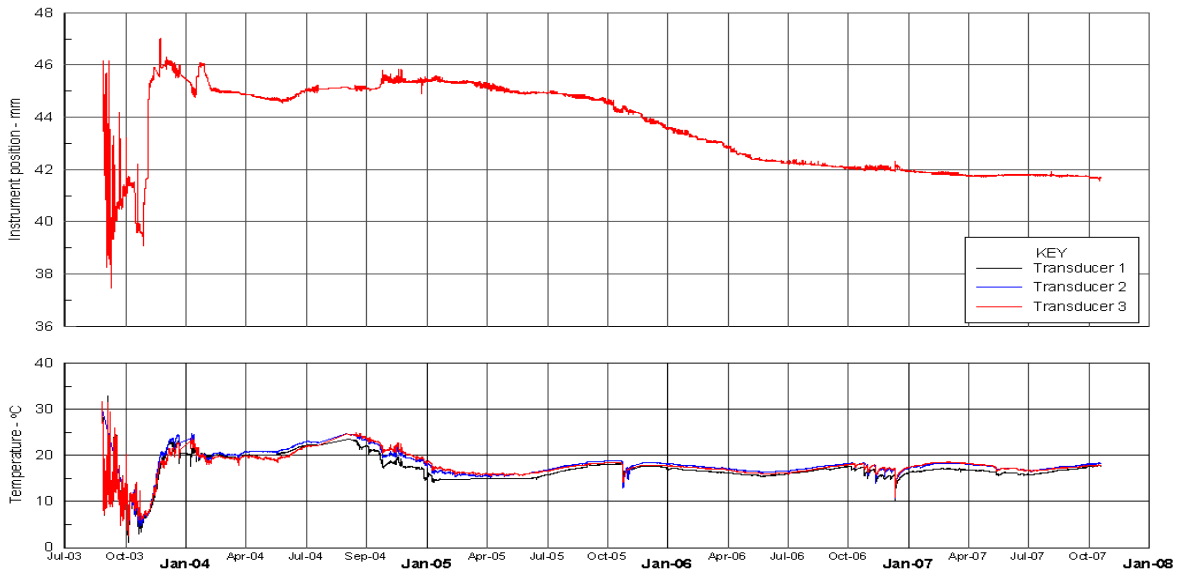
Figure 7: Transducer No. 3 displacement data and all temperature data vs. time

Figure 7 includes the full set of position data as recorded by transducer No. 3 against time. The data were reduced to millimetres to present the actual measured position in relation to the total potential travel distance of 200mm. The temperature data for all three transducers are also presented in this graph showing the relationship between displacement, time and temperature.

During the settling-down period, the instrumentation panel was partially exposed to the weather and recorded temperature varied between 1°C and 32°C, see Figure 7.

From the end of 2004, displacement readings became more stable; electrical noise/interference was only infrequently recorded. The measurement position of transducer No. 3 returned to its initial datum position at 46mm approximately. The shape of the displacement graph thereafter appears to be analogous to that of a typical consolidation settlement curve (i.e. self-weight settlement), particularly for the period between November 2004 and September 2007 as illustrated in Figure 7.
