MEASURING RESULTS ON THE LANDFILL SURFACE LINER SYSTEM "ASBACH"

S. M. Schmitz

University of the Federal Armed Forces, Munich

ABSTRACT: The landfill Asbach is located in the south-east of Bavaria and represents a municipal solid waste landfill. The first part of the landfill liner system was installed in 1996 and combines a capping system of a mineral sealing and a CBR-C (Clay Geosynthetic Barrier [1]). This first part represents an area of about 22,000 m². The area is divided in 16 parts, which have different inclinations. Some of them have a very steep slope and others have a very flat slope. Some parts are exposed directly to the solar radiation and other parts of the area are capped by the shadows of a nearby forest. During the installation of the sealing system, intercepting reservoirs were integrated in each of the 16 fields. These reservoirs allowed the recording of the leakage rate through the CBR-C by manual measurements. Therefore only temporary recordings were possible, which implies, that the exact leakage rate and the behaviour of the CBR-C on the precipitation could not be obeyed. In fall 2002 an automatic measuring system was installed. This system works with doubl

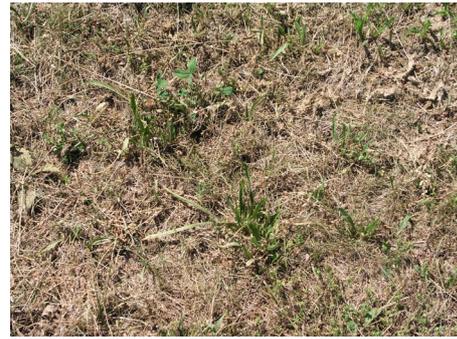
The vegetation cover basically consists of grass and is cutted twice a year. No bushes can be found.

Figure 5: Vegetation cover in the summer 2003

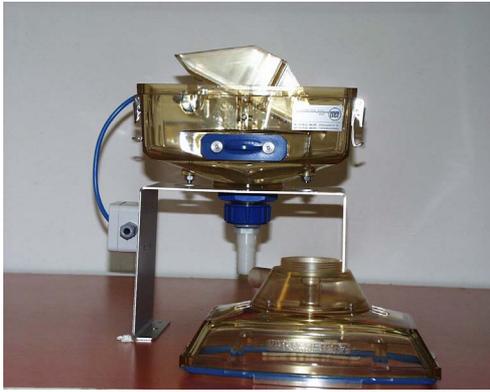
Figure 11: Double-pan balance as it's been integrated in the inner reservoir

Each pan has a capacity of 100 ml and after each tilt, an impulse is registered on a computer system.
