An example on the construction of MSW landfill site with the leakage detection and restoring automatically

ABSTRACT: The impermeable structure developed in this study adopts that the double liner system sandwiches excellent permeable material to detect leakage of leachate from the impermeable sheet. The site divided into some blocks made in the bag of a liner sheet with wideness of 300–500 m². Each block has a tube for detection of the leakage. When some water leaks, it flows to the detection pit through the tube quickly. The PH-sensor/EC-sensor installed in the site analyzed whether or not the fluid is contaminated. If the dew water is clean, it is just taken off. Otherwise, the restoration material will be pumped into the bag through the tube and defect part in the liner was recovered urgently. Administrators in the room controlling landfill can monitor the barrier performance of liners using the telephone line for 24 hours.

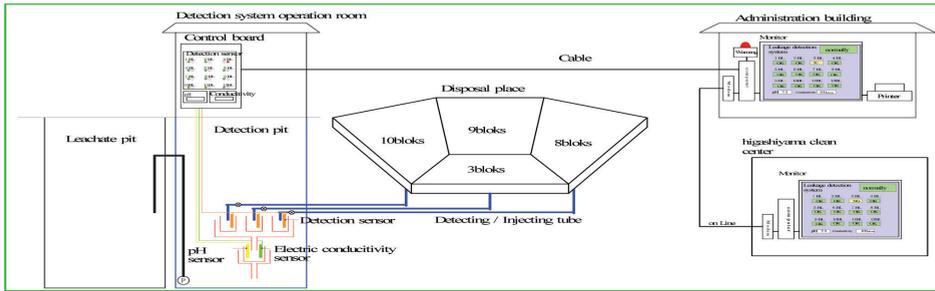
Figure 1. Schematic of entire system with the leakage detection and restoring automatically.

Figure 1 illustrates an entire system developed in this study. This system basically has the 5 layers with lower protective mat, lower impermeable liner sheet, inner good permeable mat, upper impermeable liner sheet and upper protective mat. The cross section of the bag structure is shown in Fig. 2. An area of cross section of the bag is approximately 300 m² to 500 m² (Kanou et al. 1995). If any damage is caused in the impermeable liner sheet, the water should be drained into the detection pit through the tube connected to every bag with gravity flow.

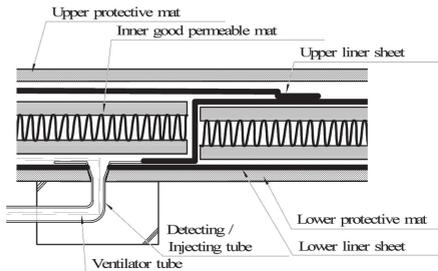
Figure 2. Cross section of the bag structure.

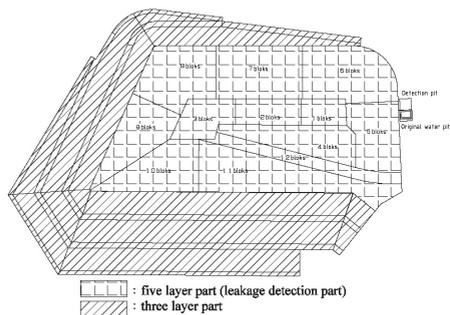
Figure 9. The plane view of the site.

The pictures of construction site are shown in Figs. 6–7 and the plane view of this site is shown in Fig. 8. The barrier system in this site can detect the leakage up to the first level of the slope with much possibility of the damage to the impermeable liner. The impermeable liner with 5 layers was installed in the division. In more than 5 m depth, it has 3 layers on the shotcrete because it has little risk, which the sheet is defected. Based on this concept, it is recognized that the MSW landfill will be into stable period.

Impermeable liner is composed of a polyurethane sheet with 1.5 mm thick. Lower protective mat is non-woven fabric made of short fiber. Upper protective mat is non-woven fabric with laminating made of long fiber. The reason using the mat with laminating is to avoid the damage with snow load. The site is divided into 12 blocks which are the bag structure and have the detecting/injecting tube each.

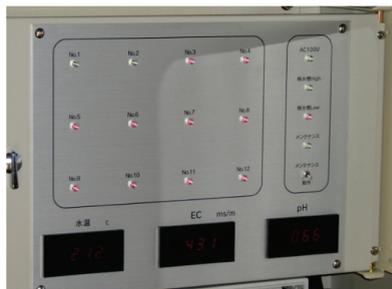
Figure 10. Picture of control panel.

Figure 10 shows the control panel and, Fig. 11 shows the distribution of the injecting pipe in the detection pit. The screen of monitoring on a personal computer is displayed in Fig. 11. The detecting tube has the sensor, which detects the leakage with measuring and recoding every one hour. If the sensor detects the leakage, light emitting diode (LED) in control panel warns emergency by turning red from green. The data is transferred to the administration building at the same time.

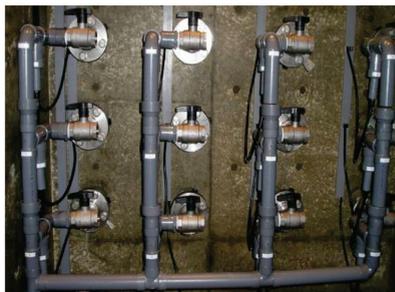
Figure 11. Picture of detecting/injecting tube in the detection pit.

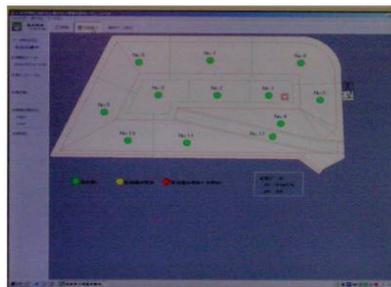
Figure 12. Screen of monitoring on PC.
