SAND FILLED CONTAINERS IN DUNE EROSION CONTROL A CASE STUDY FROM THE NW COAST OF PORTUGAL

L. das Neves, F. V. Gomes

Faculdade de Engenharia da Universidade do Porto Hydraulics and Water Resources Institute

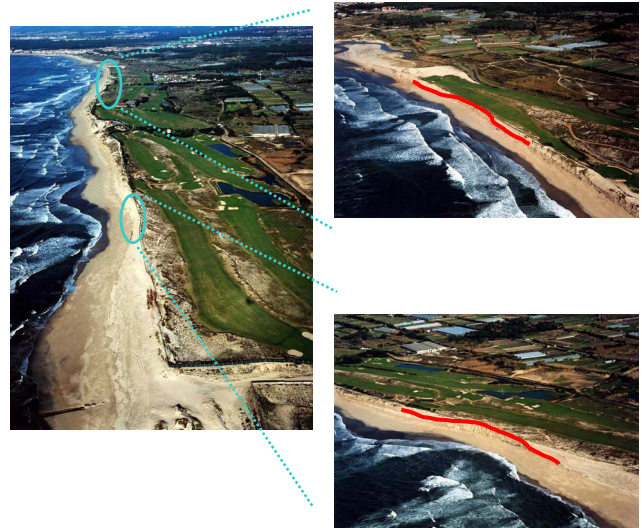
Figure 3 Critical erosion zones.

As a consequence of this direct wave action, the dune system was becoming more and more fragile. This state of fragility was particularly visible in the decrease on the beach width and dunes and the coming in sight of dune erosion cliffs. At the time of the 1997's aerial survey there were two stretches of the dune where the erosion was more critical (Figure 3).

The two designated stretches correspond to holes 5 at North (top), assigned has critical zone 1 (CZ1) and 13 at South (bottom), assigned has critical zone 2 (CZ2). The dune restoration interventions are taking place in these two stretches and will be discussed more ahead in this paper.

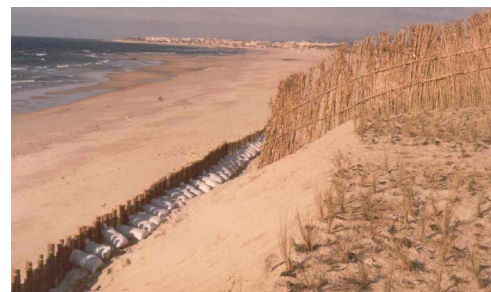
Figure 4 Dune consolidation with woodpiles and small bags full with sand, April 1999.

The first documented intervention to the dune system of Estela dates from 1 to 12 April 1999. This intervention consisted of the local reinforcement of the dune through mechanical sand replacement. This replacement was later strengthened with woodpiles and very small bags (~50 N) full with sand (Figure 4). The same intervention was made in critical zones 1 and 2.

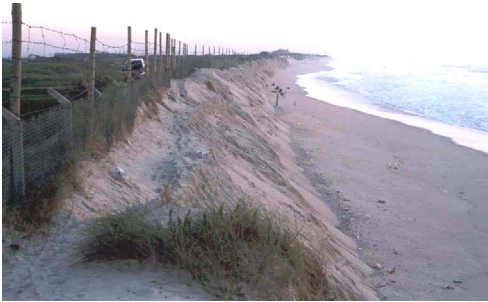
Figure 5 Aspect of the dune in CZ1, October 1999.

It was still in October 1999 that a new reinforcement intervention using the same technique was necessary, but at this time only in critical zone 1. Figure 5 shows the aspect of the dune before this intervention. As it can be observed, its state was of an advanced degradation, being the limit of

the eroded dune very close to the golf course fence. Before the end of the 1999/2000 winter season it was necessary to proceed with two more interventions, one in January and the other one in March.

Indeed, when comparing the state of damages caused by similar wave climate conditions to the dune (Figures 5, 6 and 9) one can easily conclude that these are much less when the dune is strengthened with sand filled containers.

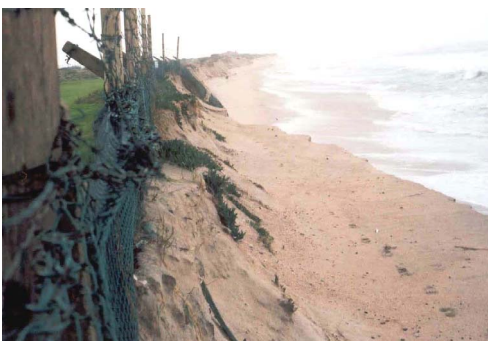
Figure 6 Aspect of the dune in CZ1, November 2000.

December 2000 marks the beginning of the use of a new technique. The severe storms that had attacked the dune and had caused significant damages, since October, required the use of a new protection scheme (Figure 6). This new protection scheme was constructed with sand filled containers of $\sim 1 \text{ m}^3$ which were placed on a sand core with a geotextile filter cloth underlay. As observed in Figure 7, sand filled containers have been placed at the dune slope in sections of 350, 70 and 50 m length. Figure 8 shows some aspects of the execution of this technical solution – forming the dune platform trough sand ripping, placing and anchoring the geotextile filter cloth and settling the sand containers.

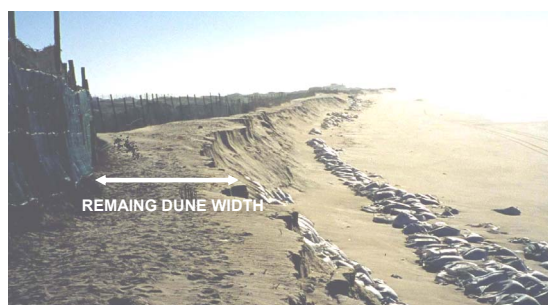
Figure 9 Aspect of the dune in CZ1, January 2003.

The measures taken so far to control the ongoing erosion process in the dune system of Estela can be classified as rather ineffective, in a medium to long term basis. Nevertheless, this last protection scheme constructed with geotextile sand filled containers is keeping the dune erosion within certain limits, even when submitted to severe wave conditions (Figure 9), and thus, it is reasonable to expect that some improvements at the level of materials and design will enhance its effectiveness.

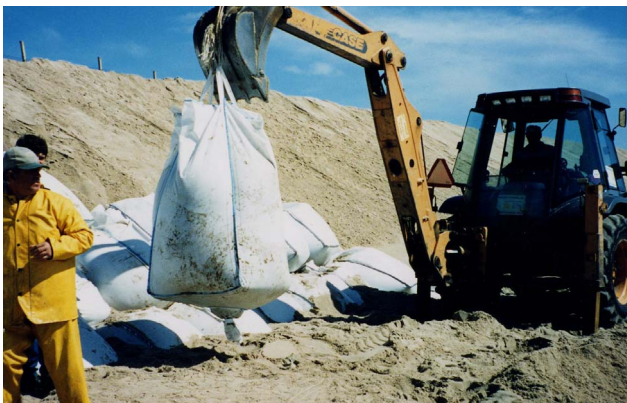
Figure 10 Geobag currently use in the strengthening of the dune of Estela.

The geobag currently in use at Estela is a woven geotextile manufactured from polypropylene fibres. Its dimensions are $0.96 \times 0.96 \times 1.50 \text{ m}^3$ width \times length \times height of which corresponds a volume fill of approximately 1.00 m^3 (Figure 10).

Mechanical characterization tests to this geobag were carried on in the Geosynthetics Laboratory of the Faculty of Engineering of the University of Porto. The results of these tests show that this material has good strength properties. However, and even though hydraulic characterization tests have not been made, it is possible to say, just through the observation of the geobag, that it is practically impermeable, thus not the most suitable for this application since it does not favours the release of pressure that is generated by wave flow. The friction behaviour of the material is also inadequate for the application once it does not promote the behaviour of the structure as one, enhancing its overall stability.

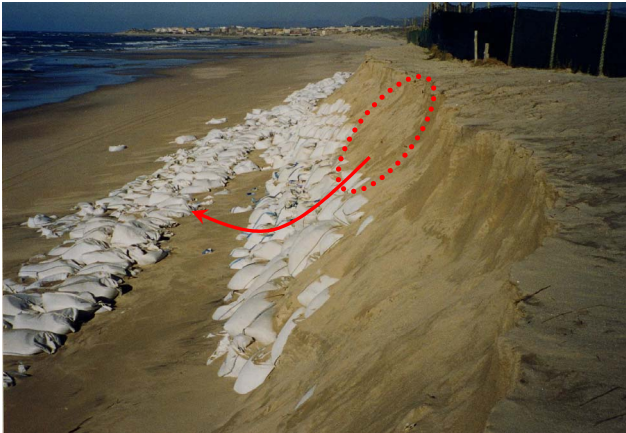
Figure 11 Probable mechanism of failure.

The probable mechanism of failure of this coastal protection is the sliding of bags along the dune slope, as indicated in Figure 11. This way it is most important to intervene in order to keep the bags in position allowing only very small movements.

This sliding has though the positive effect of creating a wave breaking berm, because the bags remain buried in the frontal beach, which allows the dissipation of some wave energy before it reaches the dune. Nevertheless, the structure is in fail so it is necessary to proceed with replacement works of the washed away sand. The frequency of these works is related with the occurrence of storm surges and this is why it is necessary to seek other solutions with higher longevity.
