RESPONSE ANALYSIS BASED ON TWO-YEAR MONITORING ON LIGHT-WEIGHT STRUCTURES WITH EPS GEOFOAM

ABSTRACT: In the scope of reconstruction and widening of the A15 motorway (Rotterdam-Germany) and associated slip roads and overpasses a total quantity of nearly 100,000 m³ EPS has been built-in. The motorway is located in an area where the subsoil consists of very compressible peat and organic clay layers with average thickness of 10 meters. The existing embankments and abutments are only partly reused. Where possible high sand pre-consolidation embankments have been placed to minimise EPS quantity for cost-saving reasons. In order to investigate occurring settlements and general pavement behaviour critical cross-sections of the A15 project have been monitored. The considered road structures have a sub-base that consists of more than 3.5 m thick EPS layer. Settlement hoses, telescopic rods and profile measurements, registered the time settlements, the creep behaviour and compression of EPS-blocks. Furthermore, pressure gauges measured occurring stress values in unbound roadbase. Finally, asphalt strain measurements and surface deflection measurements have been carried out by means of the Fa

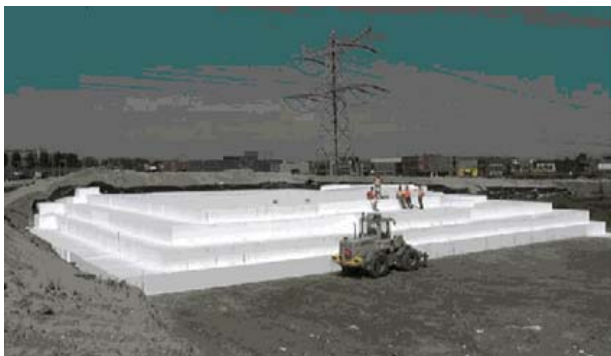
Figure 2 Partly covered EPS-blocks of the monitored approach road on the north side of the Sliedrecht-East junction

In Figure 3 uncovered EPS-blocks are shown during construction of one of two monitored light-weight embankments situated on the northern side of Sliedrecht-East junction. The EPS package is up to 4.5 m high and consists of 1.0 m thick blocks. The light-weight part of the approach road along axis M100 reaches 175 m from the new fly-over. The light-weight section along axis MR05 is about 100 m long. The upper pavement layers, identical for all approach roads, consist of 1 to 1.3 m sand sub-base, 0.25 m thick roadbase of unbound material and 0.25 m thick asphalt package. No concrete capping is applied; the sub-base lies directly on the EPS-blocks. Besides price, the advantage from the Dutch contractors' viewpoint seems to be the possibility of building road furniture directly into sand, in the way they are used to. However, such a thick sand layer does not contribute to a higher bearing capacity and longer lifetime of the pavement structure.

Most blocks used have dimensions 6.0×1.2×1.0m. EPS with a density of 20 kg/m³ has been applied with a modulus of elasticity between 8 and 9 MPa. Such huge EPS blocks are not easy to move and require mechanical handling. However, stacking up is very efficient plus the EPS package consists of only few layers. As illustrated in Figure

2 EPS-blocks are covered by an (oil resistant) impermeable membrane for protection against oil spills. These characteristics are more or less valid for the remaining locations with EPS on the southern side of the Sliedrecht-East junction.

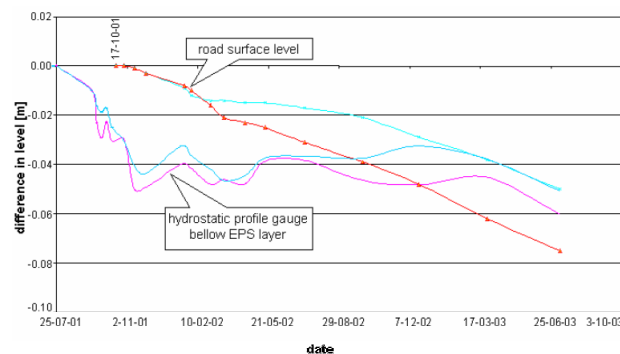
Figure 6 Settlements registered by the hydrostatic profile gauge below a 3.5 m thick EPS layer as well as measured road surface levels in the middle of cross section - km 195 of axis M100 between July 2001 and July 2003

The prediction for the performance of the light-weight road embankments were such that settlements in service are indeed minimized. The measurements of settlements during 2-year period after replacing of preload by EPS geofoam and pavement layers show that the rate of settlement reduces and the total amount of settlement is about 0,15 m. If we exclude construction time the settlements amounts to approximately 0,08 m since the road has been in service as illustrated in Figure 6.

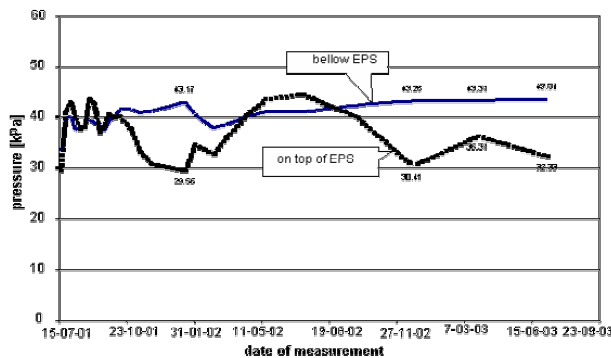
Figure 8 Measured vertical stress values above and below 3.5 m thick EPS layer in cross section - km 126 on axis MR05

The sub-base loading conditions are characterized by both the deadweight of the overlaying layers and the dynamic loads due to the traffic passing above. In the case of the pavement structures being considered with an extremely thick (1 to 1.3 m) sand layer the occurrence of static stress had been expected to be much higher than the dynamic component. The values measured by pressure cells placed above and below the EPS layer, are shown in Figure 8.

A stress of 43 kPa in EPS means relatively high static loading. Generally speaking, sufficiently thick pavement layers cause up to 20 kPa. However, according test results (Duškov 1997) no permanent deformations of practical importance will occur. Regarding dynamic loads the effects on the considered EPS sub-base are very limited. The pavement layers with a total thickness of 1.5 m contribute to very good load spreading above EPS.

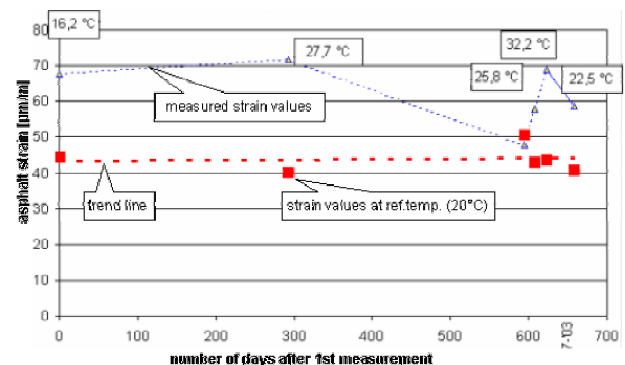
Figure 10 The measured strains with associated temperatures and the calculated asphalt strain for the asphalt temperature of 20°C as a function of time for the measuring point 4 on the light-weight road structure belonging to the northern quadrant of the Slidrecht-East junction

The temperature dependent behaviour of the asphalt layer prevents a direct comparison between the measured strain values. It implies that those values have to be translated to a reference temperature before comparison. The back-calculated E-values in the pavement structure layers were used to translate the measured asphalt strain values to a reference temperature of 20°C and to present the trend of the translated strain values as a function of the pavement structure age. In Figure 10 both the measured strains with belonging temperatures and the calculated asphalt strain for the asphalt temperature of 20°C are shown as a function of time.

From Figure 10 it can be observed that the asphalt strain at the reference temperature (20°C) remains more or less constant two years after pavement completion. The constant value of the strain is a sign of a good condition of the pavement structure. Furthermore, both measured small asphalt strain values and low deflections suggest sufficient bearing capacity of the pavement structure with a 0,25 m thick asphalt layer.

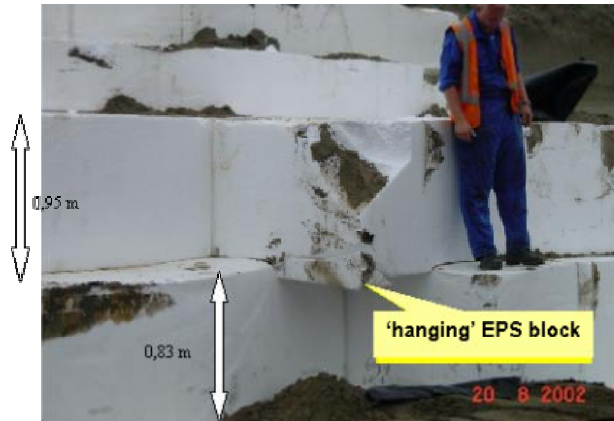
Figure 11 After excavation visible overloaded and permanently deformed (compressed) EPS-blocks on the front (southern) side of light-weight approach road structure along axis M100

The quality of delivered work became obvious in the middle of 2002. At that stage construction activities started again as a part of finishing of approach road including the abutment and realisation of the new fly-over along axis M100 (see Figure 1). After excavation on the front side it turned out that lower laid EPS-blocks were overloaded by up to 5 m thick sand package. Accordingly, permanent deformation of approximately 17% occurred and instead of the original thickness of 1.0 m the blocks were reduced to 0.83 m. The EPS-blocks in the second layer were compressed to 0.95 m. It was absolutely unacceptable and all those blocks had to be removed and replaced by new ones. Extensive material research (Duškov, 1997) pointed out that after the cell structure is damaged due to overloading effective stiffness of the material decreases. Water also penetrates faster into EPS deformed beyond the failure limit of its cell structure.

Additional shortcomings observed after excavation were wide open joints between the blocks which proved inaccurate stacking due to lack of attention during construction. It is also contrary to the Dutch design guidelines (Duškov and Houben, 2001) where it clearly states that all joints should be closed and load transfer across the joints should be promoted. Finally, as shown in Figure 11, even a 'hanging' corner was discovered with no support at all on the underside.

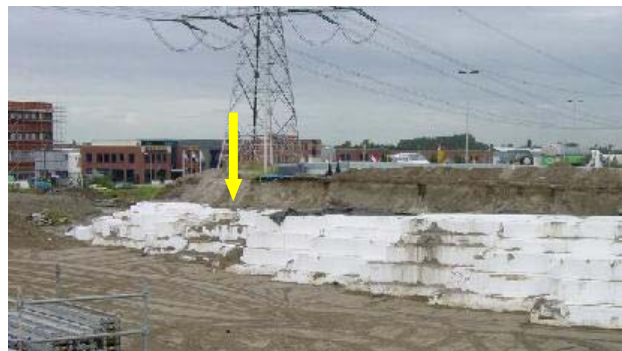
Figure 12 Asymmetrical deformation in the cross section of light-weight road embankment due to not taking into account preload history (1999-2001) in the northern quadrant of the Slidrecht-East junction

The biggest problem due to this inadequate preloading was significant asymmetrical deformation of the whole south-eastern part of the light-weight embankment of EPS-blocks as illustrated in Figure 12. In the scope preloading geotechnicians did not take into account local differences regarding consolidation history. The location marked by an arrow in Figure 12 with extra settlements was not loaded in the past because of protection by a covering concrete structure founded on piles. Therefore, despite identical sand and EPS thickness in the road cross section the subsoil did not settle uniformly everywhere.

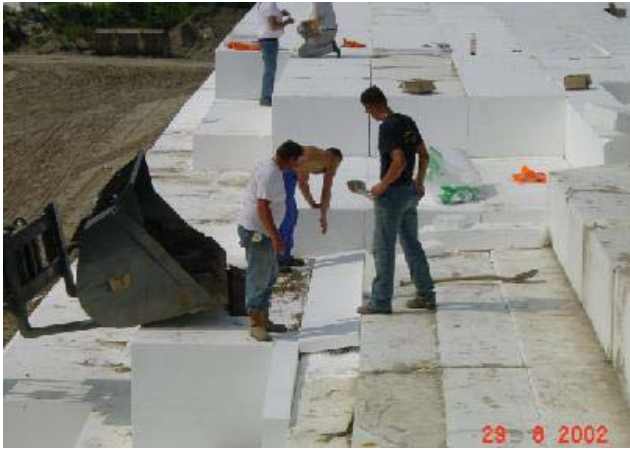
Figure 12 Improvised levelling of asymmetrical deformation in the cross section on axis M100 by means of too thin EPS-blocks which as such might not be used at all according Dutch standard

In spite of the demonstrated serious shortcomings of delivered work, the contractor continued the activities without paying extra attention on critical aspects specific for the use of EPS-blocks. Significant asymmetrical deformation in the road cross section was levelled by using very thin geofabric 'boards'. Official Dutch standard (CROW, 2000) prescribes a minimum thickness of an EPS-block of 0,25 m. Figure 13 shows how the contractor simply ignored the prescriptions.

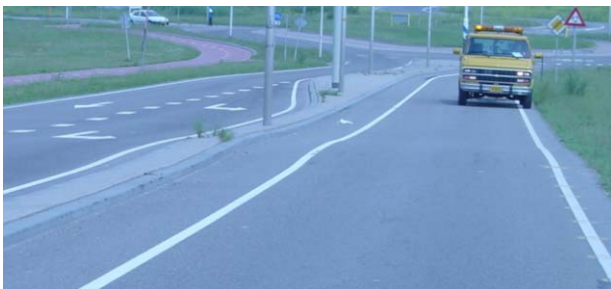
Figure 13 'Threshold' arisen between on road founded on piles and light-weight road parts along axis MR100 due to settlement differences

The settlements on their own are not the real problem from a functional viewpoint but the settlement differences are especially over short distances. Design and/or construction shortcomings are most visible on the locations between light-weight embankments and road parts founded on piles (therefore settlement-free). Figure 13 shows such a short settlement-free road section along axis M100. The attached road parts on both sides are constructed with EPS-blocks but they obviously settled further and a visible 'threshold' still grows. It was necessary to use a thicker EPS-layer on both sides.

The road parts attached to sections founded on piles are critical locations. In the case of the northern quadrant of the Slidrecht-East junction visible thresholds have

arisen on those transitional parts as a result of growing settlement differences. To improve the design thicker EPS-layers are necessary with gradually decreasing thickness at both sides of the settlement-free road section. It is also difficult to reach proper and uniform compaction of unbound roadbase materials applied directly above EPS-blocks on this section.
