**GRAY, C. G.**

ICI Fibres, Pontypool, Gwent, U.K.

**Abrasion Resistance of Geotextile Fabrics****La résistance à l'abrasion des géotextiles**

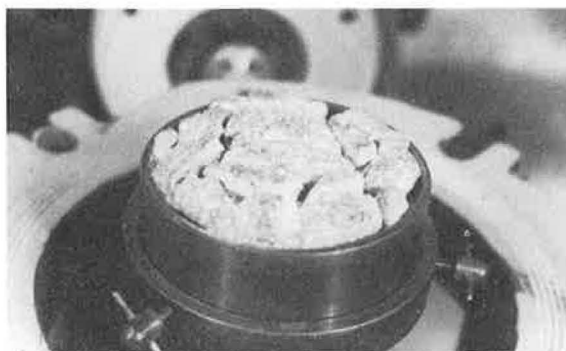
An apparatus was set up which could subject a fabric sample to the type of abrasion produced by aggregate when used on railway tracks or during the construction of roads. Using an epoxy resin, the appropriate aggregate was set into a metal cup which could be mounted on the end of a ram. The ram was vibrated in three different directions simultaneously, the directions being mutually at right angles. One direction was vertical, the other two horizontal. A circle of fabric 250 mm in diameter was cut out, clamped into the apparatus and subjected to the abrasion. The photographs, Figures (1) and (2), show the apparatus used.

Figure (1). Aggregate fixed in cup.

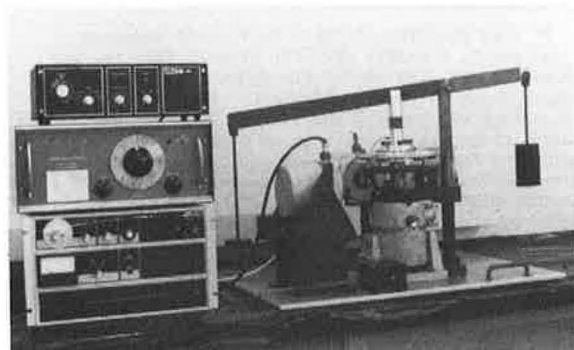
The reason for this type of abrasion test was that certain customers wanted to use Geotextile fabrics as protection layers for impermeable liners against the abrasion and puncturing by stone or rough concrete. A laboratory test was needed to determine which would be the best fabrics for their particular use. An apparatus similar to that used in experiment 3.1 was set up, but with the following differences:- the aggregate ram was replaced by a metal dish filled with "shattered" metal (small particles of steel, see figure 6), the fabric sample under test was clamped over the divided metal, and a circle of small steel cones was pressed against the fabric from above. The ram was vibrated vertically at a frequency of 10 Hertz with an amplitude of 5 mm and a load of 1 kilogram. An electrical circuit was made connecting the steel cones via a battery - and - lamp combination to the steel dish containing the divided metal. When the cones pierced the fabric they came into contact with the divided metal and completed the electrical circuit causing the lamp to light. The whole apparatus is shown in figure 7.

Figure (7). Vibrating Cones Apparatus.

For the initial experiments the times taken for the lamp to light for different fabrics were used as a measure of their resistance to this type of abrasion. However, some fabrics took a long time, hence to speed up the test each fabric was subjected to the above conditions of vibrating cones for two hours, after which the static load required for the fabric to be pierced was measured; the higher the load required, the higher the resistance of the fabric to this abrasion. Seven different fabrics were compared, five non-woven and two impermeable sheets. There were three polypropylene/polyethylene continuous filament melded fabrics of different weights, 100, 140 and 230 g/m<sup>2</sup>, a high bulk c.f. polypropylene/polyethylene, a c.f. polyester and two polyvinyl chloride sheets of thickness 1.0 and 1.2 mm. The results are given in figure 8.

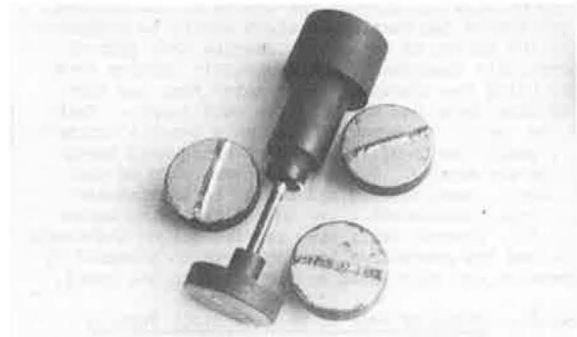
In this test the standard Martindale abrasion test equipment, normally used for apparel fabrics, was modified for use with Geotextile fabrics because the abrasant needed to be much stronger. The weighted sample holder was removed and its end modified by placing a ridged weld across it as shown in figure 9. The modified Martindale abrasion equipment is shown in figure 10. The Martindale tester works by moving in a horizontal plane first in one direction then gradually changing to a direction perpendicular to the first, thus giving a circular abrasion patch.

Figure (9). Modified weighted sample holder for use as Abradant.

The purpose of this trial was to try to use a standard equipment for abrasion. The Martindale equipment which was chosen needed its abrasant to be changed from a fabric to a solid metal. The weld modification was chosen because in one end-use there was frequent contact with welded materials. The results showed that this test too could differentiate between fabrics, but again only comparatively, not in an absolute sense. Further test development will be needed to standardize the equipment, in particular the abrasant.

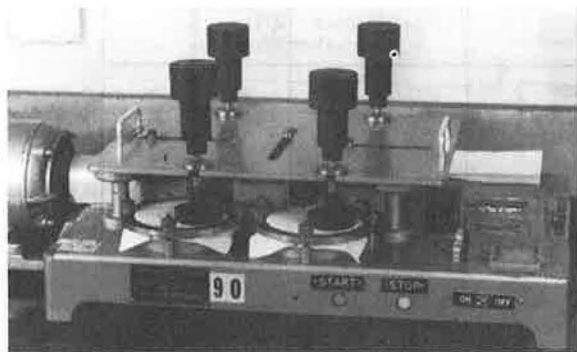
Figure (10). Modified Martindale Abrasion Equipment.

The Geotextile fabrics compared in this experiment were two non-wovens and a woven split tape. The non-wovens were a continuous filament polypropylene/polyethylene melded fabric and a needle punched c.f. polyester; the woven fabric was of polypropylene. Two pairs of samples were abraded on the equipment at the same time until one pair was worn through. On each of 4 trials the woven split-tape was worn through, with the others showing visible signs of abrasion but not being destroyed. A visual assessment of the two non-wovens showed the needle punched fabric to be the more abraded.
