Van DINE, D. and RAYMOND, G.
Queen's University, Kingston, Canada
WILLIAMS, S. E.
EBA Engineering Consultants Ltd., Edmonton, Canada

An Evaluation of Abrasion Tests for Geotextiles

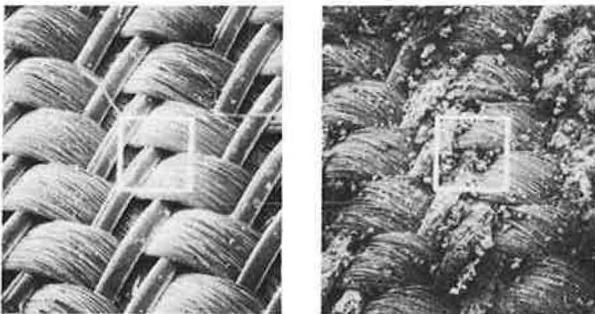
Fig. 5 GEOTEXTILE D (scale bar is 500 microns)
(a) Unabraded
(b) Rotary Abraded (1000 cycles)

(c) Ballast-Impact Abraded (10 drops)
(d) Repeated Loading Abraded (100,000 cycles)

After undergoing 10 ballast drops of the Ballast Impact Test, the woven geotextiles frequently showed evidence of peeling, splitting, and being cut. A minor amount of slippage of the filaments was also noted. Geotextile B proved to be the most resistant to impact abrasion while Geotextile D was the least resistant; the multifilaments having been cut all the way through. Geotextiles A and C were abraded to approximately the same degree and to an extent between the Geotextiles B and D.

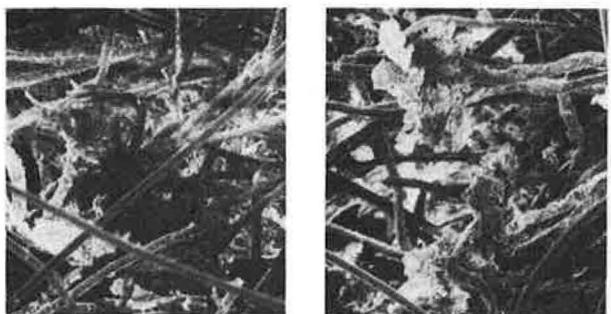
Fig. 6 GEOTEXTILE G (scale bar is 100 microns)
(a) Unabraded
(b) Rotary Abraded (1000 cycles)

(c) Ballast Impact Abraded (10 drops)
(d) Repeated Loading Abraded (100,000 cycles)

The common impact abrasion processes seen after 10 ballast drops of the Ballast Impact Test were peeling and being cut. Less frequently the filaments were flattened and fused. Geotextiles G and H were found to abrade the most, and Geotextile G was the only sample punctured by this test. The remaining 5 samples showed approximately the same amount of impact abrasion.
