Reactivation of a geogrid-bridged sinkhole: A real life solution approval

D. Alexiew

HUESKER Synthetic GmbH, Gescher, Germany

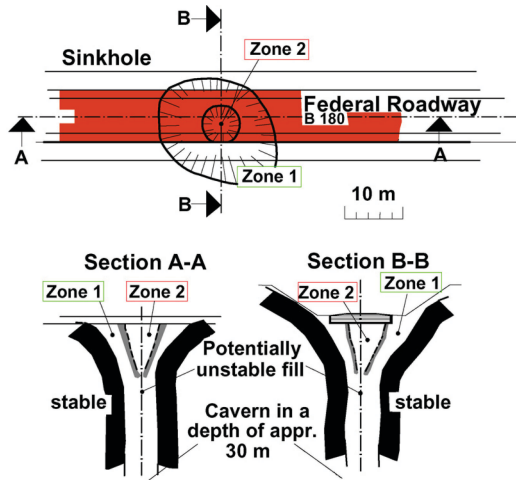
Figure 1. Geometry and potential sinkhole zones under the B180.

- The primary consideration was the safety of the driver and the vehicle traveling at up to 100 km/h on the B180 right where a new large sinkhole opens (Zone 1, Fig. 1). The longitudinal and transverse deflections (or bending or settlement) of the

carriageway had to be kept within acceptable limits and the carriageway should not crack or collapse locally over the underlying gaping “large” funnel (Zone 1, Fig. 1). No sharp edges / steps should form on the carriageway.

for bridging the smaller funnel (Zone 2) and to 0,06–0,07 for bridging the worst case (failure of Zone 1, big funnel) (Fig. 1).

(say 12 to 13 m); the “large” Zone 1 (Fig. 1) had collapsed. The carriageway was severely deformed but was still intact as a whole unit.

Next morning the irregularly-shaped funnel had a diameter of over 20 m (Fig. 8). It cannot be clearly established whether and by how much the hole in the carriageway (on the previous evening) had grown after the tear. Its position corresponded with the estimated position of Zone 1 in 1993 (see Fig. 1). It was obvious that the bridging system had more than met the requirements and expectations of the 1993 design and construction in terms of load carrying capacity, deformation and behaviour over time. This was all the more crucial as the warning system and the stop signs had not reacted.

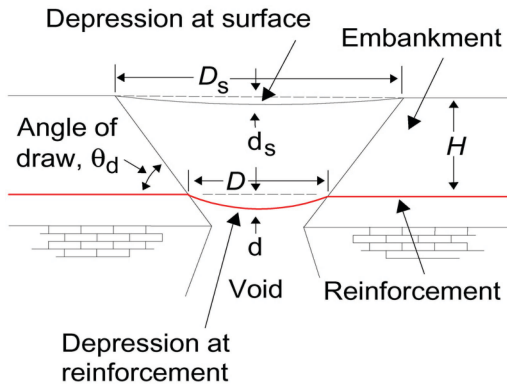
Figure 2. Analysis model in accordance with BS 8006.

The structural analysis, design and detailing was carried out in spring 1993 in the Engineering Department of HUESKER Synthetic GmbH (HUESKER, 1993). Three possible design methods were examined: (Giroud, 1982), (Giroud et al, 1990) and (BSI, 1995), which were all based on the use of the membrane theory for the geosynthetic reinforcement solution, the theory being considered safe and plausible at that time. BS 8006 was then only available in draft. The BS 8006-method (Fig. 2) was preferred due to different reasons (Alexiew, 1997 & Alexiew, 2007).

Later on for other sinkhole projects modified design procedures were developed (Alexiew et al, 2002b). One of the focal points is that the limitation of strain in reinforcement reduces the deflection (d/D) and finally the deflection on the surface (ds/Ds) (Fig. 2). Further details of the model and analysis can be found in (BSI, 1995). Generally, a geogrid was preferred as reinforcement (instead of e.g. a woven geotextile) mainly due to its higher coefficient of interaction (bond) to the soil.

The determination of the design strength of the reinforcement was carried out in accordance with the requirements of the German Guidance Note (FSGV, 1994), which was only available in draft form in 1993. The final design calculations were performed in a way to minimize deflection (ds/Ds , Fig. 2) to 0,02–0,03

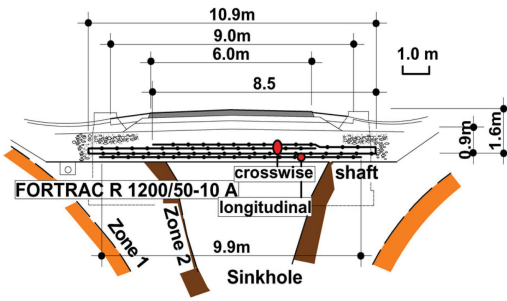
Figure 3. Schematic cross section of the sinkhole bridging system.

If the movement of the ends of the wires indicates a settlement of the reinforced soil structure equal to a strain of 1.5% (ca. half the ultimate, Fig. 4) in the geogrid, a warning system comes into operation and traffic in both directions is stopped at a safe distance on both sides of the critical area by electronic warning signs. The warning system was designed to be activated before the complete opening of the “large” Zone 1 (Fig. 3).

About 19:00: One hour after the start of renewed sinkhole activity, the whole of the carriageway area was undermined and the cutting slope to the west side of the road collapsed. The sinkhole funnel was already bigger than the width of the reinforced system (Fig. 3) i.e. the pavement width plus the trenches on both sides

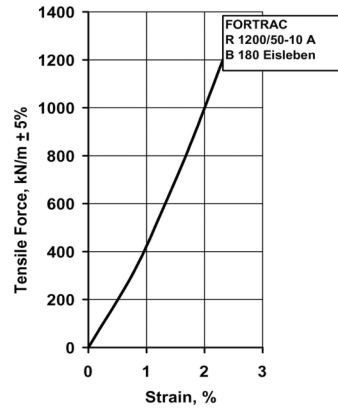
Figure 4. Tensile force/strain graph for the new geogrid used.

The analysis, the polyvariant calculation with various load cases and variations of other properties showed that a uniaxial low-creep geogrid with a mobilisable tensile force in the rolled-out (or “machine direction” MD) direction of 1200 kN/m at $\leq 3.0\%$ strain and 600 kN/m at $\leq 1.5\%$ strain (short-term) would be required. More detailed explanation regarding the design assumptions and the engineering background for the final solution (Fig. 3) can be found in (Alexiew, 2007). Geosynthetic reinforcement with these properties was not yet available in 1993. Thus, a new geogrid had to be developed for this project with extreme strength, high tension modulus and low creep. The choice was a yarn made from Aramid. A five meter wide uniaxial geogrid was specially developed, manufactured and tested. A world first. The typical tensile force/strain graph (short-term) in the rolled-out direction (MD) is shown in Figure 4.

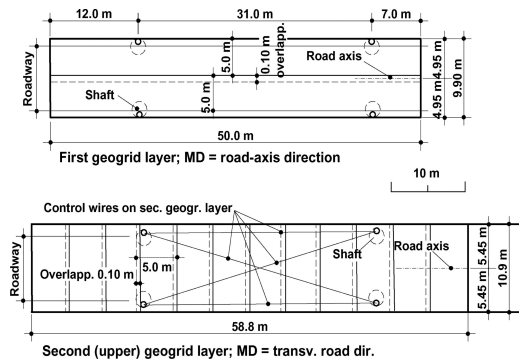
Figure 5. Simplified layout of the reinforcement and the warning system.

Figure 5 shows a plan view of the geogrid reinforcement (simplified execution drawings from (HUESKER, 1993)) and the warning system (see

Due to the great importance of the B180 and the high traffic flows it carries, the complexity of the problem and the impossibility of an exact analysis of all the theoretically possible situations and the then uniqueness of the project (see “Philosophy” in Section 2.2), the client decided to install a control and warning system with steel wires and control chambers. The layout is shown in Fig. 5. The almost non-extendible wires were connected to electrical sensors (contacts) in the chambers.

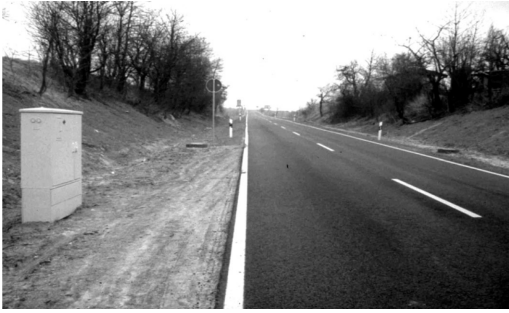
Figure 6. The B180 after completion: the carriageway, two of the control chambers and the warning system automatic switching cabinet.

The reconstructed section of the B180 was back in operation in October 1993 (Figs. 6 and 7). The road has been monitored for deflection ever since using the measurement and inspection chambers.

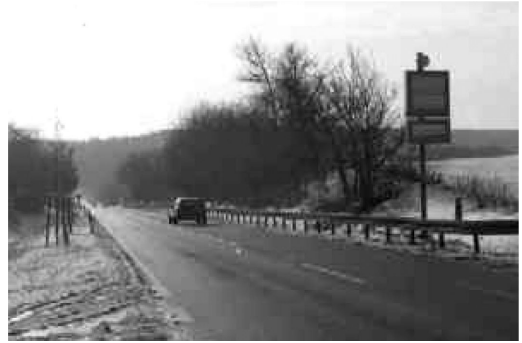
Figure 7. The B180 operating again: a warning stop sign in the foreground, the area made safe in the background.

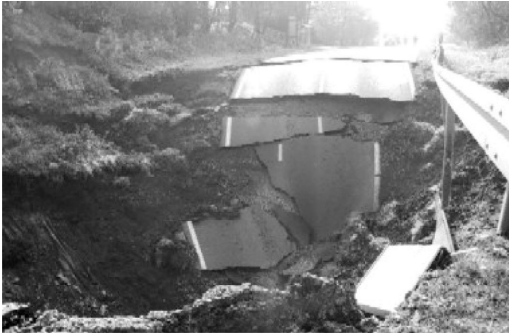
Figure 8. View in the morning after the renewed sinkhole activity.

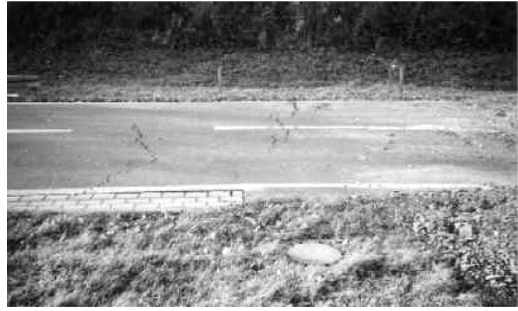
Figure 9. Cracks in the asphalt in the geogrid-anchorage zone; the funnel is to the right, just out of the photograph; one of the control chambers in front.

Tensile forces of at least 1200 kN/m would have been carried (anchored) over a relatively short stretch. The wide cracks in the asphalt surfacing in the anchorage zone near the sinkhole funnel gave an indirect indication of the large loads on the area (Fig. 9).
