LEAK MONITORING FOR A DOUBLE LINER SEPARATED BY A NOVEL CONDUCTIVE GEOTEXTILE

ABSTRACT: A critical double lining system in an anaerobic digester of a waste water treatment plant required assurance of there being no leaks through the primary high density polyethylene (HDPE) liner. Three different types of leak location surveys and monitoring techniques were proposed for implementation prior to filling the basin with water. To enable such surveys to be effective a novel conductive geotextile was placed between the primary geomembrane and the otherwise non-conductive geonet leak detection layer. A permanent in-situ system of sensors was used for the continuous in-service monitoring of the system. Prior to filling the basin, spark testing, wading, and water lance surveys were performed on the primary liner. The few leaks found were repaired. Since filling, through 11 months of service, the liner, under 8 m of water, has recorded zero leakage.

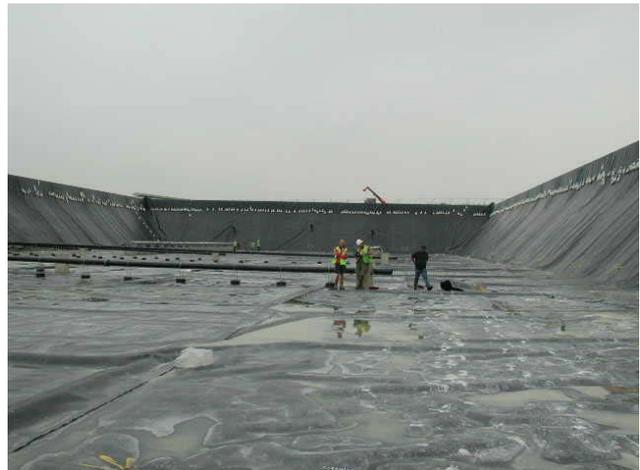
Figure 1. General view of basin

The new digester was designed and built (Figure 1) with a double 2 mm thick high density polyethylene (HDPE) bottom liner with a geonet leakage detection system. Subsequently a 1.5 mm linear low density polyethylene (LLDPE) floating cover would be installed. The prepared soil sub-grade floor was approximately 63 m by 150 m. The 2H:1V compacted soil side slopes were 13 m long with a 2 m high concrete wall at the top. There was no bench at the top of the slopes. The liner was to be taken over the top of the wall and attached with batten strips to the outside of the wall.

Prior to filling the basin the geosynthetic layers were simply draped over the top of the peripheral wall. Sandbags were used to prevent the geosynthetics from slipping back into the basin and, as shown in Figure 1, to push the liner components into the angle between the top of the slope and the base of the wall. This was not very successful due to the rigidity and expansion and contraction of the HDPE geomembrane. The ultimate objective was to allow the rising water to progressively confine the liner against the slope, to push the liner into the corner (while not tensioned), and to confine it against the wall before the liner was battened to the outside of the wall. In this way there would be no danger of the liner bridging (under tension) the angle between slope and wall as the water reached that level, with resultant stressing of the liner under the hydrostatic head.

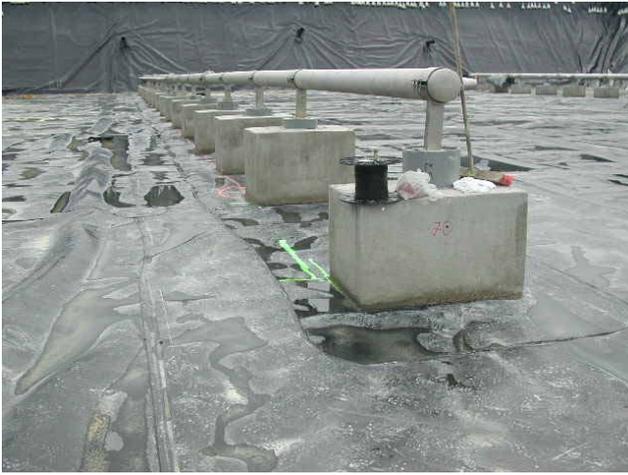
Figure 2. Pipe support blocks

Due to the previous liner failure and possible inconvenience of having to remove the floating cover in the event of a liner problem, much regulatory attention was focused on the new liner. Consequently the owner, owner's engineer, and design/build liner contractor were anxious to demonstrate that there were no leaks in the primary geomembrane before the facility was filled with water. This would be a particular challenge due to the presence of many pipe penetrations through the slopes and many concrete pedestals to support influent and effluent pipes placed on top of the liner. A protective strip of liner was placed under each pipe run, and each concrete pedestal was placed on a geotextile pad (Figure 2).

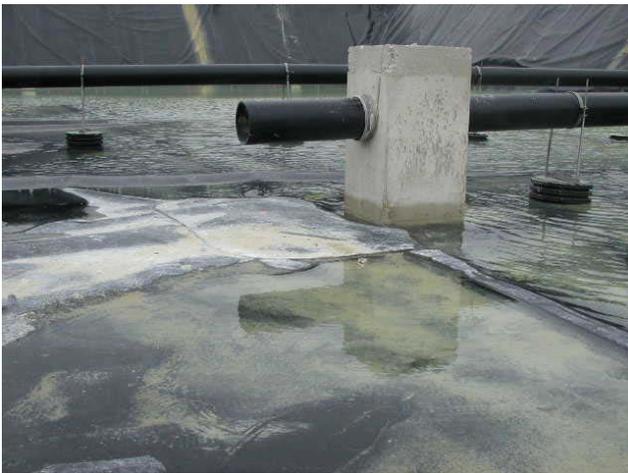
Figure 3. Bubble at end of protective strip.

When water was initially placed on the liner it was noticed that there was a bubble of air (Figure 3) under the high end of the protective strip since it had been completely welded to the primary geomembrane. To prevent the possibility of the seam rupturing and tearing the liner under the higher operating hydrostatic head a vent hole was placed in the strip.

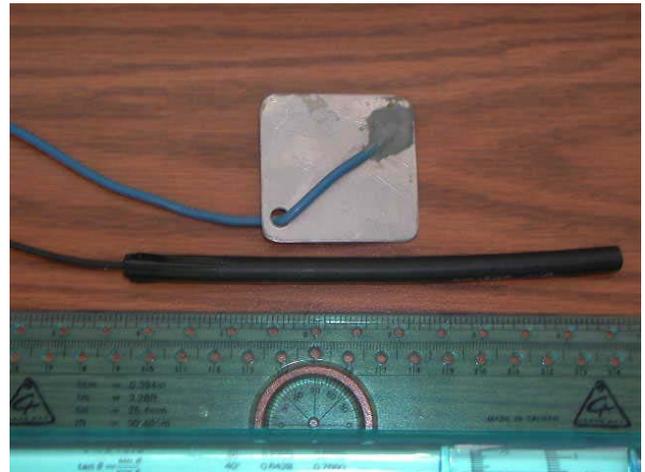
Figure 4. Leak monitoring sensor

Prior to placement of the primary geomembrane the in-situ sensors were attached to the geonet with cable ties, then the geonet was overlain by the conductive geotextile and the primary geomembrane. The sensors are conductive HDPE rods cast on to the ends of HDPE-insulated wires as shown in Figure 4. These sensors do not corrode nor do they damage the geomembrane.

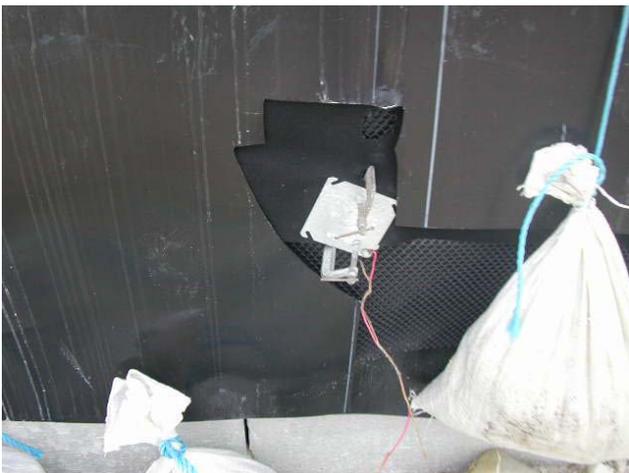
Figure 5. Electrode clamped to conductive geotextile.

The wading survey was performed with approximately 300 mm of water on the floor. A 48 VDC power supply was connected between metal plates clamped to the geotextile at the outside of the wall (Figure 5) and an electrode placed in the water. A handheld adjustable-spacing dipole probe was used to measure the potential gradients in the water, searching for any characteristic high signals above a leak. The balance of the floor, the pipe boots, the slopes, and the walls, were surveyed with the water lance. In this case the positively charged water on the floor was pumped to the water lance directing a solid stream of water on the liner. When the water penetrated a hole and contacted the negatively charged geotextile, current flowed through the water stream between two electrodes in the water lance and was recorded. The leak could be exactly located from the different signals obtained when the water stream was on the dampness around a hole, when the peripheral water was washing over the hole, and when the full stream was directly over the hole. The signal, of course, is proportional to the cross sectional area of the water pathway between the hole and the water lance.

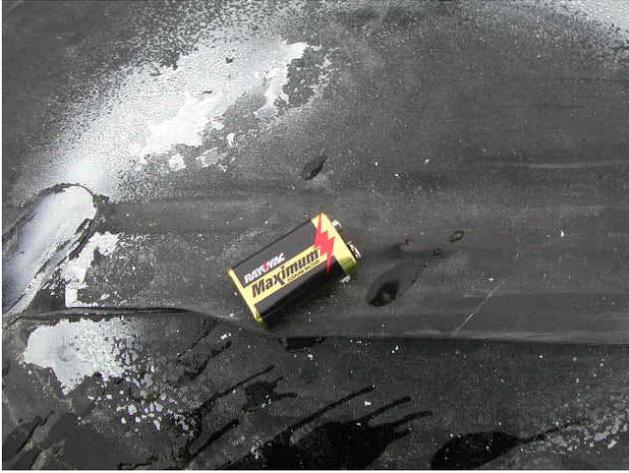
Figure 6. Needle hole in fusion seam (right of top of battery)

Leak indication 5 was consistently obtained at the hole (Figure 6). However, a second air pressure test confirmed there to be no leak in the seam. The only explanation is that some fibers from the geotextile had been fused in the weld and were exposed in the air channel. The hole was beaded and the signal was no longer present.
