## AGEING OF POLYPROPYLENE GEOTEXTILES UNDER NATURAL WEATHERING CONDITIONS

In this paper, several polypropylene geotextiles (stabilised with different amounts of the additive Chimassorb 944) were exposed to natural weathering in Portugal (41°13' N, 8°39' W) for a maximum period of 24 months. The geotextiles were placed in appropriate specimen holders facing south at an angle of 30° and samples were taken at selected intervals (6, 12, 18 and 24 months) for mechanical (tensile, tearing and static puncture tests) and physical (mass per unit area and thickness) characterisation. Microscopic changes on the geotextiles morphology were characterised by scanning electron microscopy.

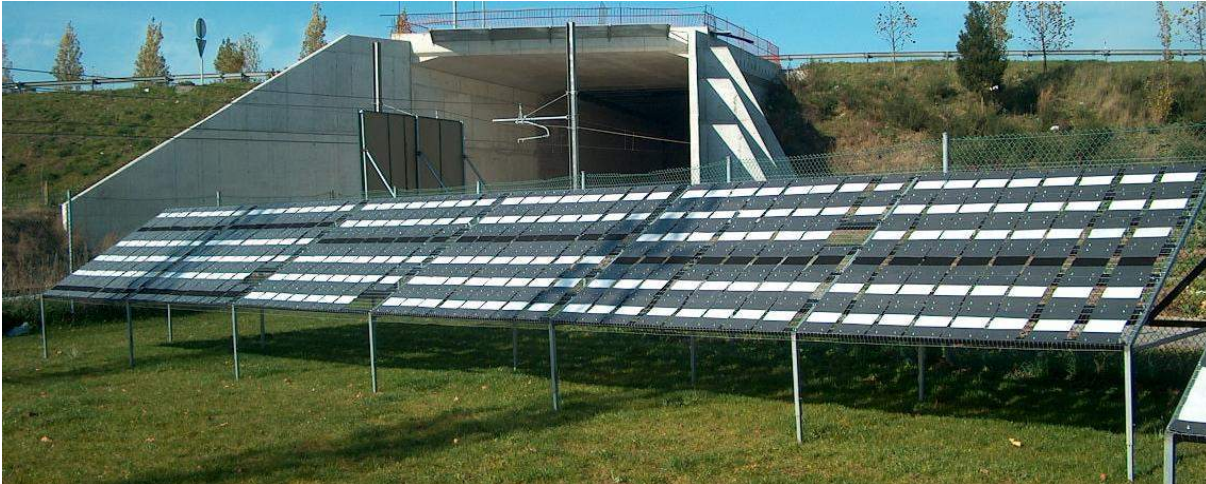
**Figure 1.** GTXs exposed to natural weathering conditions

The GTXs were exposed to natural weathering conditions in the north of Portugal (latitude 41°13` N, longitude 8°39` W, elevation of 49 m above sea level). The GTXs were placed in appropriate specimen holders facing south with an exposition angle of 30° (Figure 1).

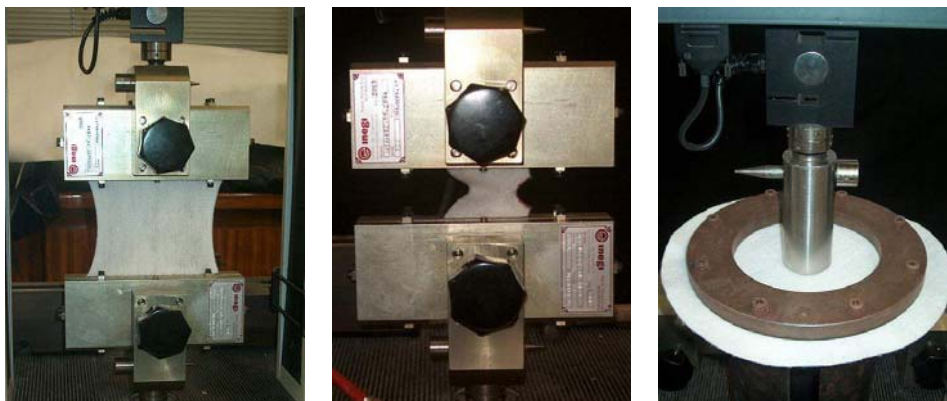
**Figure 2.** Mechanical characterisation of the GTXs: (a) tensile test; (b) tearing test; (c) static puncture test

The tensile strength of the GTXs was determined according to EN ISO 10319 (1996), while the tearing strength was determined according to ASTM D4533 (1996) (all specimens tested in the machine direction of production); the static puncture tests were performed according to EN ISO 12236 (1996). A minimum of 5 specimens were tested in the tensile and static puncture tests; in the tearing tests a minimum of 10 specimens were tested. Figure 2 shows the mechanical tests used for the characterisation of the GTXs.

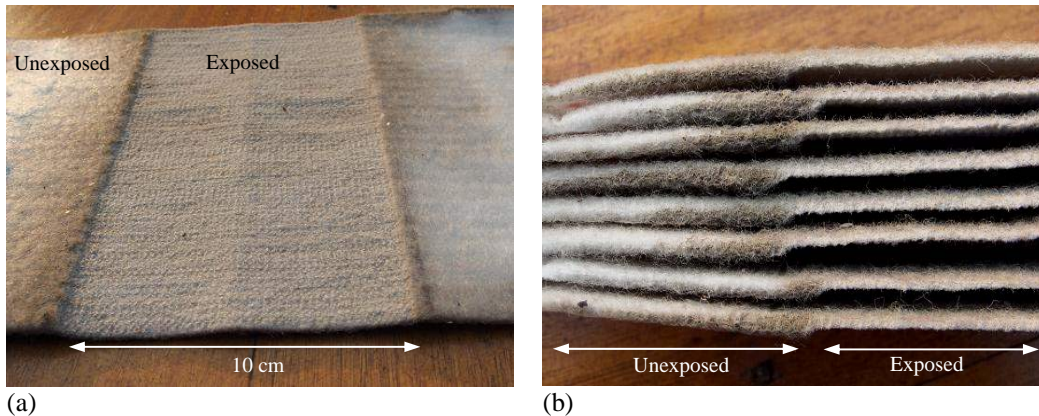
**Figure 3.** Reduction on the thickness of the GTX without C944 after 12 months of natural weathering: (a) a specimen at horizontal position; (b) several specimens at vertical position

The GTXs acquired a greyish coloration (originally they were white) during the exposition to natural weathering due to the accumulation of small particles (dust, filth) between their fibres. After 6 months of exposition, no visible signs of degradation were noticed on the GTXs. By the 12-month of exposition, some degradation on the GTX without C944 was perceptible due to the release of depolymerised PP fibres; this caused a considerable decrease on the thickness of this GTX (Figure 3). The degradation suffered by the GTX without C944 was much more pronounced after 18 months of exposition (some specimens were almost destroyed). After 24 months of exposition, the GTX without C944 was completely destroyed; the GTX was reduced into small pieces that were found on the ground (taken by the wind) near the exposition site.

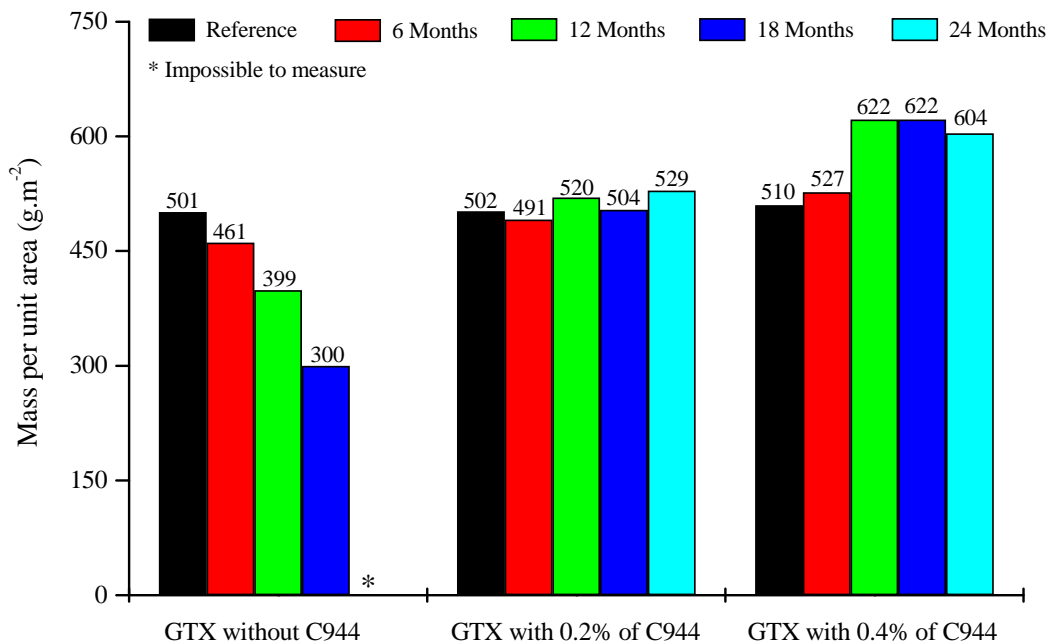
**Figure 4.** Mass per unit area of the GTXs before and after exposition to natural weathering

The GTX without C944 suffered a considerable decrease on its mass per unit area during the exposition to natural weathering. This loss of mass occurred due to the liberation of depolymerised PP fibres resultant from the degradation of this GTX. The mass per unit area of the GTXs stabilised with 0.2% and 0.4% of C944 increased during time, being this increase more pronounced for the GTX with 0.4% of C944. This increase is obviously not a gain of polymeric mass, but occurs due to the accumulation of dust and filth between the fibres of the GTXs. As the accumulated amount of dust and filth is expected to be equal for both GTXs, the lower mass presented by the GTX with 0.2% may indicate the occurrence of some depolymerisation on this material.

The evolution of the mass per unit area of the GTXs exposed to natural weathering seems to be a competitive process between the release of depolymerised fibres and the accumulation of dust and filth within the GTXs structure. The first will cause a decrease (with real loss of polymeric mass) and the second will cause a “false” increase on the mass per unit area of the GTXs.

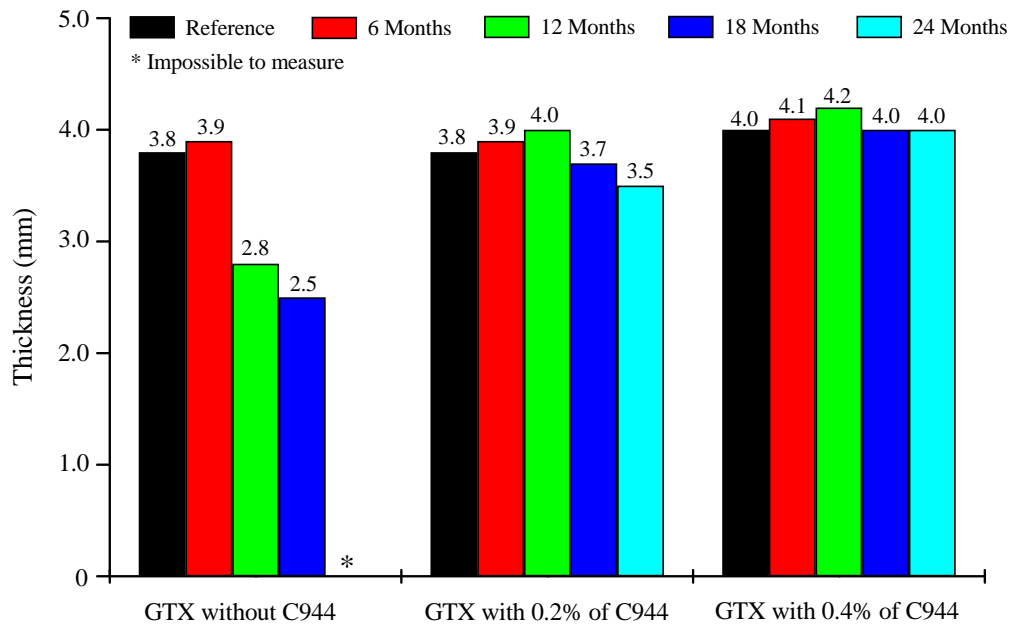
**Figure 5.** Thickness of the GTXs before and after exposition to natural weathering

The thickness of the GTX without C944 decreased during exposition to natural weathering due to the release of depolymerised PP fibres.

The GTX with 0.2% of C944 suffered a slight increase on its thickness during the first 12 months of exposition; after that, a slight decrease was observed. The initial increase on thickness can be explained by the accumulation of dust and filth on the material; the decrease occurred after that, may be due to the release of damaged fibres. Again, this seems to indicate that some depolymerisation occurred on the GTX with 0.2% of C944.

In the first 12 months of exposition, the GTX with 0.4% of C944 had an increase on its thickness similar to what happened for the GTX with 0.2% of C944. After that, a slight decrease was also observed. However, this decrease was not as pronounced as the decrease observed for the GTX with 0.2% of C944.

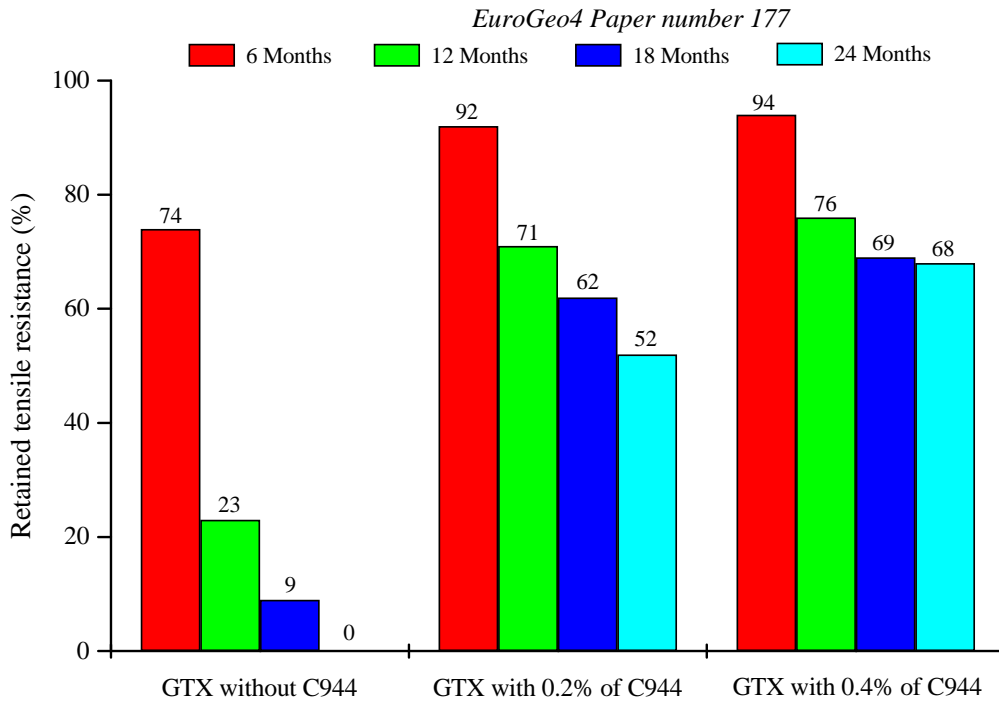
**Figure 6.** Retained tensile resistance of the GTXs after exposition to natural weathering

The tensile strength of the GTX without C944 suffered a huge decrease during the 24-month exposition to natural weathering. After 12 months, the GTX without C944 had only 23% of its original strength, confirming the existence of serious damages on its polymeric structure. By the 18-month, the retained tensile resistance of this GTX was already less than 10% and the material was near complete destruction, what inevitably occurred between the 18-month and the 24-month of exposition.

The GTXs stabilised with C944 also suffered a considerable reduction of their tensile strength during the natural weathering test, but in a much lower extension than the degradation suffered by the GTX without C944. After 24 months, both GTXs still had retained tensile resistances higher than 50%. The incorporation of C944 on the PP fibres was essential to retard the degradation promoted by weathering (but did not assured a total protection of the materials against this degradation agent).

The GTX with 0.4% of C944 was less damaged than the GTX with 0.2% of C944, showing that a better protection against weathering was achieved by the incorporation of a higher concentration of C944 on the materials.

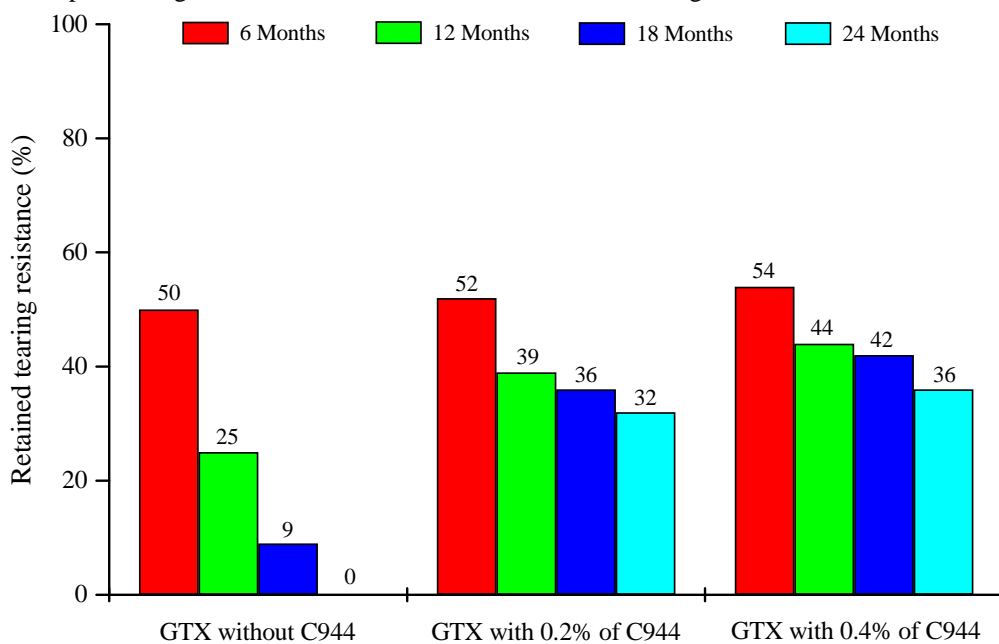
**Figure 7.** Retained tearing resistance of the GTXs after exposition to natural weathering

The tearing strength of the GTXs suffered a considerable decrease during the natural weathering test. After 6 months, the GTXs had their original tearing strength reduced to half and no big differences were seen between the stabilised GTXs and the unstabilised one. The tearing strength of the GTXs was much more affected by weathering than the tensile strength. For instance, after 6 months, the GTXs stabilised with 0.2% and 0.4% of C944 had retained tearing resistances of 52% and 54% and retained tensile resistances of 92% and 94%, respectively.

As the exposition time increased, the tearing strength of the GTXs continued to decrease, but not in the same way; the reduction suffered by the unstabilised GTX was higher than the reduction suffered by the stabilised ones. After 18 months, the GTX without C944 had only 9% of its original tearing strength, while the GTXs stabilised with 0.2% and 0.4% of C944 had retained tearing resistances of 36% and 42%, respectively.

Again, the GTX with 0.4% of C944 was less damaged than the GTX with 0.2% of C944, confirming that a higher concentration of C944 resulted in a better protection against weathering.

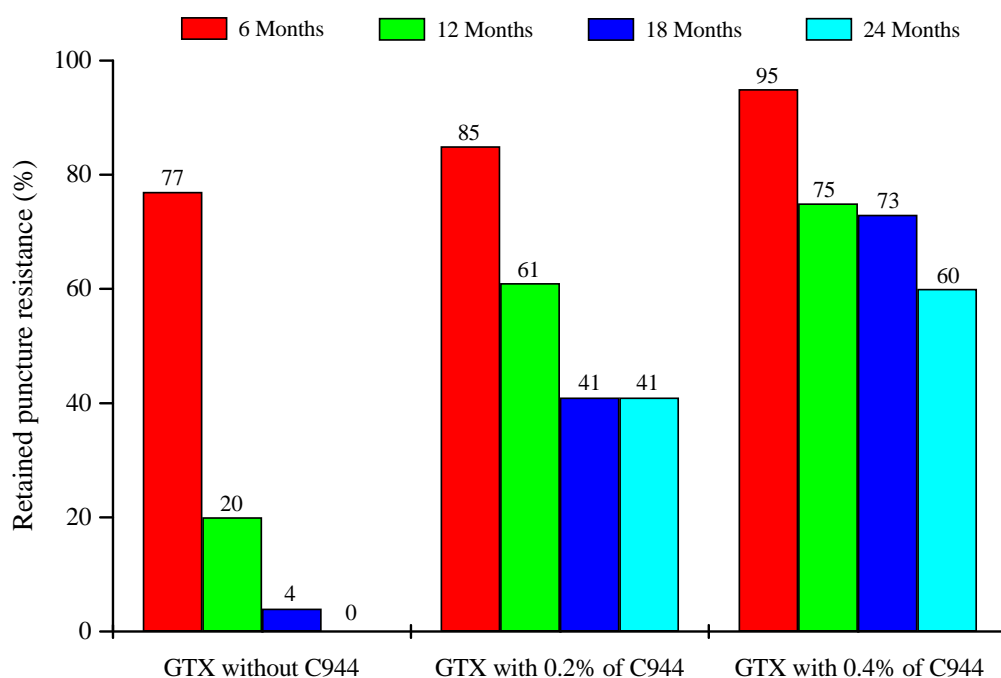
**Figure 8.** Retained puncture resistance of the GTXs after exposition to natural weathering

The reduction on the puncture resistance was more pronounced for the GTX without C944. Among the stabilised GTXs, the puncture resistance of the GTX with 0.4% was higher than the puncture resistance of the GTX with 0.2% of C944 (comparing weathered specimens with equal exposition times). These results are in agreement with the previous mechanical results (tensile and tearing strength), confirming that the unstabilised GTX was much more damaged than the stabilised ones and that a better protection against weathering was achieved by the incorporation of a higher concentration of C944 on the materials.

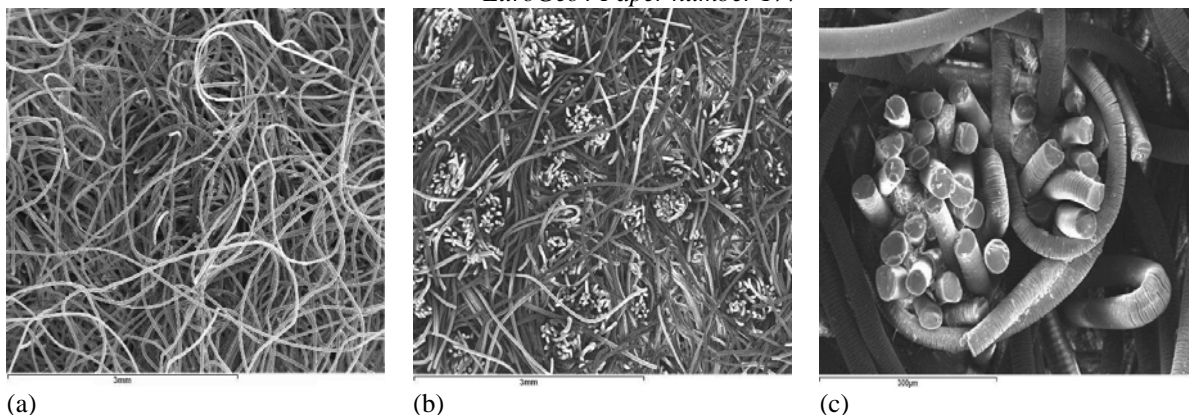
(a) (b) (c)  
**Figure 9.** SEM photographs of the GTX without C944 before (a) and after (b and c) 12 months of natural weathering: (a) x20; (b) x20; (c) x200

After 12 months of exposition, the GTX without C944 presented a considerable decrease on its thickness, due to the release of depolymerised fibres (dust, powder). SEM analysis showed that the fibres disposed vertically (orientated up, perpendicularly to the plane of the material) were all broken and the fibres disposed horizontally (on the same plane of the material) presented visible signs of degradation (some of them were already near complete destruction). Figure 9 illustrates some SEM photographs of the GTX without C944 after 12 months of natural weathering.

The degradation suffered by the GTX without C944 started by the upper fibres, which were successively broken and removed from the top of the material (taken by the wind or washed by the rain). Some of the little depolymerised fibres were accumulated between the empty spaces of the fibres lying under. This way, these damaged fibres can even protect the fibres lying under by impeding the solar radiation to reach them.

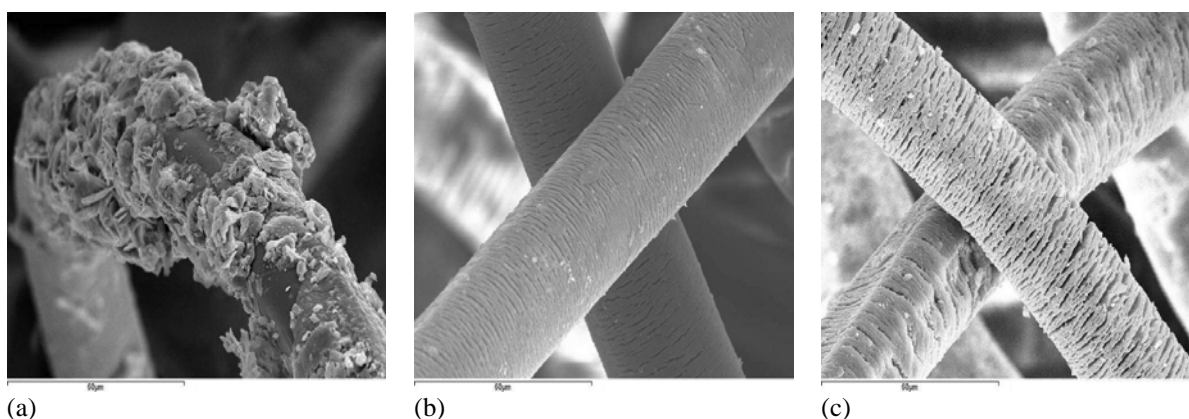
(a) (b) (c)  
**Figure 10.** SEM photographs (x1000) of the GTX with 0.2% of C944 after 12 (a), 18 (b) and 24 (c) months of natural weathering.

By the 18-month of exposition, the GTX with 0.2% of C944 presented visible signs of degradation, such as transversal fissures on its fibres; the dirt found by the 12-month of exposition was no longer protecting the fibres against degradation. It is important to note that in SEM analysis we are only observing the upper fibres of the GTXs (the first ones to suffer degradation). The fibres lying under are not so damaged because they are protected by the upper fibres and still have accumulated dirt between them. As the exposition time increased, more damages were found on the fibres with 0.2% of C944 (the transversal fissures become bigger and some little pieces of fibre were lost), which is in agreement with the previous physical and mechanical results. Figure 10 shows some SEM photographs of the GTX with 0.2% of C944 after 12, 18 and 24 months of natural weathering.
