Erosion control for sustainable highway and urban constructions in Southeast Asia

Keywords: best management practices, erosion & sediment control, sustainable slope rehabilitation, bioengineering and geosynthetics reinforced techniques

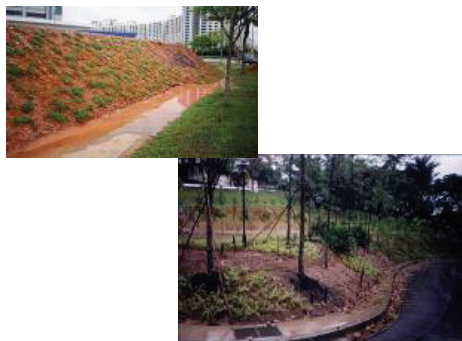
Figure 1. Examples of urban road side construction with serious erosion and sediment concerns

Figure 1 shows examples of some urban and road side construction with serious erosion and sediment concerns. The principle elements of erosion and sediment problem in tropical areas can be characterized as follows (Fifield, 2004):

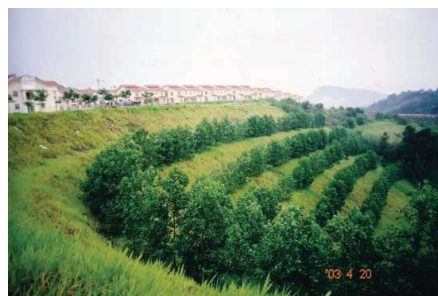
Figure 2. The environmental friendliness of the slope 2 years later

A look at slope at several locations on this project after 2+ years into the service, as shown in Figure 2, clearly showed that the initial hydro-seeded grass has been replaced by local indigenous plant species and this vegetation is sustainable with a gradual establishment of vegetation canopy. This indicates that the bioengineering technique used has given the local slower growing indigenous plants a chance to establish on a steeper slopes.

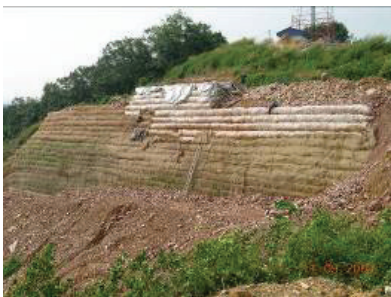
Figure 4. Wrap around reinforcement facing with coconut fibre ECM.

The unique feature of this slope is that the slope facing, a geosynthetics wrap around system, was designed to incorporate an erosion control mat. Erosion control mat using coconut fibre of mass $> 400 \text{ g/m}^2$ with soil munching was laid, overlapping the front part of geosynthetics reinforcement, during the construction of wrapping around facing with the aid of removable formwork. The performance of this slope was excellent with no sign of any significant movement and with no significant soil lost during monsoon period.
