Long term efficiency of erosion control geomats

Keywords: geomats, long term efficiency

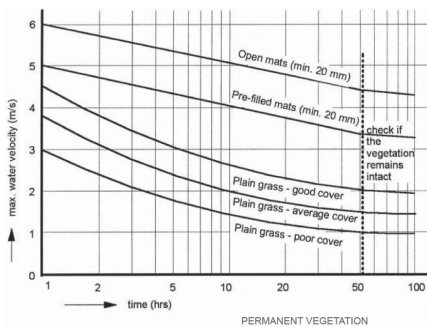
Figure 4. Recommended limiting values for erosion of plain and reinforced grass (Hewlett, 1987).

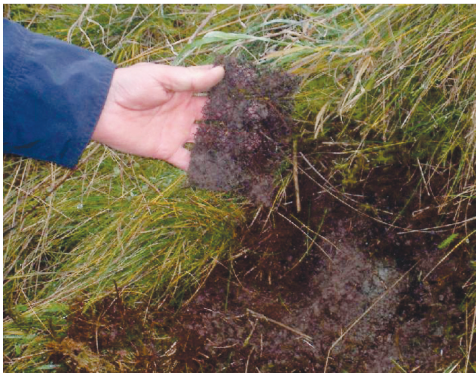
Figure 6. Sample of geomat 23 years old.

The observed geomats highlight that more than 20 years later the material looked in good condition (Figure 6). The test on the material from the tract without vegetation was also particularly interesting: even if subject to the most critical environmental conditions (temperatures changes, sunbeams, etc.) that part remained complete (Figure 7).

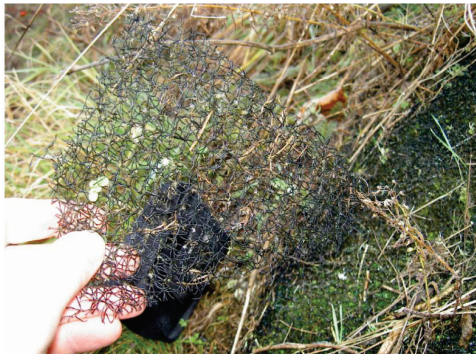
Figure 7. Sample of geomat 23 years old.

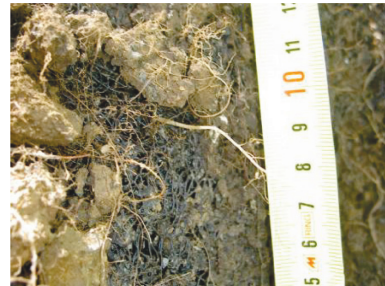
Figure 8. Roots trough the geomat after 1 year.

The intervention was carried out in 2002 through the application of a polyamide geomat prefilled with chippings with a bitumen binder. The on-the-spot investigation which was conducted in 2003 after a flood of watercourse along which the vegetation had not yet spread confirmed that there was a marked interaction between roots and geomat in the already formed vegetation (Figure 8). Another inspection in 2005 pointed out a wide vegetation blanket confirming the good permeability to vegetation of this kind of geomat.

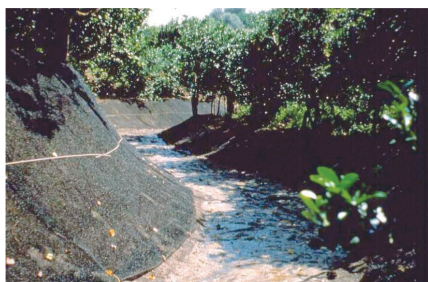
Figure 9. At the end of construction.

The intervention carried out on the Farinella stream dates back to 1988. The stream presents a regular section with a bottom about 2 m wide and banks of a varying range between 2 and 3 m high with an average gradient of 35°. The design solution planned the laying of an asphalted geomat onto the bottom and of a geomat filled in with soil for the banks (Figures 9 and 10). Both were fixed onto the soil by iron pins. During the survey in November 2003 it was observed that the intervention was completely effective since there was a good vegetation blanket on the banks.
