THE LONG TERM PERFORMANCE OF POLYMERIC REINFORCED WALLS UNDER STATIC AND SEISMIC CONDITIONS

Abstract: High tenacity polyester encased in a durable polyethylene sheath (Paraweb), was the first polymeric soil reinforcement material. This geosynthetic was used in reinforced wall applications in the mid-late 1970's and in the intervening 30 years has been used extensively world wide in a large variety of climates in this application.

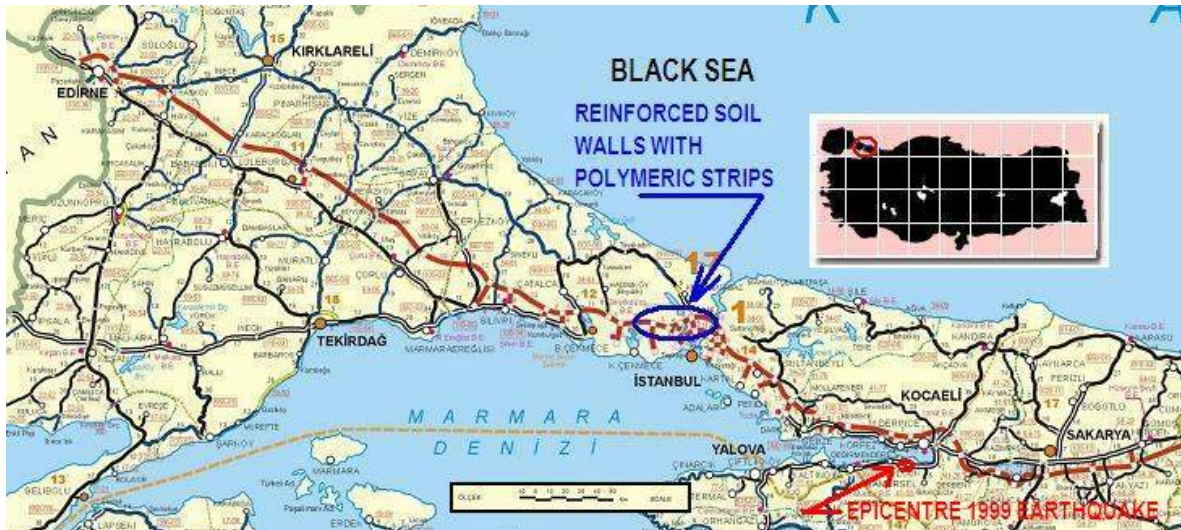
Figure 3. Location of reinforced soil walls with polymeric strips on the Kinali-Sakarya Motorway and the epicentre of the 1999 Kocaeli Earthquake.

Mainly on the European side of the Kinali Sakarya section starting from Bahcesehir to the Second Bosphorus Crossing (Fatih Sultan Mehmet Bridge) on a stretch of 30km (Figure 3), all the wing walls of the overpasses and the

retaining walls of the connecting roads from the motorway to the existing circular road were constructed with a reinforced soil system using polymeric strips. The wall area constructed was more than 60,000 sq.m.

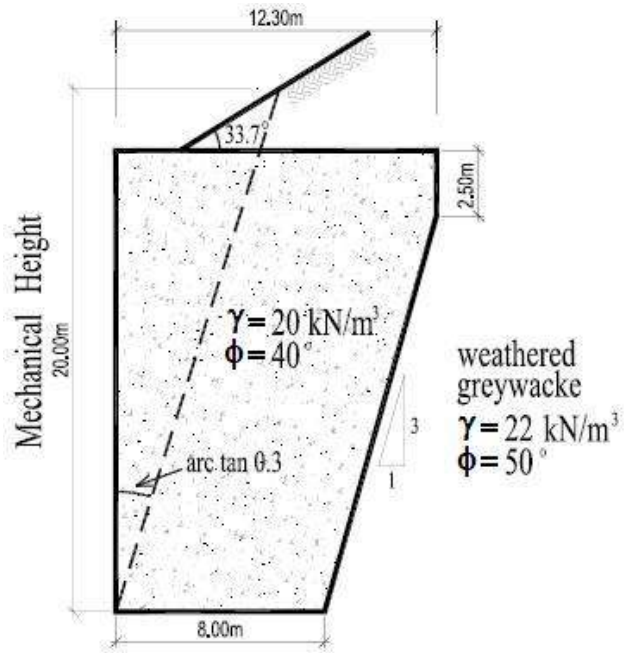
Figure 4. Typical wall cross-section.

The purpose of many of the retaining walls, some as much as 18m high, was to support steep cut faces as the Motorway went through hills on the approaches to the second Bosphorus Bridge. This necessitated a cross-section shape which was trapezoidal, being narrow at the base and wide at the top to follow the line of the cut. The width at the base was taken as not less than $0.4 \times$ the mechanical height. Generally the design was done to the French Code at the time, "Reinforced Earth Structures – Recommendations and Rules of the Art". Today this would be very similar to the coherent gravity method described in BS8006. Fill within the walls was assumed to have an angle of internal friction of 40° while the cut slope was taken as having an angle of internal friction of 50° . Typically the 'overall' factor of safety on reinforcement rupture worked out at 2.7. A typical wall section is shown in Figure 4 and a section of wall under construction is shown in Figure 5. A nearly completed wall is shown in Figure 6.

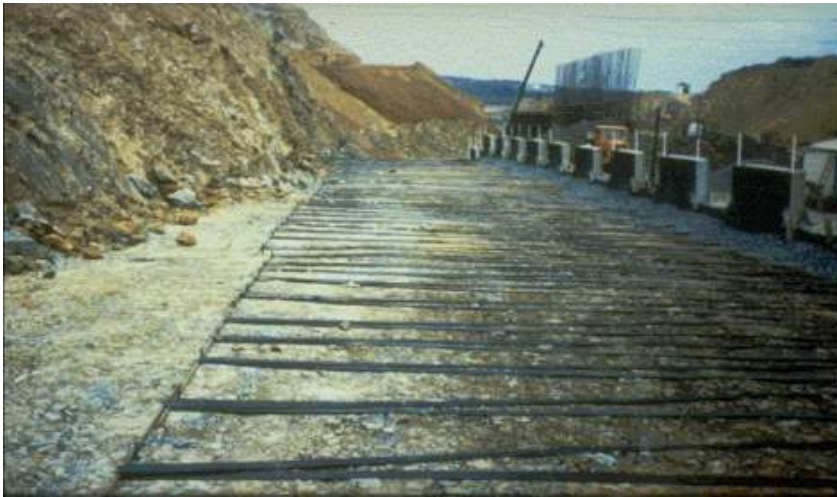
Figure 5. Wall under construction with 'Greywacke' cut face on left and reinforcement elements laid out.

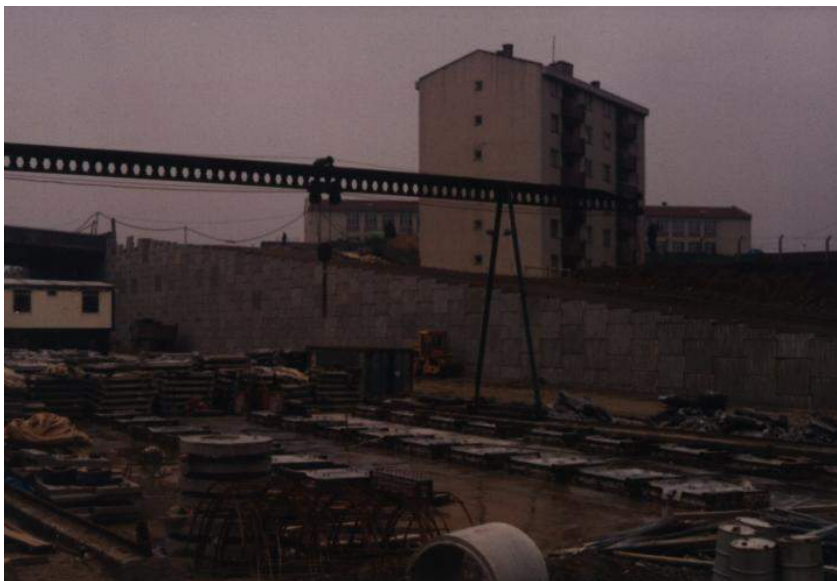
Figure 6. Precast yard and nearly completed wall behind.

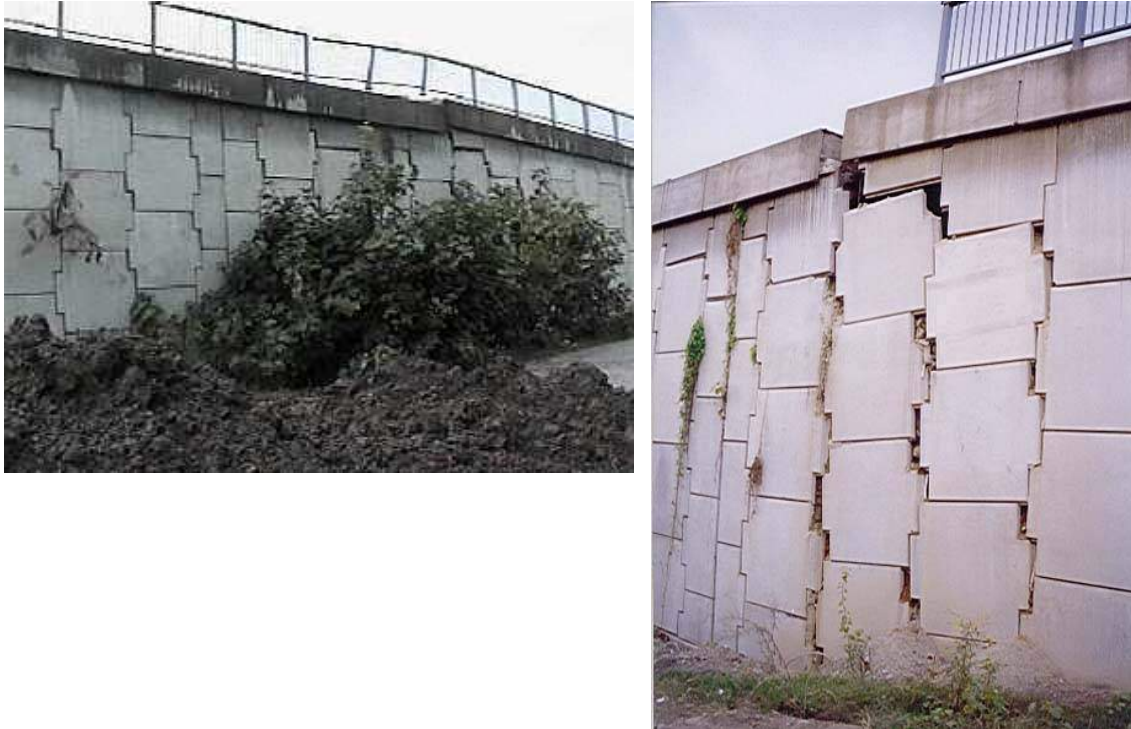
Figure 7. Reinforced Earth wall damaged in the Kocaeli Earthquake prior to demolition.

On 17th August 1999 a magnitude MW 7.4 earthquake struck the Kocaelis and Sakarya provinces in north western Turkey, a densely populated region in the industrial heartland of the country. In terms of destruction and loss of life this earthquake was one of the world's worst during the 20th Century (Ansal et al, 1999). The earthquake developed at a depth of about 15 km and around 10 km to the east of the town of Golcuk (Figure 3). It is associated with a 120 km rupture involving four distinct fault segments on the northern-most strand of the Western extension of the 1300 km long North Anatolian fault system (Erdik, 2000). Istanbul also felt the earthquake and several buildings collapsed causing loss of lives in the districts such as Avcilar, Kucekcekme (on the European side) which are a few kilometres from the site of a number of reinforced soil walls. None of the polymeric reinforced soil walls was damaged. One Reinforced Earth wall close to the epicentre was badly affected by the event in terms of serviceability (Figure 7) and was subsequently demolished. Pamuk et al (2004) discussed the performance of the failed metallic strip Reinforced Earth wall in detail.

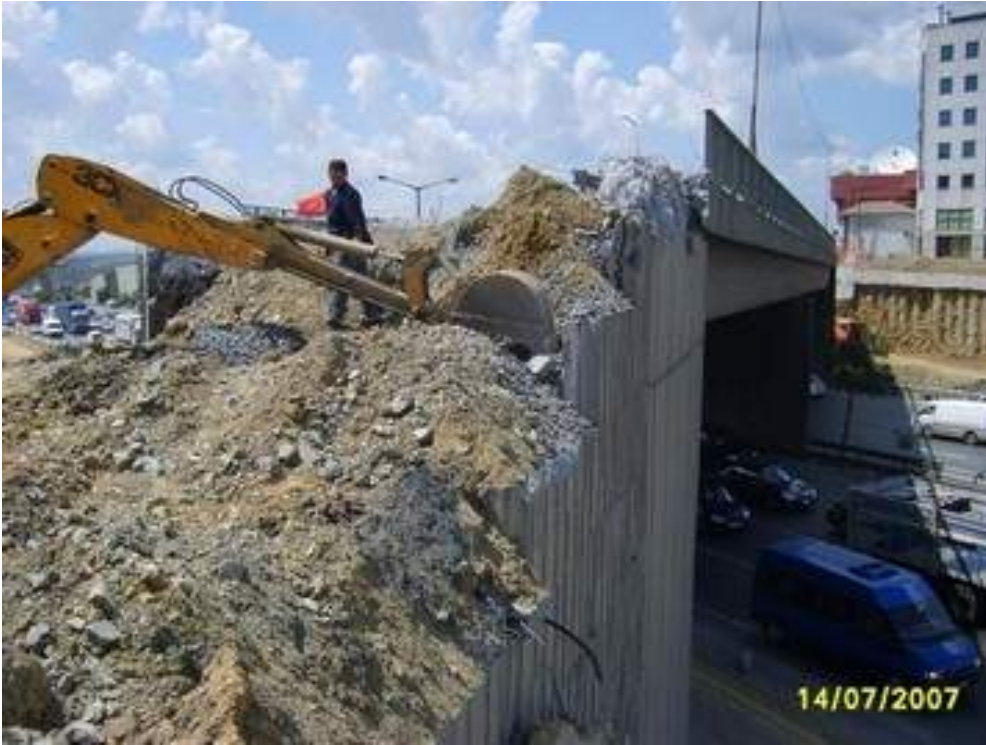
Figure 8. Demolition of the polymeric reinforced soil wall.

In late 80s and early 90s the route of the motorway was passing unpopulated areas. Presence of the motorway and the connecting roads brought the opportunity to inhabit these areas and new settlements were established. The growth of these areas and the increase of traffic on the connecting roads were exponential and could not serve the needs of the area. The Istanbul Metropolitan Municipality has planned new junctions and widening of connecting roads to ease the transportation to these new settlements. For this purpose a new junction construction located at Seyrantepe has been planned to enable exit and entrance to the motorway. Within the scope of the project the two span existing overpass was to be demolished and replaced with a four span overpass. The wing walls of the existing overpass were polymeric reinforced soil walls. Therefore the demolition of the overpass brought the opportunity to recover polymeric strips. The location of the overpass was on a section of the motorway where there was heavy traffic 24 hours a day. Unfortunately there was not enough time to recover strips with hand excavation so the fill was excavated behind the panels with the help of a backhoe (Figure 8) and the polymeric strips at the connections to the panels were cut and the panels were removed letting the fill flow. Therefore only the strips that were hanging from the embankment could be recovered with minimal damage (Figure 9)

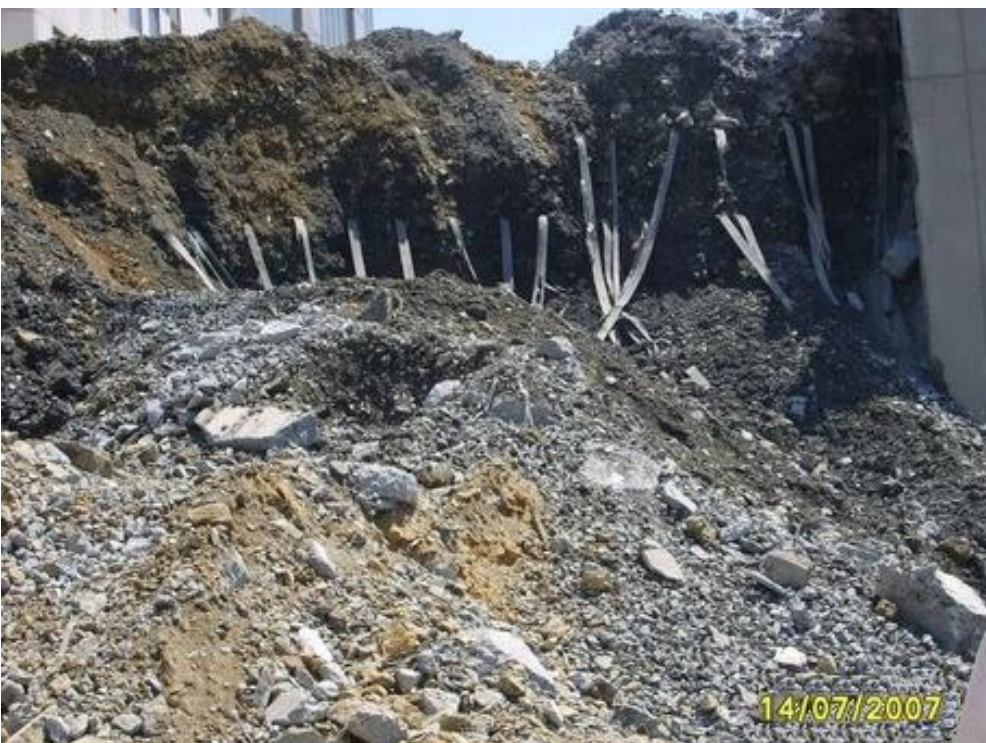
Figure 9. Recoverable polymeric strips from the embankment.

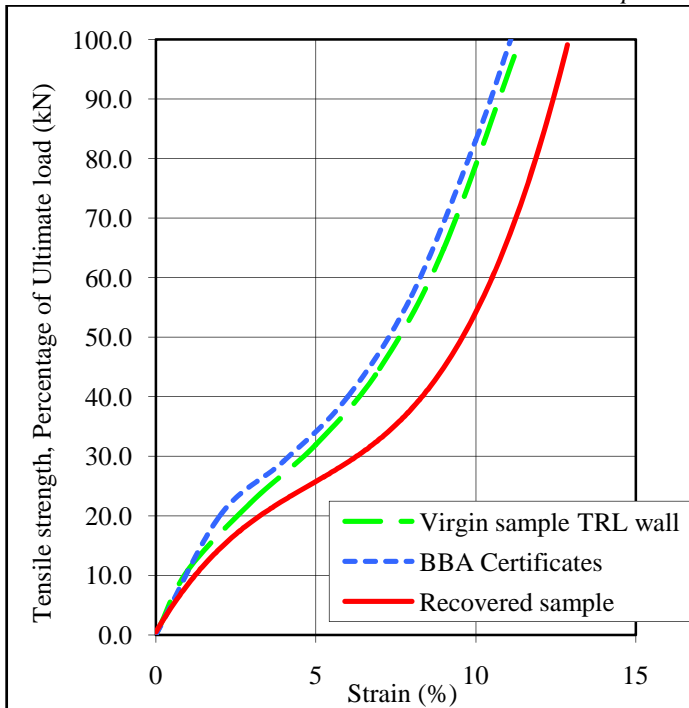
Figure 10. Results of tensile tests carried out on exhumed 50kN Paraweb samples compared with virgin material.

A number of samples were recovered from the demolished wall and were available for test so that they could be compared with the behaviour of the materials at the time of installation. Tensile tests were carried out using similar techniques to those used in the 1980's although some improvements in the equipment used may have a minor effect on the results. The mean tensile test results, expressed as a percentage of the ultimate load, are shown in Figure 10 and compared with the expected behaviour of the original material as shown in BBA Certificates No's 82/22 and 88/38, both entitled 'Websol Frictional Anchor System' and that measured for the virgin material used in the 1977 TRL wall (Naughton et al., 2005). The polymeric strips exhumed was grade 50 which would have had a Nominal Breaking Load (NBL) of 50 kN but an actual breaking load of closer to 60 kN with a strain at NBL of around 11%.
