Woorim beach protection – chasing the tide sand filled tubes vs. sand filled containers

Buckley, J.
Geofabrics Australasia Pty Ltd

ABSTRACT: Emergency foreshore protection was required for a dune stabilisation project at Woorim, Bribie Island, Queensland, Australia. The project was given emergency status due to dune erosion occurring in close proximity to an existing road. Hard revetment structures, such as concrete or dumped rock, were considered unacceptable solutions because the area was situated at a popular beach in close proximity to a surf lifesaving club and would have had a significant impact on public amenity. Also, potential sources of quality rock were situated at a significant distance from the site. Therefore, based on the successes of similar sand filled geosynthetic structures on nearby Maroochydore beach, the use of Soft Rock[®] sand containers was initially recommended.

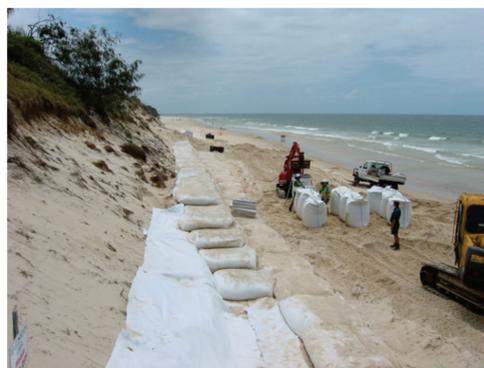
Photo 1. Placement of geotextile and initial containers.

1. Excavate toe of wall to desired width of structure;
2. Place Terrafix separation geotextile in excavation and along rear bench up to finished height;
3. Fill, close & position containers with scour flap at toe of structure, refer to Photo 1;

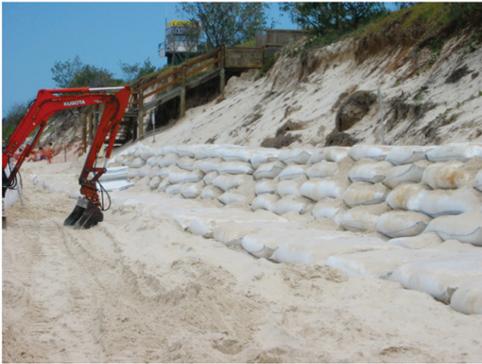
Photo 2. Completed foreshore protection structure.

4. Fill, close & position remaining standard containers using stretcher bond pattern up to 5 containers high.
5. Place sand to cover toe of structure, see Photo 2.

The structure has performed well with a good natural build up of sand at the toe and at the face of the bags. The construction of the geotextile sand containers offered the following advantages over the geotextile tubes:

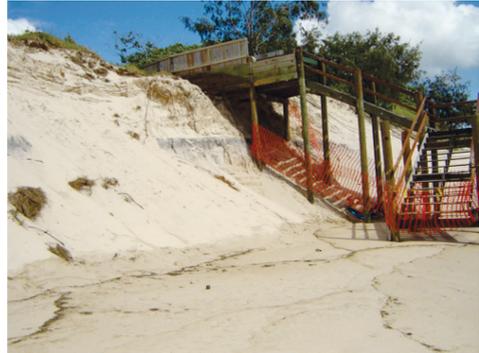
Photo 3. Eroded dune adjacent to protection structure, southern end.

In December 2005, the structure was subjected to a combination of storm effects and king tide surges. The geosynthetic structure remained essentially intact, even though significant erosion of the adjacent dunes occurred, see Photo 3.
