Duration of the geosynthetic container in actual sites

Keywords: duration, geotextile, geosynthetic container

ABSTRACT: The proper disposal of construction surplus soil has become a major problem in recent years, as evidenced by the increase in unlawful disposal of the soil. Therefore, it becomes important to promote reusing construction surplus soil. The Eco-tube is a geosynthetic container developed for reusing low quality surplus soil such as dredged soil and improving its quality. But polyester material used for the tubes deteriorates rapidly due to the effect of ultraviolet. This paper describes the duration of the Eco-tube at three test sites: Lake Kasumigaura, Lake Inohana, and Niyodogawa River reaches. Each site was adopted different strategies to provide shielding from sunshine. From the investigation, covering by vegetation, placing under water, and covering by sheets, the geotextiles are able to maintain its strength.

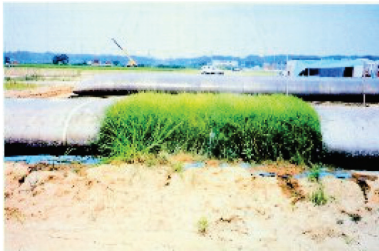
Photograph 1. Test site at Lake Kasumigaura.

The Eco-Tube involves packing a water-permeable geotextile tube with soft and high water content soil (typically dredged soil from rivers, lakes and marshes)

(Mori et al. 2002). This promotes dewater of the soil. Figure 1 shows the configuration of the Eco-Tube. The tubes after dewatering can also be used as embankments using reinforcement of the geotextiles. Recently, the Eco-Tube has been researched on filtration properties to purify the drainage during the dewatering process and trap toxic substances such as dioxins and heavy metals (Mori et al. 2002).

Figure 1. Construction image of the eco-tube.

At Lake Kasumigaura, large tubes made of three different types of geotextiles were filled with dredged soil. Some were left exposed to the sunshine, while others were provided with vegetation covering. The degradation of the geotextiles was monitored to determine the effect of ultraviolet. The experiment was conducted from May 1994 to August 1995. Table 1 summarizes the experimental conditions. Photograph 1 shows the test site.

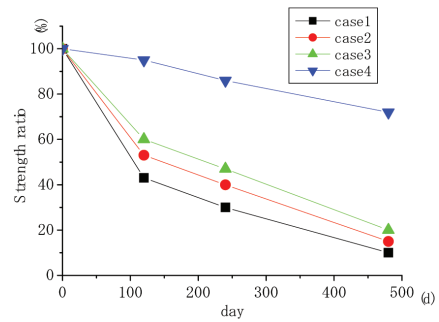
Figure 2 shows the results of tensile tests on samples of geotextiles taken at 4, 8 and 16 months. The samples were 5 cm in width, 20 cm length between clamps. The tensile test conformed to JIS1908, using a tension speed of 2 cm/min.

Figure 2. Strength ratio (Lake Kasumigaura).

Degradation is the most pronounced during the first 4 months. The samples of exposed geotextiles with no vegetation covering shows 50% decline in strength. Strength continued to decline over time thereafter, falling to 10%-20% of initial strength after 16 months.

On section covered with vegetation, grass growth was vigorous. After 4 months, the grass height had reached 20-30 cm, and in some cases the roots penetrated the tubes. Tensile tests showed residual

strength of 96% after 4 months, and around 70% after 16 months. These results indicate that vegetation covering is effective in preventing degradation of the geotextiles.

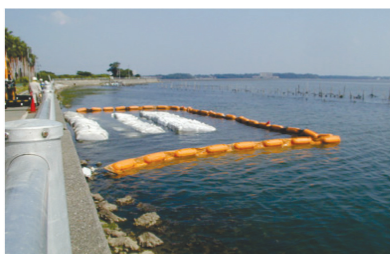
Photograph 2. Test site at Lake Inohana.

Dredged soil from Lake Inohana was packed in about 1 m³ tubes made from three types of geotextiles. The dredged soil was obtained from an adjacent construction site. Degradation of the geotextiles was monitored.

The experiment was conducted from June 2003 to March 2005. Photograph 2 shows the test site, and Table 3 lists the test conditions. In cases 1, 2 and 4, the geotextiles were high-strength general-purpose geotextiles. Meanwhile, the non-woven geotextiles used in case 3 had a high coefficient of water-permeability but low tensile strength. The tensile tests were conducted as JIS1908.

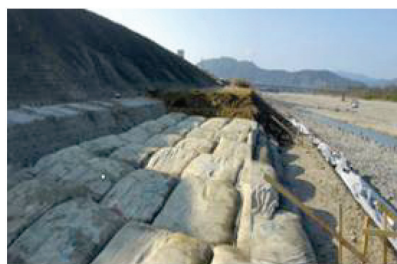
Dredged soil from the Niyodogawa River reaches was packed in about 1 m³ tubes, and then used to create river levees. In order to observe the decline in strength of the geotextiles, some tubes of soil were left in the yard. Two tubes were covered with sheets, while the other two were left exposed to the sunshine.

The tensile tests were conducted as JIS1908. The Eco-Tube was set up in November 2003 and follow-up observations were taken on March 2005. Photograph 3 shows test site, Table 4 shows the test conditions, and Fig. 5 shows test results.

Photograph 3. Niyodogawa River reaches.

The Shikoku region was hit with heavy rainfalls during 2004, and the test site was flooded several times within the first six months. However, the Eco-Tube was not found to be adversely affected.

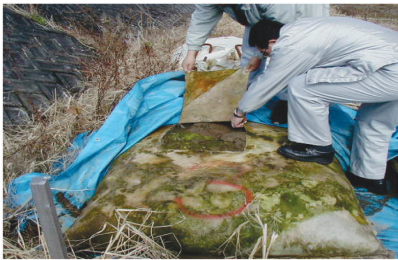
The residual strength ratio was approximately 90% in sections of the geotextiles protected by sheet. As Photograph 4 shows, the underside of the sheet was covered in moss.

Photograph 4. The Eco-Tube after 16 months (Niyodogawa river reaches).
