Construction, closure & capping of geosynthetic lined slurry pond at Vishakhapatnam-India-15 year experience

This case study deals with the 15 years of experience in design, construction, operation and closure of the slurry pond in HZL-Vishakhapatnam.

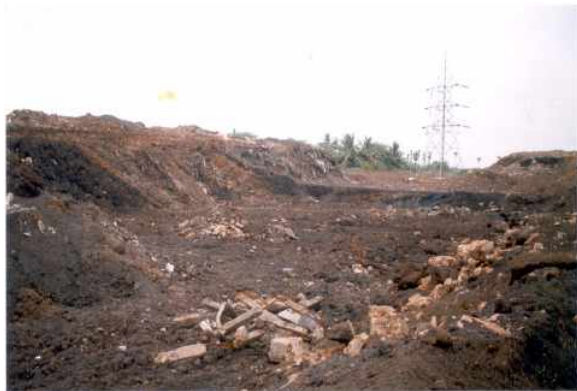
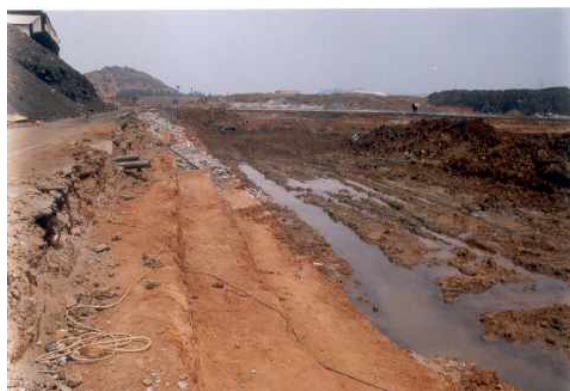
The design and construction of the pond was done from 2000-2002 having an earmarked area of 75,000 sqm approximately with an estimated capacity of 5,00,000 cum. It was impossible to design with conventional slope geometry considering the slope stability factors of 1.5. As for that capacity, minimum land area required was more than 1,00,00 sqm which was not available. Hence, it was decided to design the dyke with 1:1 slope and the slope would be in continuity to avoid further space issues. With this background the structure was to be designed and constructed, operated and closed on a slurry surface having no strength.

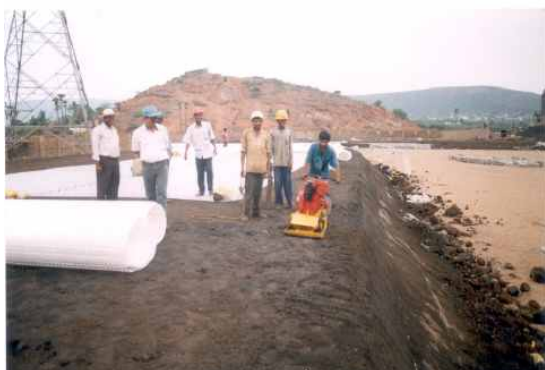
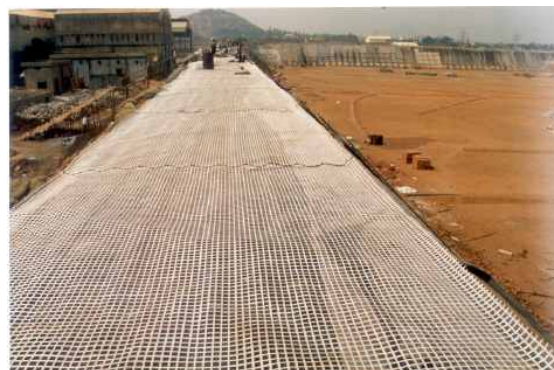
Reinforcement with Geogrid

However, as the getting the right quality of bund material was also an issue, it was decided to mix the slag from the plant along with burrow material and construct the dyke. The dyke was a reinforced dyke with biaxial geogrid inserted across the dyke width at regular depths. The geogrid was further wrapped around with non-woven geotextile to avoid dyke soil slipping out. The dyke was expanded in stage wise construction method with each lift of construction not exceeding 0.3 m. The reinforcement geogrid was inserted at every 0.6 m depth.

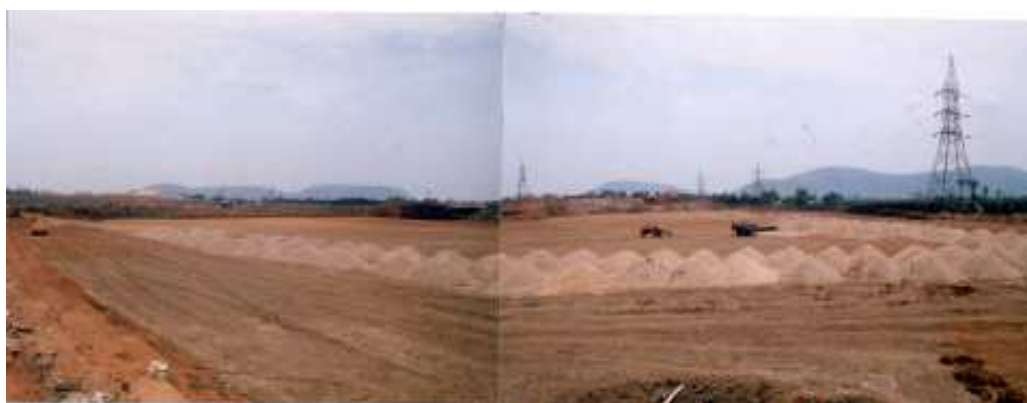
Sub-grade Preparation

While the dyke construction as in progress, in parallel, the bed preparation was also done. The bed preparation was done by carefully preparing the sub grade with slope towards the effluent evacuation corner fitted with slope riser and pumping main.

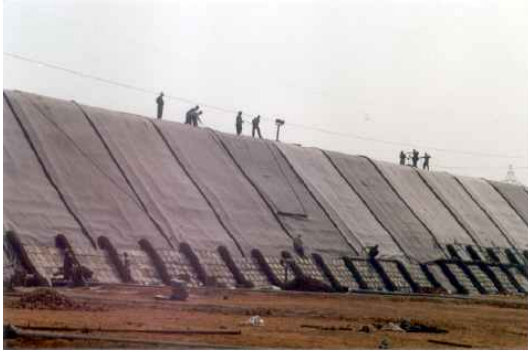
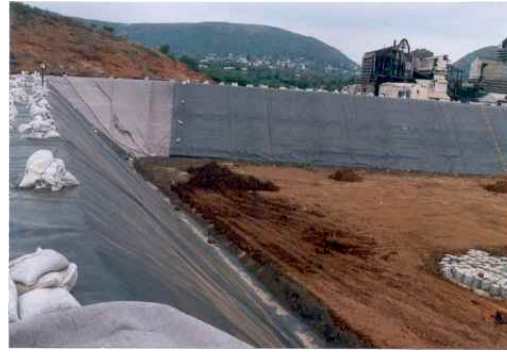
Geomembrane Installation

The bed and the slope of the facility was lined with clay liner, HDPE Geomembrane 2.0 mm thick and further protected with non-woven geotextile.

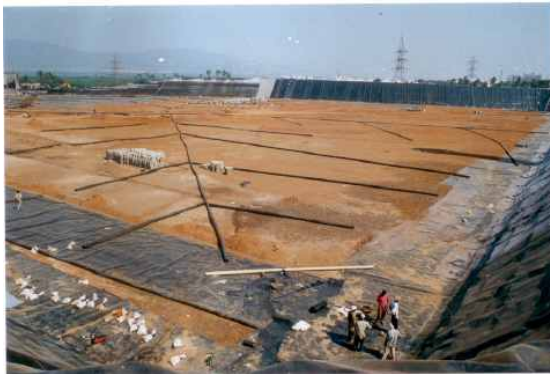
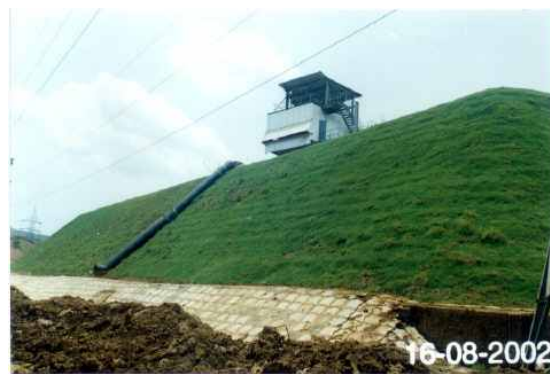
Perforated Pipe and Main connected to pumping system

The perforated HDPE Pipes were laid as per the drawing and all the perforated pipes were connected to main header which was connected to the suction main of the slope riser system.

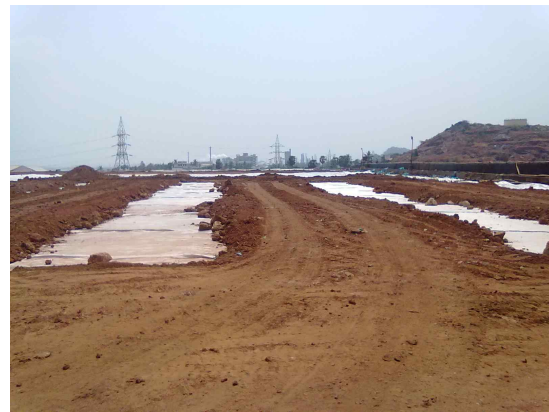
It was recommended to use Polypropylene Woven Multifilament Geotextile, (GWF 80-350) for the first layer of the Geotextile reinforcement which would be in direct contact with the Jarosite. More over this first layer predominantly functions as temporary reinforcement in providing initial access to the construction materials and equipment's, and as a separation layer. For subsequent layers of reinforcement, Polyester Woven Multifilament Geotextile, GWF PET 70/70 was used.

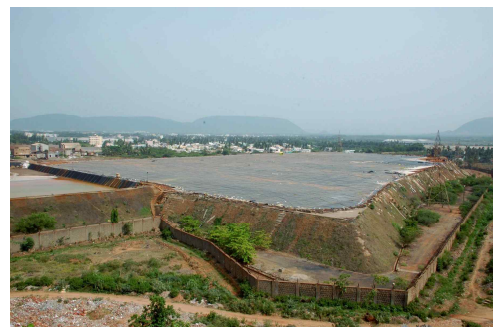
After closure of landfill facility, to allow drainage of precipitation by gravity, a slope of 3% to 5% was required. Considering pond area of 55705 Sq.M and weak base of Jarosite slurry a single soil cap would lead to heavy surcharge. Hence the total top area of the pond is suitably bifurcated into 6 cells/caps (each one 50 m wide) as shown in the drawings. Thus the maximum height of any cap (including 0.6 m vegetation layer) was not more than 2.15 m

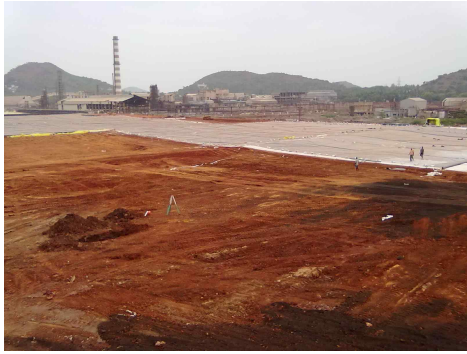
1. Geosynthetic Clay Liner (GCL) - 6 mm thick
2. High Density Polyethylene (HDPE) Geomembrane – 1.5 mm thick
3. Geocomposite Drainage layer
4. Vegetative Soil cover of 600 mm thick.
5. Vegetation

The periphery of the liner system was properly finished at the top bund of the existing pond to enable proper drainage of the precipitation. The Geomembrane of the cover liner system was welded with that of the existing liner at suitable location on the top anchorage of the exiting lining on the bund top.

Strengthened surface and HDPE Liner Liad

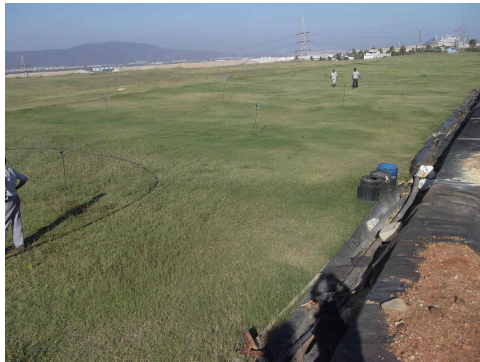
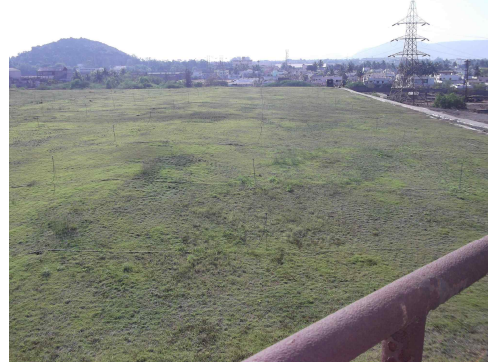
Capped Surface, Vegetated with irrigation system to maintain greenery
