## Coastal protection of Figueira da Foz Dune

**ABSTRACT:** Due to the constant change of climate, the erosion on coastal areas is increased caused by big storms, challenging man to protect land through efficiency solutions. The use of geotextile construction elements offers economical, efficient and flexible solutions, contrary to massive and cost intensive structures made of concrete, steel or rock.

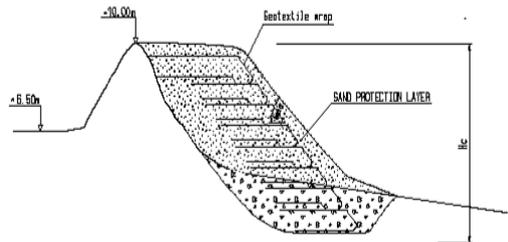
The solution adopted in 2005 consisted to construct a shelter to the front of the dune, through the overlap of seven layers of sand wrapped in geotextile - "wrap around system". To protect the foot of slope, and to prevent the loss of sand to a lower level, was installed a row of geotextile bags, filled with sand, forming a pyramid set.

Figure 1 - Cut the dune, with involvement of the layer of sand

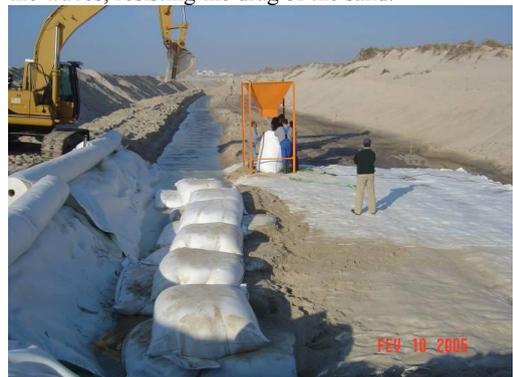
The geotextile, as a filter material, not woven fabric, needle punched, with a properly open size, allows the hydraulic flow of seawater, keeping stable the sand inside. Its design took into account the need to absorb the energy caused by the action of the waves, resisting the drag of the sand.

Figure 2 - Installation of the bottom layer with bags of sand

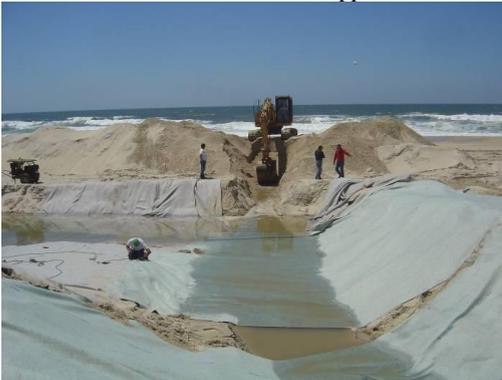
In order to protect the erosion of the base of the dune during the filling of tubes, was installed a geotextile with 600 g/m<sup>2</sup>. This geotextile avoid the erosion of sand from the base of the support tubes.

Figure 3 - Application of geotextile for protection

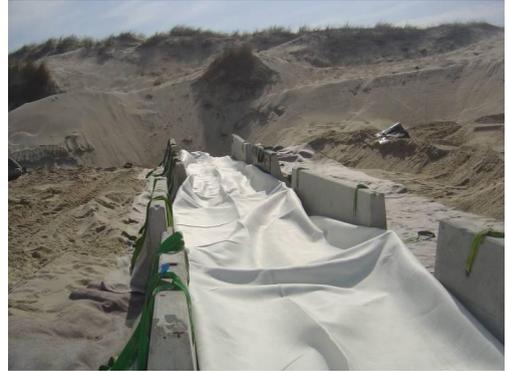
As part of stabilization, profiles in concrete were installed, for filling in a secure way. These profiles are taken when the tubes are completely filled with sand, and moved in the position of the next tube below.

Figure 4 - Implementation of the profiles and tube

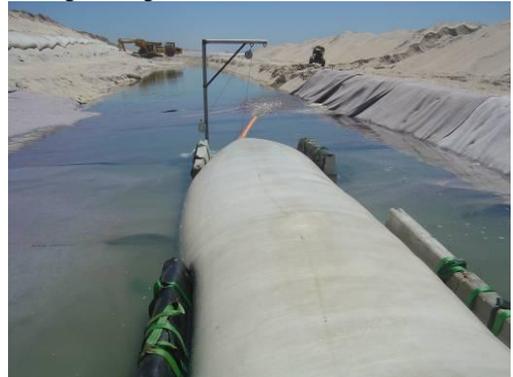
This is done by filling pump 900 m<sup>3</sup>/h of flow, reduced to about 500 m<sup>3</sup>/h, initially only with sea water until the complete filling and adequate positioning of the geotextile tube.

Figure 5 - Fill the bag with water

After the unroll of the tube to the correct position, with the mouths of entry and exit position to its upper part, it is the installation of the hose of entry, from the pump. It also installed a hose-out in the area opposite the tube, which control the flow of drainage water and consequently the amount of solids deposited inside the tube.

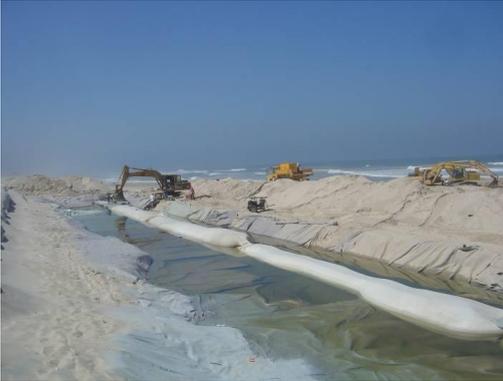
In the continuous process is started by filling with solids by pumping water and sand (maximum 20%). The water continues to be drained by the geotextile and the output mouth, while the sand was retained inside the tube, until the complete filling. The relationship between the quantity of fine sand and greater granulometry allows a constant filling without "clogging" of the tube, which are difficult to release.

In the end, the mouths of entry and exit of each tube is completely closed. This procedure takes about 4 hours for each tube.

Figure 6 - Placement of tubes in 1 layer of protection

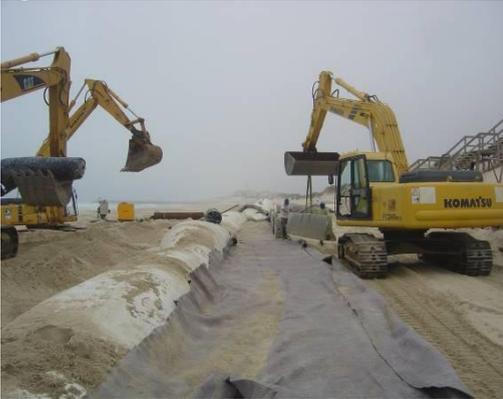
The whole process is repeated again for the next tube, which overrides the previous approximately 1 m, until complete 120 m in the front and 20 m meeting ends.

Figure 7 - Positioning of the tubes

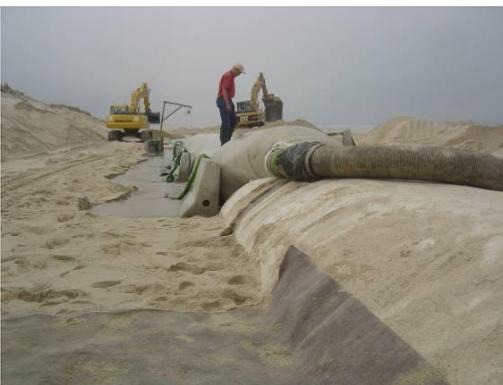
Figure 8 - Filling the upper layers

The layers are placed following disagreements with the tubes of the layer immediately below, indented on this in order to establish the initial slope inclination of the dune.

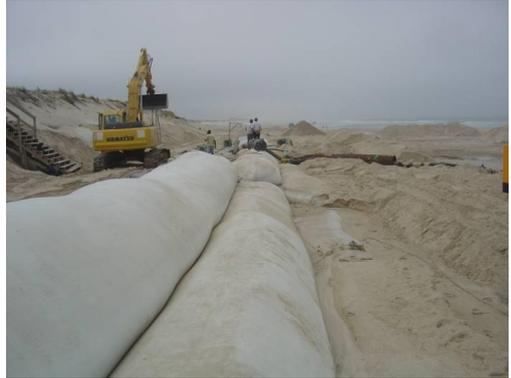
Figure 9 - Implementation of the beds above

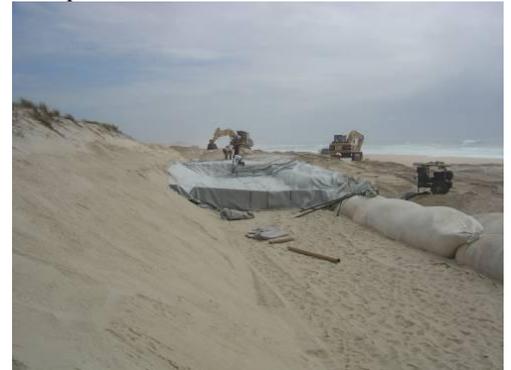
In the final layer of about 1.5 m in height (top layer), and to ensure the containment of the sand between the tubes and the existing dune, was applied a horizontal layer of geotextile bags, which sewn with appropriate equipment, allows the execution of a large bag (21 m x 6 m). It was installed in a structure of containment geotextile to involve the entire dune, ensuring retention of the sand during the storm periods.

Figure 10 - Implementation the bag top

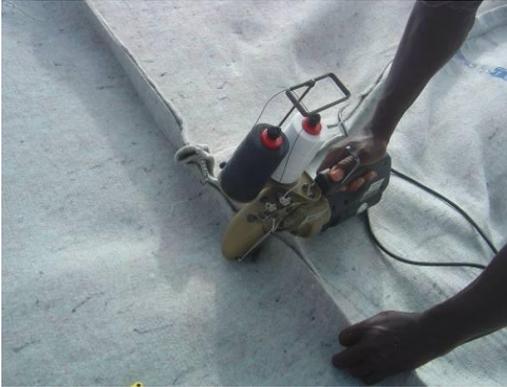
Figure 11 - Lashing the bag top

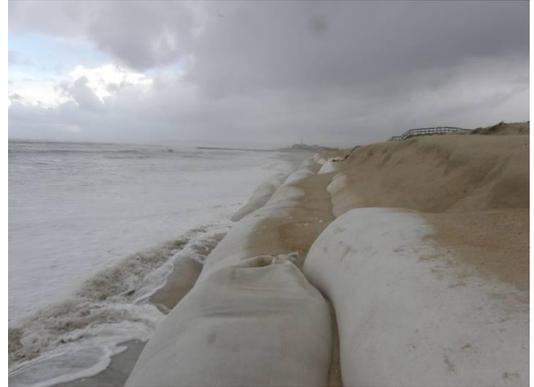
Figure 13 - Direct action of the sea on the tubes

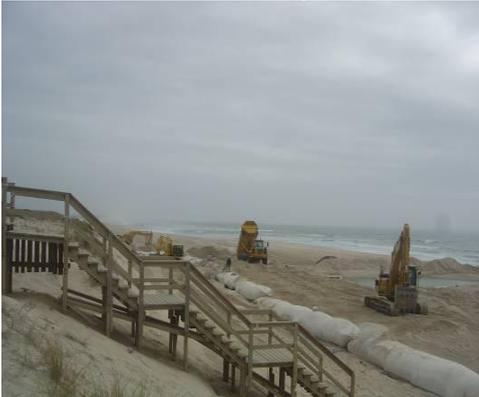
To protect the structure of tubes installed, was made the cover with 1 m of sand in order to proceed with the planting of vegetation suitable to the area and contribute to environmentally intervention area.

Figure 12 - Cover with sand
