The Growth And Development Of Geosynthetic Solutions For Coastal Erosion Repairs In South Africa.

J.J. Maastreht, Kaytech, South Africa julian@kaytech.co.za

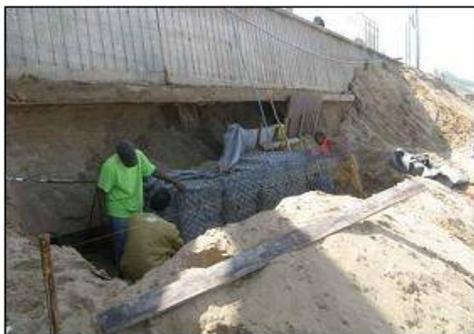
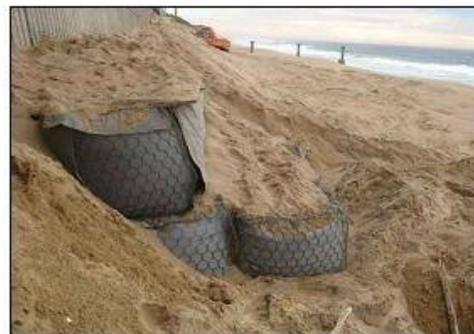
Figures 8 and 9 – 1.0 m by 1.0 m by 1.0 m gabion bag underpinning to seawall at Ansteys Beach , Bluff.
3.1.1 Case History 1:

Protection to the promenade and surf lifesavers clubhouse at Ansteys Beach was undertaken as a pilot project. A double row height of 1.0 m by 1.0 m by 1.0 m sandbag gabion baskets was installed directly in front of a concrete seawall to prevent loss of sand from under the promenade (figure 8 and 9). The system was adopted elsewhere, such as this slipway damage repair shown in Figure 7.

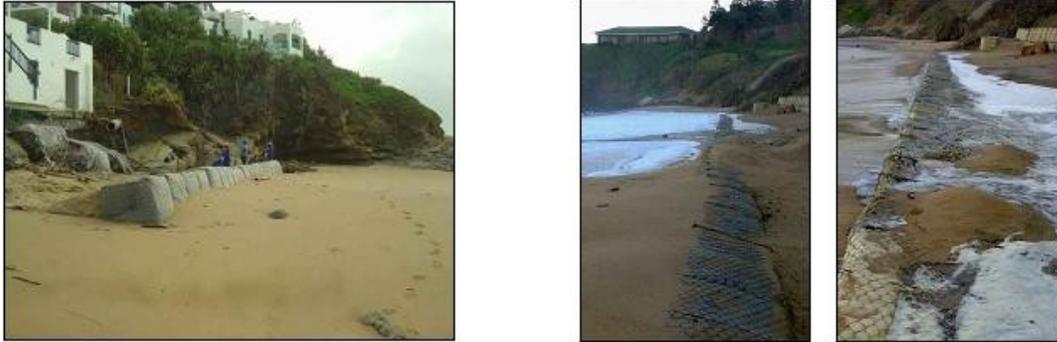
Figures 10 and 11: 1.0 m by 1.0 m by 1.0 m gabion bag temporary defence barrier at Santorini, Ballito.

At Santorini, a private development in Ballito, a 2.0 m high vertical sand-filled gabion basket wall was constructed directly under the exposed building foundations. A single line of gabion baskets was placed in the high tide zone as temporary protection for construction repairs (figure 10 and 11). As vertical gabions in the tidal zone produce rebounded waves, which result in further erosion and are a danger to beach users, these baskets were set back at an angle. Wave run-up energy was dissipated upwards while transported sediment was deposited directly in front of the line of gabions. The wave sediment deposition process quickly buried the structure. Due to its proven effectiveness, this system was continued in front of the remaining eroded beach at Santorini.

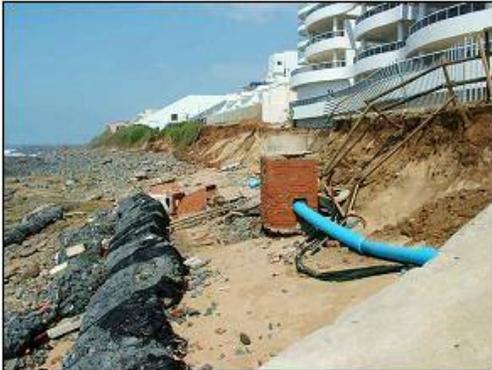
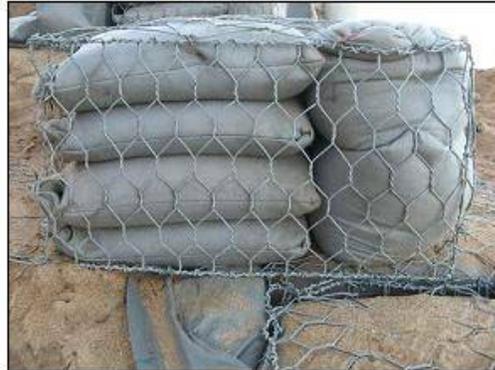
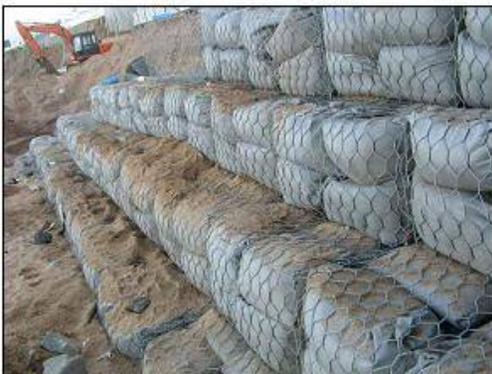
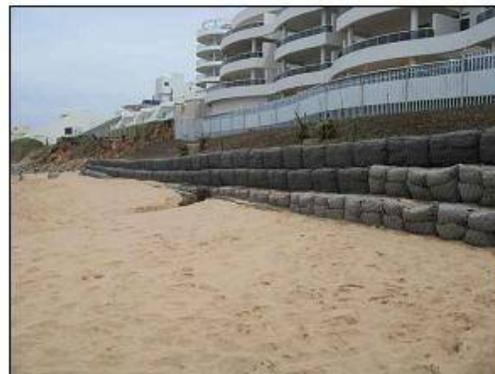
Figures 12 to 15 – 70 kg gabion bag defence wall at Ballito Manor.

Occupation of the newly constructed Ballito Manor was halted after erosion along the side exposed to the sea (figure 12). Installation: Shallow bedrock was exposed and a doweled concrete foundation cast directly in front of a replaced municipal sewer line. Specially manufactured 0,5 m high uPVC coated Class A galvanised mild steel wire reinforced gabion units, called Green Terramesh® were placed to

3.5 m height from bedrock level. Wire reinforced units consist of an integral tieback, which strengthens the backfill material, simultaneously keeping the unit in place and providing a face to resist wave attack. The wire reinforced units were offset 0,5 m, with every 0,5 m lift to provide greater stability and dampen the effect of wave run up. 0.8 m by 0.5 m geocontainer sand bags were used inside the wire reinforced units in place of traditional rock fill. The use of 0.8 m by 0.8 m geocontainer sand bags offered a “soft finish” in line with environmental constraints and provide greater protection to the uPVC coated wires (figures 13 and 14). The final structure was 56 m long by 3.5 m height, consisting of 5 500 by 0.8 m by 0.8 m geocontainer sand bags in 230 wire reinforced units of 3.0 m by 0.5 m by 1.0 m. 1 000 m² of a 60/30 kN geogrid was also installed under every second wire reinforced unit with a 4.0 m tieback length. The contract took 13 weeks to complete (figure 15).

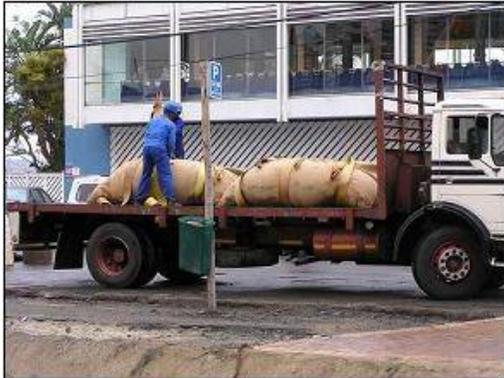
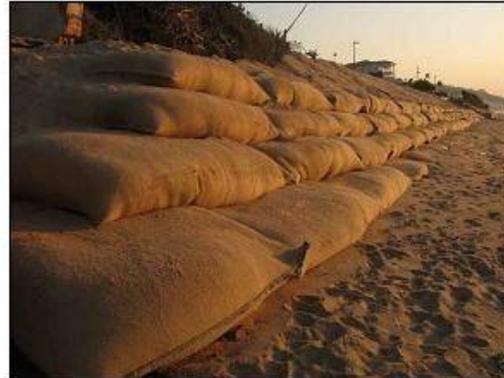
Figure 16 – Transporting of 4 ton geocontainers. Figure 17 - Geocontainers in a stretcher bond pattern.

Engineers from Ethekwini Municipality (Durban) visited the site in 2005 and noted the benefits of the system. The Ethekwini Municipality as shore protection to a yacht basin first used grade 3 geotextile geocontainers during a dredging contract. The geocontainers were filled off site, loaded onto a flatbed truck and transported to site because of the limited working area at the site. The geocontainers were placed by crane directly off the truck (figure 16).

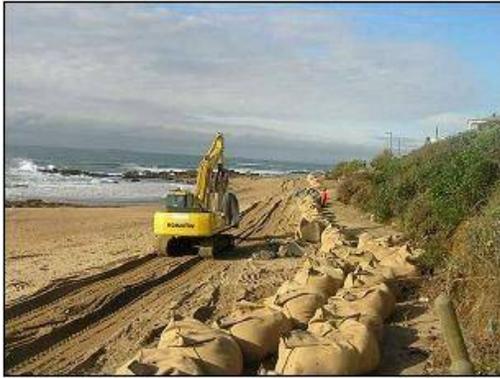
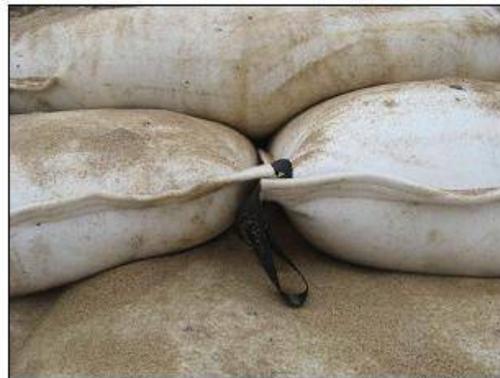
Figure 20 – Stockpiling geocontainers for closure to filling spouts. Figure 21 - Loop handles on geocontainer corners

the opposite end of the geocontainer. Proposals from a local authority led to the development of looped strapping handles sewn into the four corners of the geocontainer (figure 21). The advantage of the handles is that geocontainers placed on top of each other can be lifted using the handles, strapping placed underneath and relocated. Prefilled bags with loop straps can be stockpiled for use in emergency situations. The geocontainers can also be tied together to prevent slippage between geocontainers.

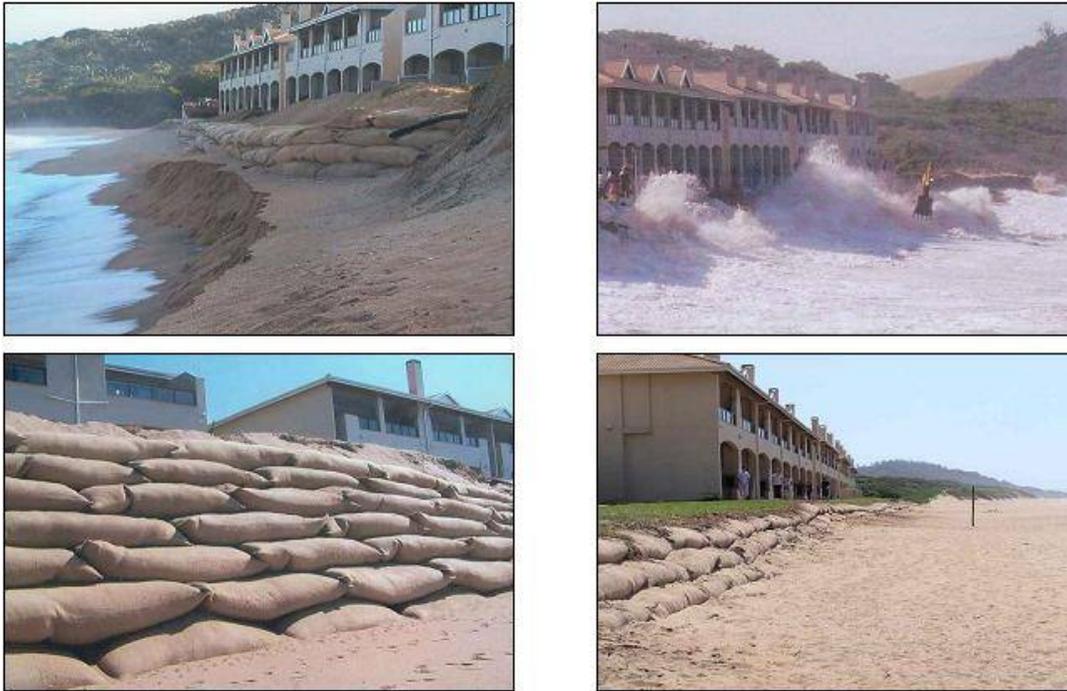
Figure 22 to 25 – Geocontainers placed in front of Happy Wanderers beach resort

Happy Wanderers resort, near Kelso on the KZN south coast was largely unaffected by the March storm. However, it appeared to have removed sand reserves from underwater, which resulted in the erosion of the beach during winter storms in July 2007. Large woven bulk bags were placed as emergency protection in an attempt to prevent further erosion and damage to the resort buildings. The bulk bags had little effect and the owner had to obtain another option quickly. By coincidence a contractor experienced in installing geocontainers was busy with an earthworks contract on the adjacent property. 3 geotextile geocontainers were proposed as a quick, effective solution. Grade 3 geotextile geocontainers were filled at a river mouth located on the northern boundary and immediately installed. Speed of installation was critical and despite some manufacturing and installation delays, 7 rows of geocontainers by 300m were installed in one month, thereby protecting the existing accommodation apartments. In September the contractor returned to site for a week to add a further 4 rows of geocontainers onto a 100m section where further erosion had caused some subsidence. The approximate total cost of the project was \$ 390 000. (figures 22 to 25)

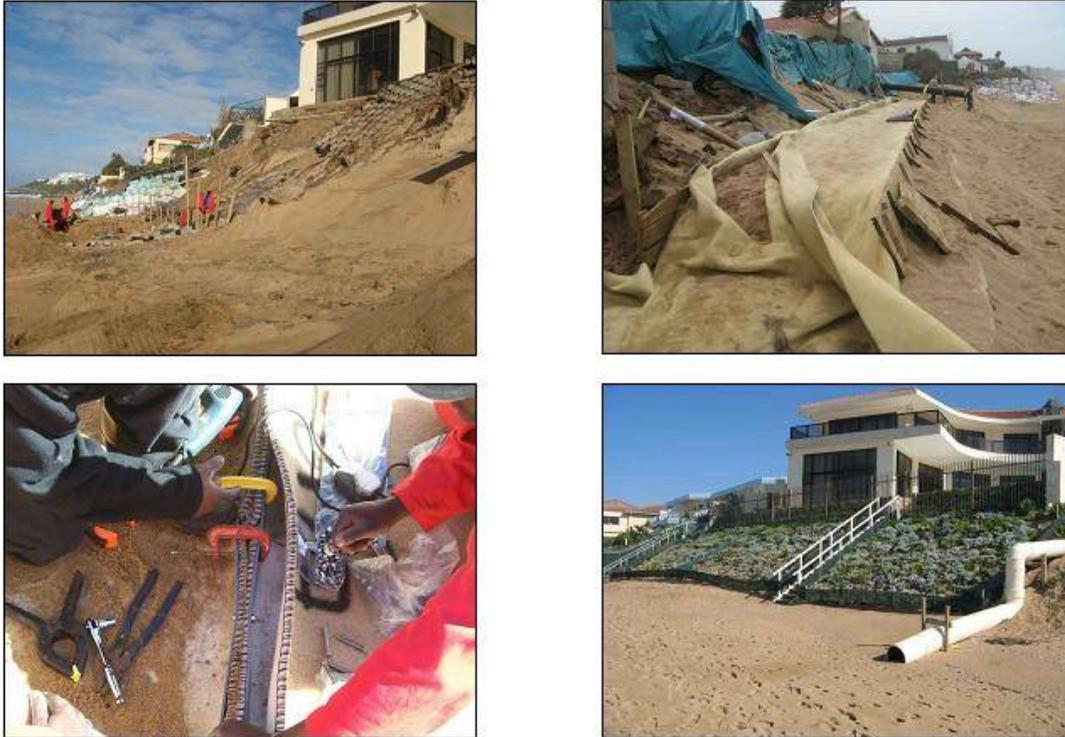
Figure 26 to 29 – Installation of geotextile fabric sausage bags at 33 Little Maritzburg Road, Ballito.

This geocontainer sausage bag technique was used for a domestic application in Ballito, where access to the beach was limited (figure 26). The design consisted of a sand bag filled gabion and Reno mattress foundation with 12 wrapped geosynthetic layers above. 70 kg sand bags were filled and stockpiled above the high water level. 1.0 m by 1.0 m PVC coated gabion baskets and 0.3 m deep by 6.0 m wide Reno mattresses were assembled ready for use on an adjacent property. The foundation was excavated using a backactor and limited to low tide and calm sea conditions. A single row of Gabions filled with approximately twenty, 70 kg bags per m³ was installed along the front toe of the Reno mattress. Rapid construction was required as the excavation readily collapsed and each day's completed work was buried by sand during the next high tide. Once the gabion toe structure was in place, the 6.0 m wide Reno foundation was installed and filled with 70 kg bags. Once the gabion/Reno mattress foundation/scour protection toe was in place construction of the 2.5 m wide by 0.5 m high grade 3 geotextile panels commenced. The bi-component grade 3 geotextile is supplied in a maximum of 4.0 m width, so panels had to be manufactured (sewn) to 6.5 m wide. Manufacturing limitations and difficulty of handling resulted in the supply of a maximum of 10m long panels. 10 m long panels were then joined using two 40 mm by 5 mm PVC strips, bolted to the inside of a volcano type joint using 8 mm class 316 stainless steel bolts at 100 mm centres. A 350 mm by 100 mm deep anchor/key trench was excavated in the middle of the placed compacted sand infill parallel to the front face of the wall. The key limits lateral sliding of geotextile upon geotextile and maximises tension in the front exposed face. Five rows 0.5 m high were installed, including two rows of Manta Ray ground anchors at 2.0 m centres. The remaining wrap systems were completed in a similar fashion with a 1 200 g/m² UV resistant high quality staple fibre geotextile (figures 27 and 28). The final layer was stabilised with cement. A reinforced concrete foundation was installed above, followed by a 1.2 m high dry stack retaining wall on the boundary. By the time construction had reached the top of the upper wrap system level a considerable

quantity of sand had returned, burying the bulk of the work. The project took four months to complete at a cost of approximately \$ 140 000 (figure 29).

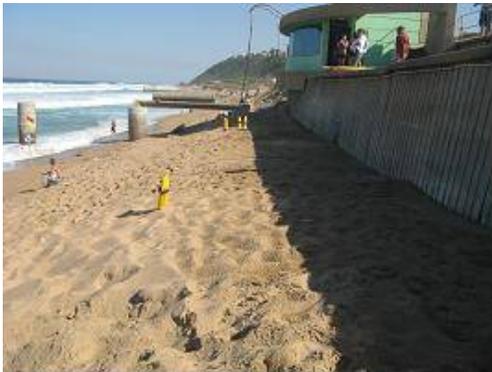
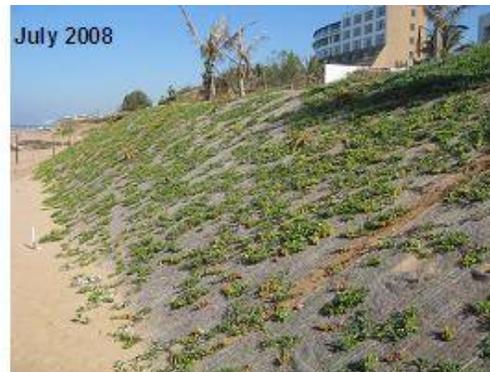
Figure 33 – Buried gabion bag structure at Brighton Beach. Figure 34 - Buried geocontainer wall with jute erosion control matting and vegetation cover.

homeowners have required immediate action and had geocontainers installed, followed by section 30 applications. As soft solutions are classed as a preferred finish there is no objection to accepting geocontainers as the permanent solution at a later date. This works favourably for the homeowner as insurance companies have made it clear that they will not pay a second time should the homeowner be instructed to remove the intervention. It was recommended that all soft engineering geosynthetic structures were covered and vegetated to provide maximum protection from ultra-violet light and vandalism (figure 33 and 34).
