# Geosynthetics applications for heavy load railway mitigation

**ABSTRACT:** The railroad system of the largest steel manufacturer in Taiwan has been in operation for ten more years. Due to the extremely heavy load and frequently cyclic loading, serious pumping problems had appeared along the rails, and resulted in aggressive ground settlements and distortion of rails. In an attempt to solve such engineering problem, geosynthetics applications of separation and reinforcement were proposed as solutions to the observed engineering problems. In order to verify the proposed designs, the authors executed a test sections plan to evaluate performance of different geosynthetics designs. In this paper, process and results of soil investigation and test section evaluation are presented. Instrumentation measurements obtained four months after the test section installation imply that proposed mitigation methods have provided a feasible solution to the railroad pumping problems under extremely excessive cyclic loads.

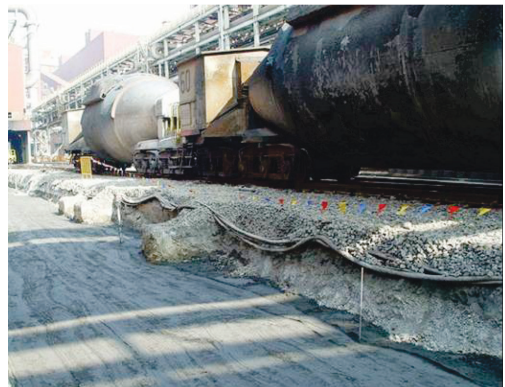
Figure 1. CSC railway system.

The railroad system of the largest steel manufacturer in Taiwan, China Steel Company (CSC), has been in operation for ten more years. It affords mainly the transportation of heavy furnace liquid steel. The rails bear very heavy torpedo shuttles that weight 500 to 800 ton individually (Figure 1). Due to the extremely excessive load and frequently cyclic loading, serious pumping problems had appeared along the rails, causing aggressive ground settlements and distortion of rails. Geosynthetics applications of separation and reinforcement were proposed as solutions to mitigate the pumping and serious contamination of aggregate and ballast layers. Concept of geosynthetics design is focus on how to stop fine grade material intrusting to the subbase layer, as well as providing better reinforcement of the bearing soil layer. Convenient construction and effective cost are also important considerations. In attempt to solve the described engineering problems, an extensive soil investigation and monitoring program was first conducted to identify the failure mechanism. Data of soil boring, test pits, seismic reflection survey, and piezometers were collected to access the ground conditions. Results of soil investigation show that the fine content of base material has contaminated the bearing layer, and the torpedo cars' passages has caused high pore water pressure. A full-scale test sections were then executed in order to further identify the efficiency of the

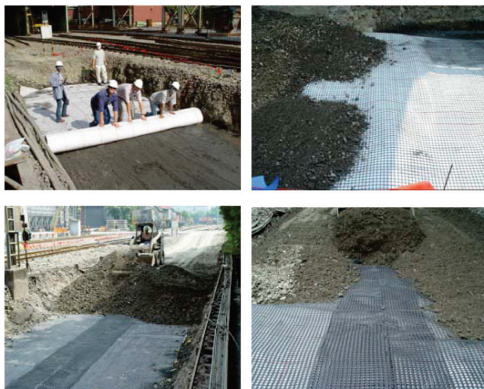
Figure 5. Test section installation.

Figure 5 shows the test section installation. By taking advantage of the geosynthetics, the subgrade material of the test sections were not compacted to 90%, a 10cm thick sand layer was used to provide the function of workplace and drainage blanket for installing geosynthetics. Fine sand of passing sieve #40 ~#100 with  $D_{85} = 0.425$  mm was selected as the blanket material on the basis of filtering criteria.

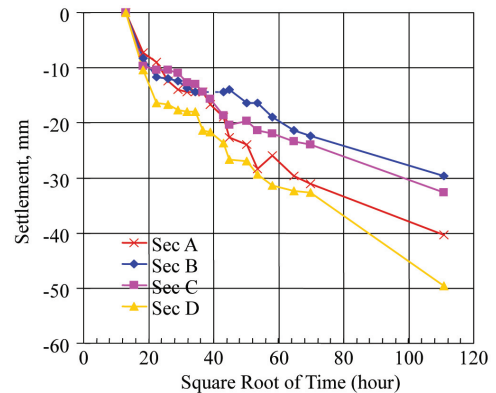
Figure 7. Average settlement of settlement plate 2, 4, 5.

Figure 7 shows the time history of the average settlement measurements seventy-four weeks after the installation. As shown in the figure, both Sections B and C appear to have much less settlement than that of control section. However, Section A still emerges an evident settlement as Section D does despite two layers of geo-composite were installed. Possible reasons for this poor performance might be the rundown drainage condition of Section A, as well as frequent engine brakes and starts of the torpedo shuttles at the section. Sections A, B and C appear no pumping problem seventy-four weeks after the installation, yet yellow clay has pumped out from the ballast again along the controlled section.
