Reinforced earth structures on soft alluvial deposits improved with prefabricated vertical drains and stabilizing berms

ABSTRACT: This paper presents a case study on foundation treatment using prefabricated vertical drains and stabilizing berms supporting reinforced soil walls and abutments constructed over Calcutta alluvial plains – a stratigraphy consisting of very soft to firm clays with organics extending down to a depth of about 15 m below ground level. The behaviour of the structure during and post construction is reported in the paper, including instances where stability problems were reported during construction. Settlements of large magnitude were observed along with serviceability-associated problems in certain cases. The authors wish to share these experiences and discuss the remedial measures adopted and suggest various preventive and corrective actions that can be employed while constructing under similar conditions.

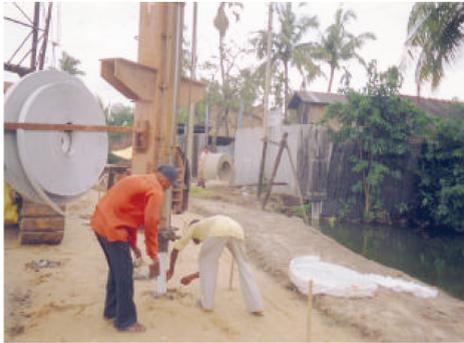
Photo 1. Installation of PVD.

the construction equipment loads. For this purpose, the top 500 to 750 mm of topsoil was excavated and was filled back with compacted sand, which also served as a drainage blanket. The installation of PVD is shown in photo 1 below.

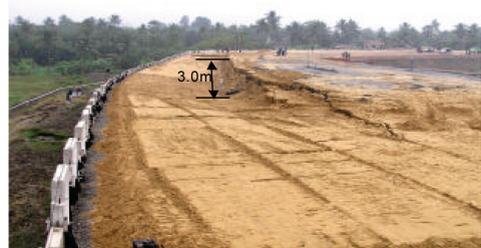
Photo 2. Slip circle failure during Stage-III construction at Km: 26.1 Loop, Kona Expressway, WB-I (Ch. 760 m to 870 m).

Problem: The wall failed in slip circle once the height of fill reached 7.5 m (just after Stage-II hold period) for a length of 120 m starting at 12 m away from abutment (see Photo 2).

Analysis: Four numbers of borehole were carried out to study the geotechnical properties of soil at the locations after the failure. The undrained shear strength profile from available field and laboratory tests are listed in Table 4 and the corresponding design values used in the original design of RS wall are listed in Table 5. The comparison of the undrained shear strength indicates:

1. Undrained shear strength considered in the original design for soil outside the embankment between depth 2 m and 4 m below original ground surface is higher than the actual.
2. Undrained shear strength considered in the original design for soil underneath the reinforced soil wall between depth 0 m and 4 m below original ground surface is higher than the actual.

The failure was due to two major reason:

1. Rapid construction (loading) and discrete foundation soil properties and could not be linked with the performance of PVDs. The gain in shear strength was not sufficient. Since it happened just after continuous rainfall for 3 days, increase in pore water pressure in foundation soil lead to the failure.
2. Subsurface investigation completed prior to the incident relied on SPT and the undrained shear strengths estimated from laboratory testing for the assessment of undrained shear strength of the fine grained foundation soils underlying the site. The lack of alternative in-situ measurements of undrained shear strength prior to the original design to verify the inferences based on SPT and laboratory strength testing may be viewed as a general limitation of the subsurface geotechnical investigation programs upon which the original design of the RS wall had to rely.

Rectification: The entire stretch is rebuilt after dismantling only the top layer of panels and by providing a 6 m height (15 m wide) stabilizing berm on other side of panel. The outputs of stability analysis (static case) for both pre-consolidated and post-consolidated cases are shown in Figs 6 and 7. Since the top alignment got disturbed, a new pad level is constructed over the filled up soil and then the wall is rebuilt.

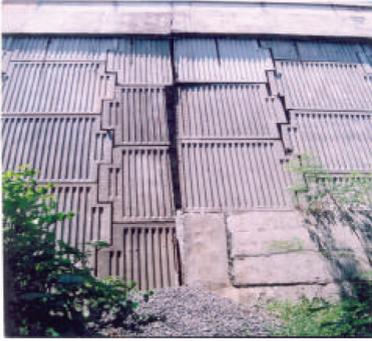
Photo 3. Opening of slip joint at interfaces of reinforced concrete reinforced concrete culvert and reinforced concrete wall.

Problem: Opening of slip joint at the interfaces of reinforced concrete (RCC) culvert (resting over pile) and reinforced soil wall resting over very soft foundation soil treated with PVD (Refer Fig. 8 and Photo 3) due to differential settlement and washout of filter material from slip joint due to dislocation of cover slab placed behind the slip joint.

Analysis: Opening of joint was due to the differential settlement of panels just near the pile cap and a meter away from the pile due to different soil stiffness created by pile influence zone. Due to this differential settlement the panels likely rotated away from the pile as a result the slip joint widened at top. The cover slab dislocated since the wall founded on the piled foundation has undergone negligible settlement whereas the adjacent area of PVD treated section has undergone substantial settlement. Since part of the cover slab is also resting on "rigid" foundation and part of it on soft PVD foundation, which has settled by more than 350 mm and due to this heavy differential settlement there has been a

dragging effect which caused the dislocation of cover block and geotextile placed behind the panel, resulting in the migration of backfill materials. Non-woven geotextile was placed as filter behind the cover slab to prevent migration of fine particles from the joint. Also few strips near slip joint snapped from connection due to dragging of strips by settling soil since the strips were laid perpendicular to the facing instead of in skew.

Rectification: The wall length adjoining the slip joints are dismantled in two steps including crash barrier, pavement, panels, strips and back fill. The entire length of reinforced soil wall is then rebuilt.
