# Performance of a 37 m high geogrid reinforced soil structure constructed over a disused sewage treatment pond

**ABSTRACT:** The development of a housing scheme on a hill site project in Cheras, Selangor, Malaysia necessitated the construction of a reinforced soil structure. The base of the structure was partially founded on a disused sewage treatment pond. The pond was reclaimed where soft unsuitable materials were excavated and replaced with rock compacted to form a firm base. A 37 m high geogrid reinforced soil structure was subsequently constructed on the rock fill foundation. The geogrid reinforced soil structure was constructed as a wrap-around system where the facing was hydroseeded with suitable vegetation. The backfill material used in the construction of the structure is composed of weathered residual soil and weathered rockfill of granite. Instrumentation in the form of inclinometers, pneumatic piezometers and settlement markers were installed at various locations in the structure to monitor its performance during and after construction, principally to measure the horizontal and vertical movements and pore pressure developments within the fill mass. Some significant mo

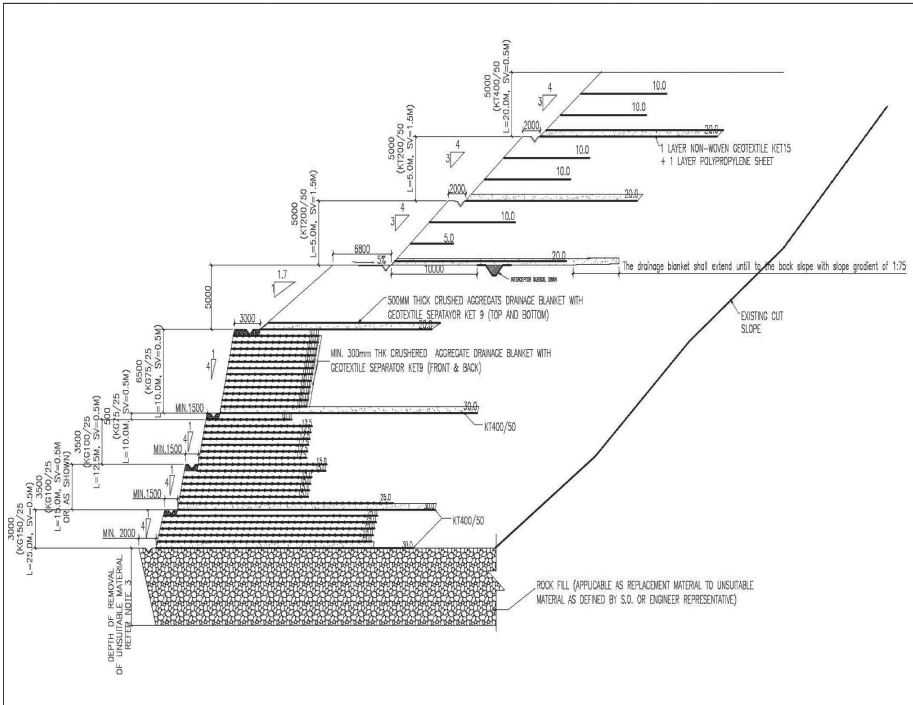
Figure 2. Typical cross-section detail of structure.

A typical cross-section detail of the structure is shown in Figure 2. The upper reinforced soil slopes were reinforced with high strength woven geotextile, KT200/50. Table 2 provides a summary of the design stresses of the geosynthetic materials used.

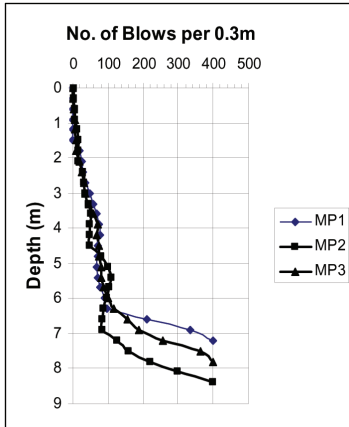
Figure 3. Results of Mackintosh probe tests carried out in Pond.

The subsoil condition of the foundation generally was treated to ensure the bearing capacity is sufficient to sustain the loads from the structure. Figure 3 shows the mackintosh probe test results carried out in the pond prior to treatment. The figure shows that about 3 m depth of soft material was present at the base of the pond. The soft unsuitable materials in the pond were removed and replaced with selected compacted rockfill materials to form a stable rock toe.

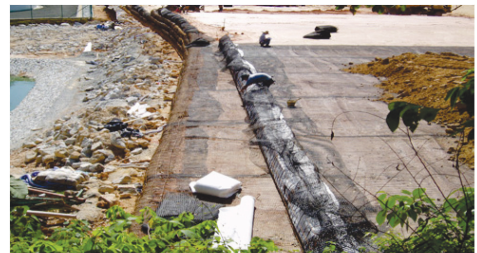
Figure 6. Base Layer of Woven Geotextile.

High strength polyester woven geotextile and high strength knitted geogrid were used to reinforce the structure. KiaraTex high strength woven geotextile KT 400/50 was laid in the founding layer of the structure. The ultimate strength of this material is

400 kN/m, and a factor of safety of 3.0 was adopted. This value of safety factor was chosen in anticipation of the heavy rainfall, which coincides with the monsoon season, during the construction period.

The stability analysis was performed considering internal stability and overall stability. A minimum factor of safety of 1.40 was adopted for the design. Both the circular and translational modes of failure were investigated for the internal and global stability. The stability analysis was based on Bishop's method of slices. Figures 5, 6, 7 and 8 show the construction of the reinforced earth structure.

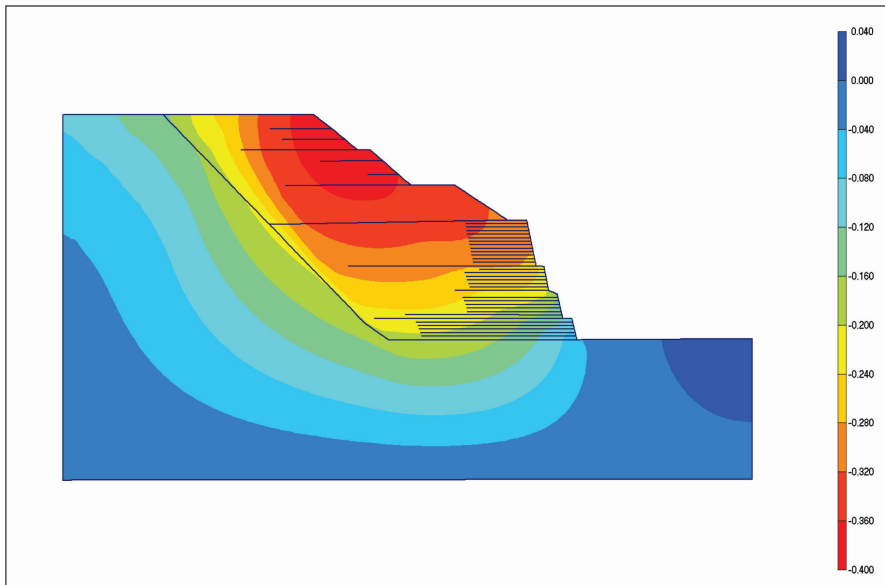
Figure 14. Plot of vertical displacements.

The reinforced soil structure was modelled in finite element using the PLAXIS Finite Element software (version 8). The geogrid and woven geotextile were modelled as tension elements. The analysis was performed with the assumption of a drained condition, adopting the Mohr-Coulomb model. Parameters relating to the stiffness of the geogrid, woven geotextile and retained backfill soil are shown in Table 3. Figures 13 and 14 show the results of the analysis.

At Berm No. 6, the calculated vertical displacement corresponds to a value of between 320 mm and 360 mm. At the crest of the structure, the vertical

displacement was calculated as between 360 mm and 400 mm.

Relating the results of the finite element analysis to the field monitoring results suggest that the finite element analysis had predicted the displacement within a reasonable accuracy. Generally, the measured displacements are smaller than the predicted values.
