Landslide stabilization using geofoam

Mann, G.

Stark, T.D.

Keywords: geofoam, landslide, lightweight fill, stabilization, retaining wall backfill

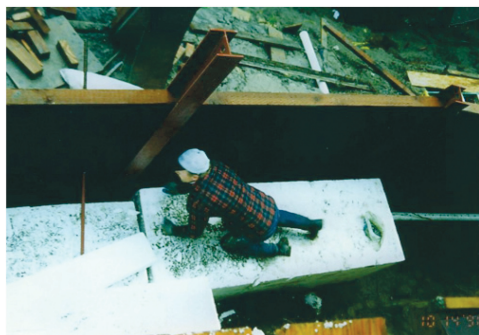
Figure 3. Geofoam block field installation.

The geofoam used here is an XPS-VII manufactured by Big Sky Insulation of Belgrade, Montana. The compressive strength at less than 2 percent axial strain is 310 kPa and the unit weight is 0.35 kN/m³. The original Geofoam blocks were 2.4 m long, 1.2 m wide and 1.2 m thick. This thickness made the blocks difficult to handle, particularly in moderate to high wind conditions. To facilitate handling the contractor cut the blocks in half with a hot wire cutter. This size reduction allowed a single workman to lift, carry and place the individual blocks with ease [see Figure 3].

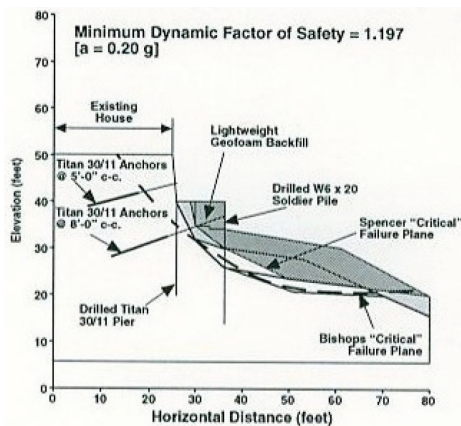
Figure 4. Slope section for stability analyses showing retaining structures, geofoam, and geologic materials.

The cross-section in Figure 4 depicts the geometry and materials considered in the stability analyses. Using the soil parameters in Table 1, the cross-section in Figure 4, Spencer's (1967) and Bishop's (1955) stability methods as coded in Slope/W, and the search routines in SLOPE/W, the minimum computed static and dynamic factors of safety are 2.1 and 1.3, respectively. The critical static and dynamic failure surfaces are shown in Figure 4. The pseudo-static (dynamic) analysis was conducted using a 0.2 g horizontal seismic acceleration.

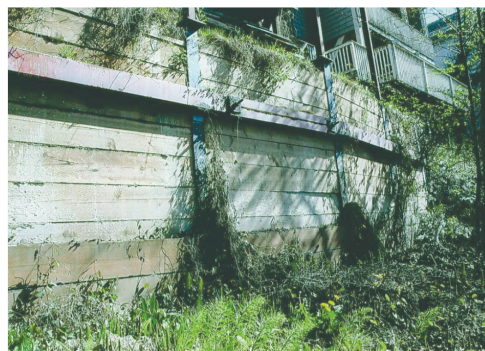
Figure 5. Existing anchored retaining wall system after nearly six years.

Both retaining structures have been in-place for about six years and survived a significant regional landslide in the downgrade slope without any detrimental impact. There has been some resulting loss of soil at the face of the wall necessitating the installation of two additional timber lagging planks at the base of the wall. However, there has been no apparent impact to the residence, the wall system, or the geofoam backfill from this soil loss. The current condition of the anchored wall is shown in Figure 5.
