## Mandena Mine Salinity Control Weir Design and Construction

F.J.G. Gibbons SSI Engineers and Environmental Consultants, Johannesburg, South Africa.

As part of the infrastructure for their Mandena mine in southern Madagascar, Rio Tinto recently constructed a rockfill weir on the Anony River. The weir consists of a 150 m long, 9 m high rockfill embankment, with an adjacent 300 m wide rock-cut main spillway, a boat lock and low flow spillway.

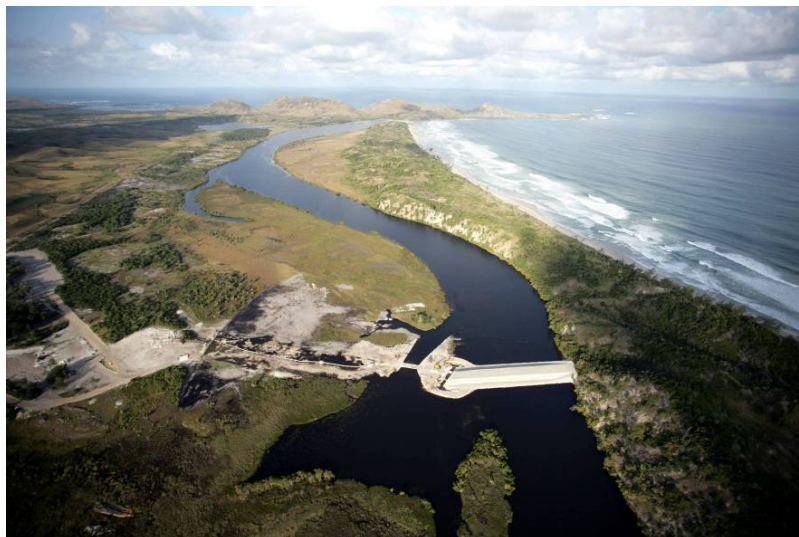
Figure 1. The Anony River Estuary and Partially Completed Weir

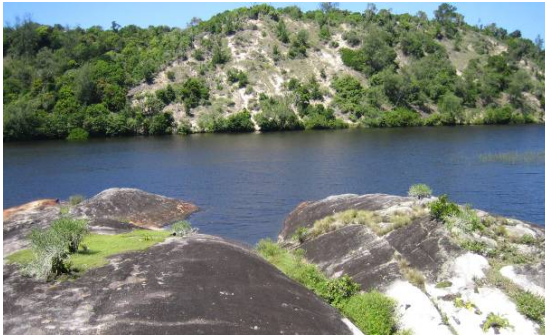
Figure 2. The weir site before construction commenced

The site is located approximately 15 km north of Tolagnaro and can be accessed either by boat, along the coastal lakes, or by road. The site chosen for the weir was at a point where the Anony River is 130 m wide, 4km upstream from the river mouth. A major feature in favour of the site was a rock outcrop about 400 m long perpendicular to the river on the left bank. The rock fell off steeply under the river such that the sand cover on the right bank was 15m thick. The right bank comprised a steep primary sand dune approximately 70 m high that is virtually at its natural angle of repose. The maximum water depth in the river channel was about 4.0m with a normal water level 0.3 m above sea level.

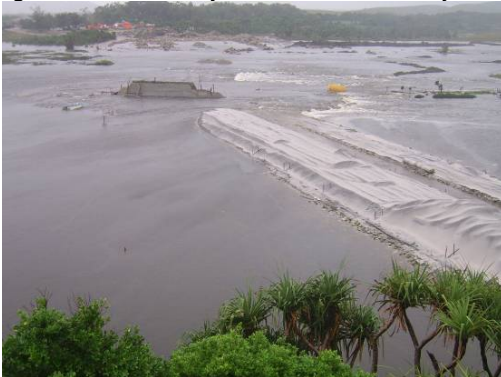
Figure 6. The 1:10 year flood in February 2008

As it turned out a 1:10 year flood occurred during construction. It was however at a late enough stage that damage to the works was minimal and work resumed quite soon after the passage of the flood.

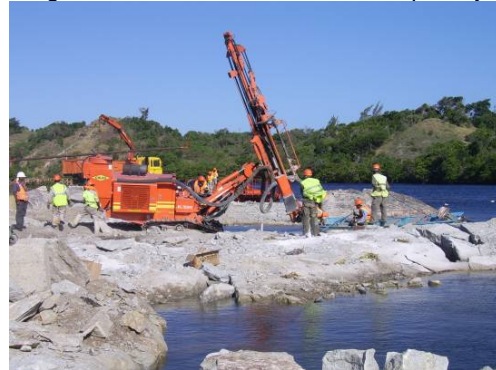
Figure 7. Excavation on the main spillway

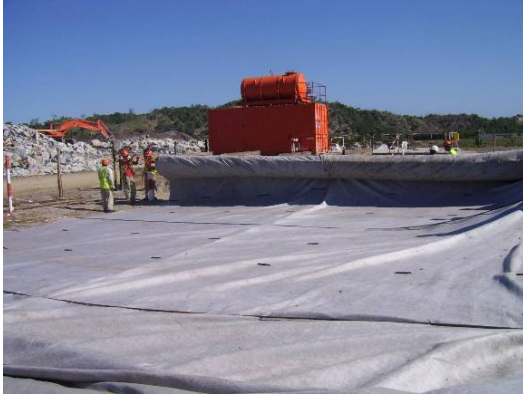
Figure 8. Preparing geotextile sheets prior to laying

A key aspect of the construction was to ensure that the foundation geotextile layer was properly placed on the riverbed with the correct laps (2 m specified). A number of ways were discussed for this including sewing large sheets together and pulling them out from the bank over the river. The final solution however included the construction of a purpose made barge by the contractor. Large panels of geotextile were pre-sewn together and fitted with 250 mm long pieces of 30 mm reinforcing bar placed at 2 m centres. The panels were 12 m wide so the net coverage after laying was 10 m. The contractor rolled each pre-sewn section of geotextile onto a large roller (a 12 m long 150 dia. steel tube). This was fitted on the rear of the purpose made barge.

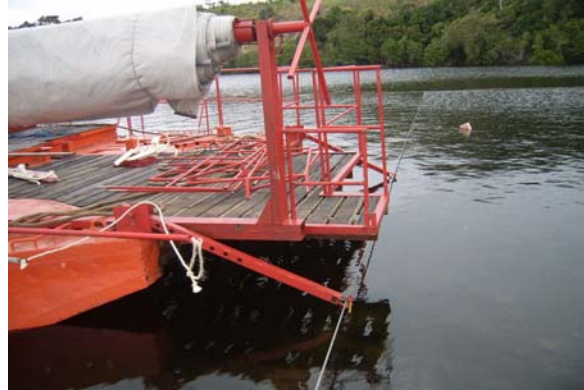
Figure 9. The cable used to guide the barge during laying operations

The position of the barge was accurately controlled by two steel cables that were strung across the river and securely anchored on each side. Slowly the geotextile was rolled off the roller as the barge was pulled across the river. The steel rebar weights made the geotextile sink and this was further aided by placing sandbags on the completed sections from a motor boat. Later a diver went down to both inspect the completed geotextile and remove the rebar weights so that they could be reused. The construction started at the downstream end of the embankment and proceeded upstream so that each new section of geotextile would lap over the previous section and prevent lifting due to flow. The final section of geotextile was securely anchored on the upstream side using sandbags. This was to reduce the possibility of a whole panel of geotextile being washed down the river in the event of a flood.

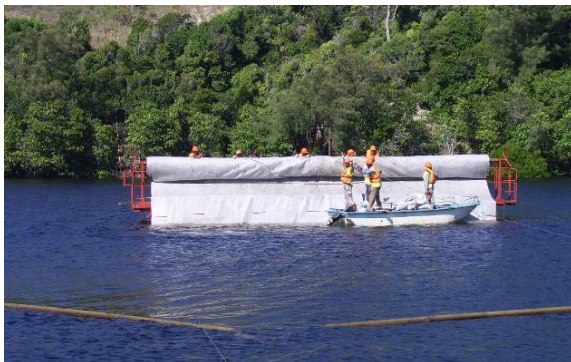
Figure 10. Laying the foundation geotextile layer from a specialised barge

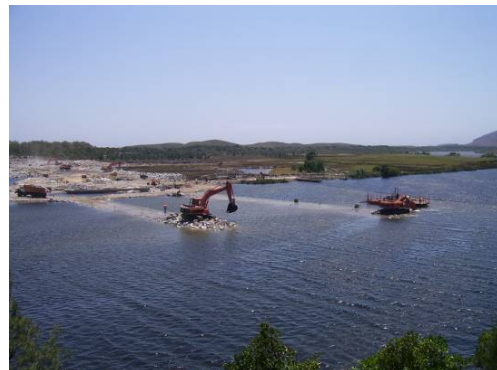
Figure 11. The two pioneer rockfill embankments as they progress across the river just below water level

After placing the foundation geotextile layer on the river bed, the contractor proceeded with the construction of the two pioneer rockfill embankments. The contractor chose to place these in two stages, the first stage entailing the construction of both embankments to just below the river water level, working from left bank to right (see Figure 11) and in the second stage raising the pioneer embankments to the design level of 1.5 m above sea level, working from right bank back to left. This two stage process allowed the contractor to place loads of rockfill on the geotextile more accurately with a back actor and gave more working space on top of the embankment. Safety on the project was a high priority and the construction vehicles were carefully directed when crossing the new embankments.

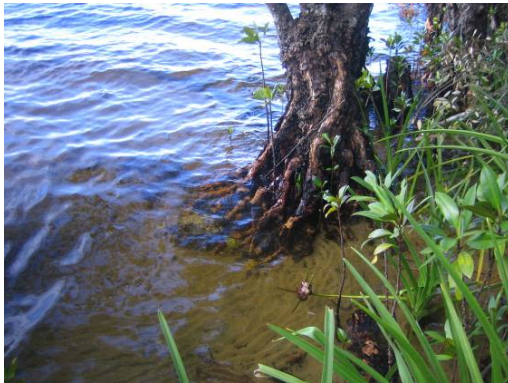
Figure 12. One of the mangroves on the right bank

One of the major challenges was the removal of 600 mm dia mangroves from under the embankment on the right bank. It was decided to leave the root systems in place to prevent damage to the sand dune and only remove the top part of the trees to below ground level. The contractor first tried to do this by hand with axes and saws but found it almost impossible. Finally they completed the clearing with an excavator immediately prior to closing against the right bank when the tidal flow in the river had been stopped by artificially closing off the estuary mouth. The holes left by removal of these trees were filled with sand prior to placing of the geotextile.

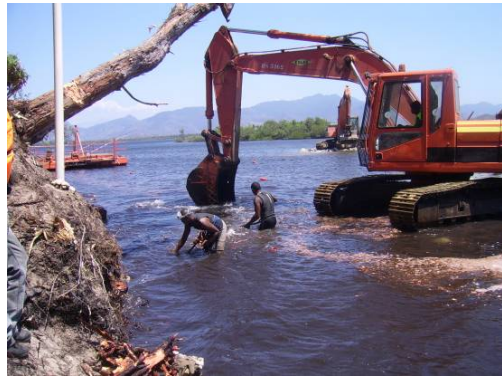
Figure 13. Closing the embankment against the right bank

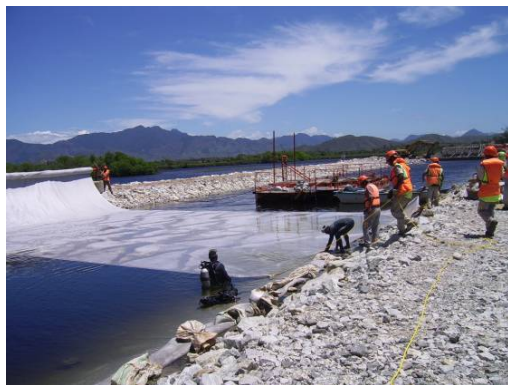
Figure 14. Placing the containing geotextile for the sand core

As mentioned previously the sand core is a critical part of the structure. The 3 m wide base of the core is the “path of least resistance” for seepage and therefore it was carefully inspected by divers with video camera prior to laying the containing geotextile on the base to ensure that no large rocks had rolled into this area. The 3 m wide base of the sand core therefore had a double layer of geotextile installed to further act as a safeguard for this critical area. This also served to simplify the construction of the sand core.

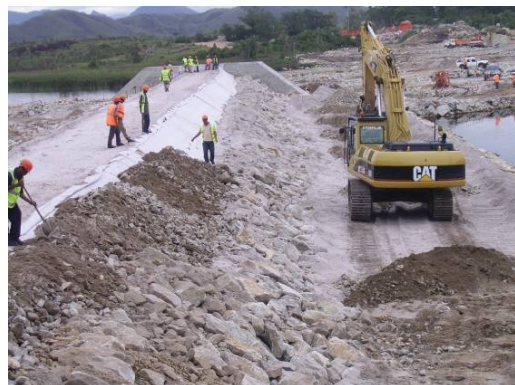
Figure 15. Final stages of the embankment construction showing the above water level sand core, geotextile, filter, rockfill and riprap layers

After the flood in February 2008 it was a relatively straightforward task to complete the remainder of the embankment by adding the required layers. This included the construction of a masonry end wall against which the embankment was finished. The local Malagasy masons made an excellent job of this wall which serves to protect the end of the rockfill embankment from the higher velocity flows during floods.

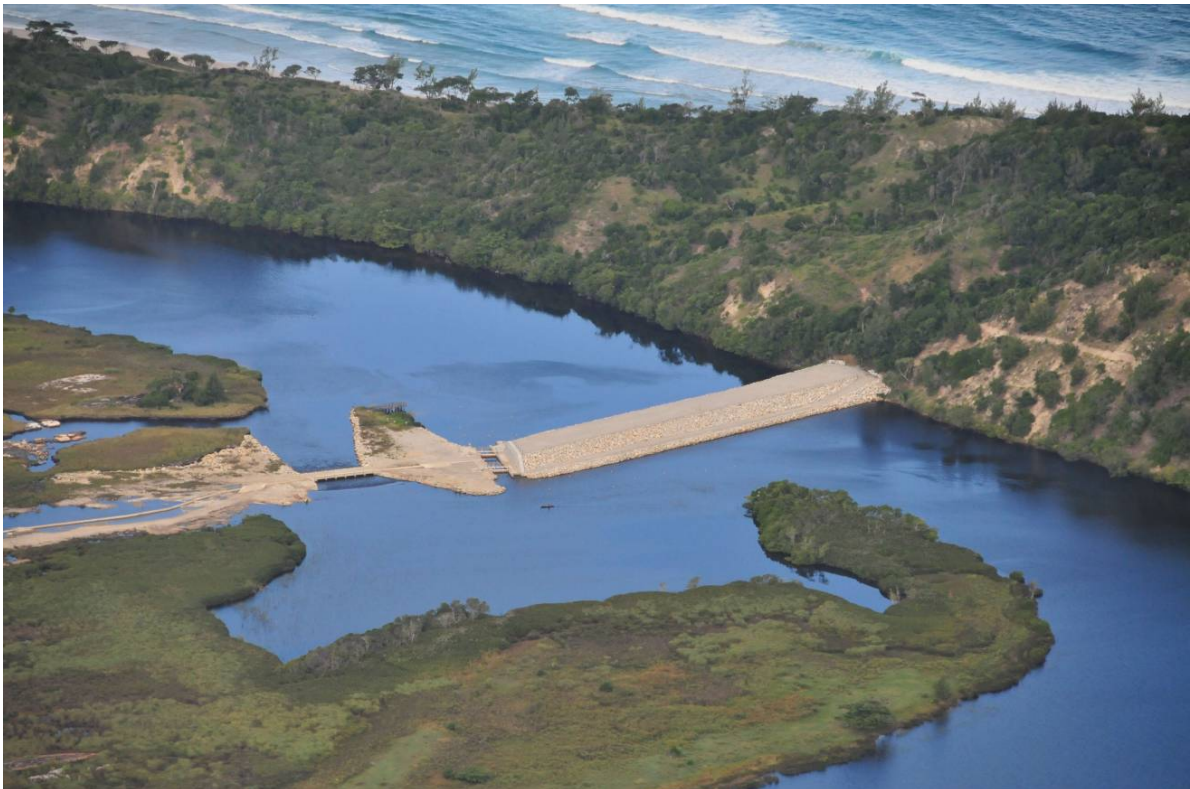
Figure 16. The completed embankment, boat lock and low flow spillway
