# Stabilization of slopes and landslides using soil nailing methods

**ABSTRACT:** Landslide-endangered slopes and active landslides are often stabilized in Germany using soil nails. In general two soil nailing methods are used. One method is characterized by a combination of soil nailing using steel tubes as nails, and cement grout injection. The other method uses threaded tie bars as tendons in grout-filled boreholes. The report describes some examples for the two nailing methods, and their advantages and disadvantages.

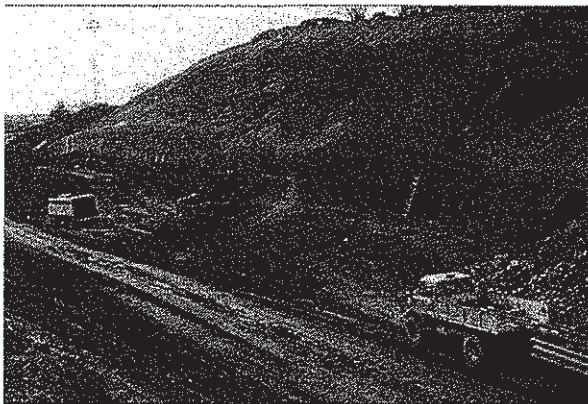
Figure 7. View of the slope during the nailing measures.

Figure 7 shows a view of the slope during the nailing works, Figure 8 the preparation of the nails. As it may be seen on Figure 9 in the neighbourhood of the reinforced slope landslides occurred during a heavy rainfall which forced the authorities additionally to extensive stabilization measures.
