Earthquake resistance of geogrid-reinforced soil walls based on a study conducted following the southern Hyogo earthquake

ABSTRACT: The earthquake at the southern Hyogo early on the morning of January 17, 1995, with its epicenter on the northern tip of Awaji Island, cause tremendous damage to the southern district of Hyogo prefecture. Earth-retaining walls, including gravity and semi-gravity types, were no exception. The Earthquake is reported to have severely damaged such earth structures in this region. We investigated ten Geogrid-reinforced soil walls that existed prior to the earthquake, near the hypocenter where a seismic intensity of 6 to 7 was recorded. We found that although the earthquake caused some settlement and cracks in the foundation, the walls themselves were almost free of deformations. In this study, we will report the findings of our on-site investigation of the Geogrid-reinforced soil walls and will verify the earthquake resistance of each ten structures on the basis of some established aseismic design procedures.

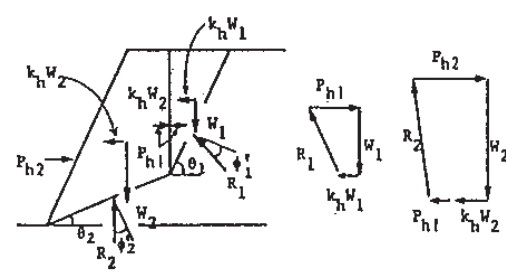
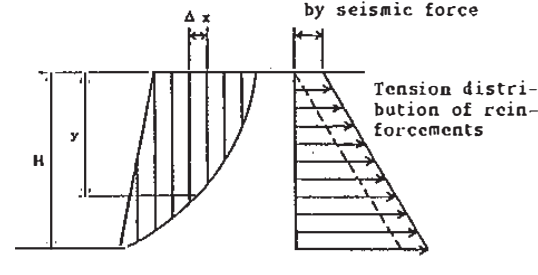
Table 4. Design method for Geogrid-reinforced soil walls

Table 4 outlines the design methods for Geogrid-reinforced soil walls proposed by the GRB and PWRI. The main differences in design concept between the two design methods are the shape of the sliding surface and determining method for earth pressure to withstand seismic load. Meantime, both design methods are based on similar ideas in terms of external stability by regarding the zone reinforced by Geogrid as pseudo retaining wall.

GRB	PWRI
Failure mode	Two-part wedge sliding	Circular slip

Design procedure	<ol style="list-style-type: none"> 1. Calculate the length of reinforcement by external stability (sliding forward <math>\langle La \rangle</math>, overturning <math>\langle Lb \rangle</math> of reinforced zone 2. Determine K for internal stability based on above failure mode 3. Calculate Lc by pull-out failure 4. Determine $Lreq = \max(La, Lb, Lc)$ 5. Determine vertical spacings of reinforcement using coeff. K 	<ol style="list-style-type: none"> 1. Determine k based on above failure mode 2. Determine vertical spacings of reinforcement 3. Determine the length of reinforcement based on overall circular slip surface 4. Study of external stability of reinforced zone (as pseudo retaining wall)

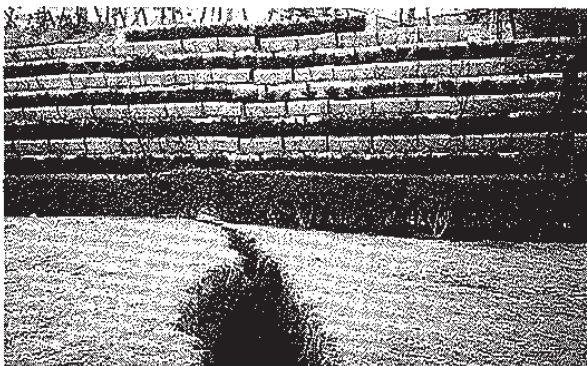
Fig. 2. Structure and appearance of No.5

This structure was constructed as part of developing land (see Fig. 2). As the structure was constructed on reclaimed land facing the sea, the seismic intensity could be 7, with ground acceleration of approximately 700 gals. Damage to surrounding structures was tremendous. The ground in front of the Geogrid-reinforced soil wall had a crack approximately 30cm wide, which met the wall at a right angle.

In spite of such considerable seismic load, the Geogrid-reinforced soil wall exhibited only minor damage, such as slight gap between concrete blocks used as facing material. No deformation was observed that would damage serviceability. Adequate stability was confirmed.

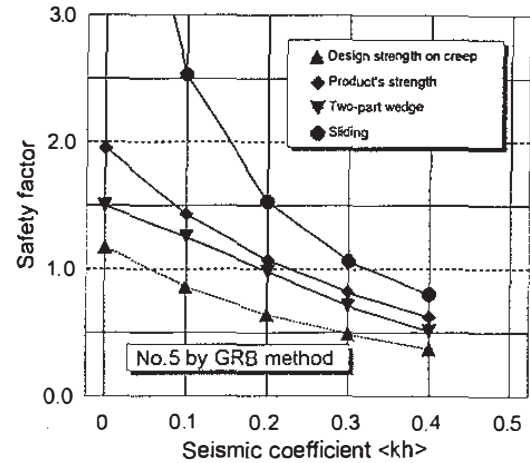
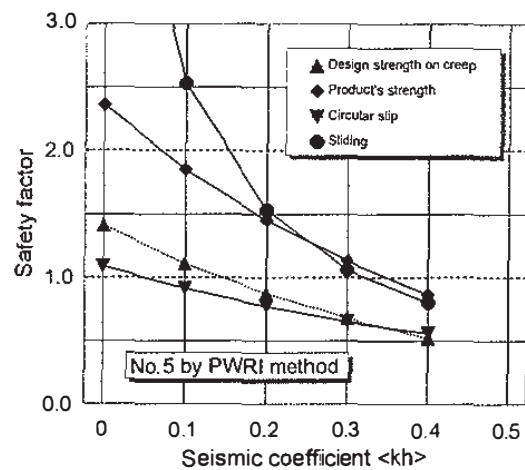
Fig. 3. The results of analysis by GBR & PWRI

Fig. 3 show the results of analysis of this structure using the design methods proposed by the GRB and PWRI. Obviously, earthquake resistance was not taken into consideration in the design stage. The safety factor by circular slip was below 1.0, which value was 0.910 at a horizontal seismic coefficient of merely 0.1. At a horizontal seismic coefficient of 0.2, as well, the safety factor by circular slip was 0.768. The stability analyzed by two-part wedge was also below critical condition.

With both design methods, the strength required for Geogrid exceeds the designed strength at a horizontal seismic coefficient of 0.1 or 0.2. This designed strength was set according to the creep characteristics based on long-term serviceability. Thus, no breaking will occurred during earthquake.

The maximum ground acceleration that acted on the structure is estimated as between 500

and 700 gals. This can be converted into horizontal seismic coefficient of approximately 0.5 to 0.7. From the view of either failure modes, the structure could be destroyed. In addition, the concrete blocks and Geogrids were not connected, thus they did not contribute to stabilization of the reinforced soil wall.

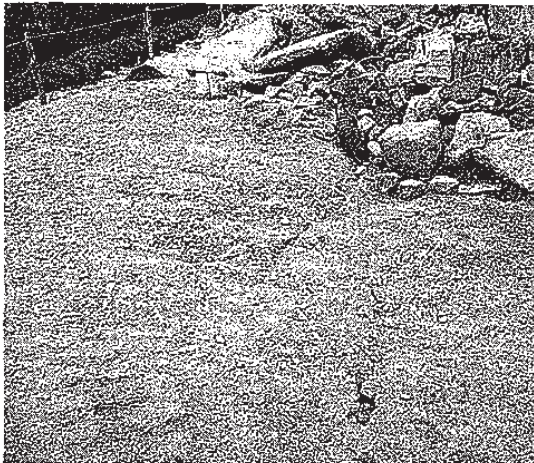
Fig. 5. A crack ran on the crest of No.8

A crack parallel to the wall surface ran on the crest, approximately 4 m from the wall face (see

Fig. 5). The wall was slightly deformed forward.

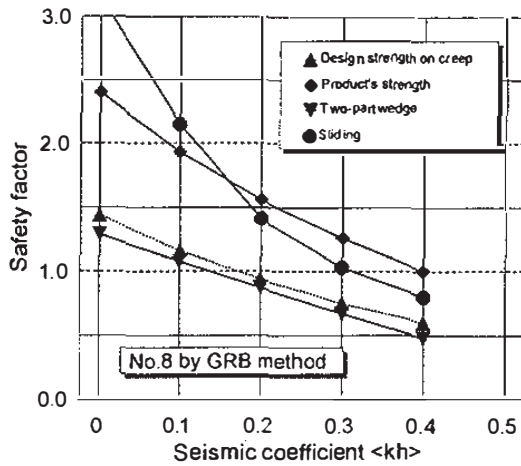
Fig. 6. The results of analysis by GRB & PWRI

The results of analysis shown in Fig. 6 are based on the assumption that the ground bearing capacity is adequately strong. Thus, it does not explain how the phenomenon in this case occurred during the earthquake. Nevertheless, circular slip or two-part wedge sliding exceed the critical point at a horizontal seismic coefficient of 0.2.

At this stage, the strength required for Geogrids has not reached the designed strength or even the product's strength. Therefore, it shows instability, because the length of the Geogrids in the upper portion of the reinforced zone was insufficient.

Thus, as measures for enhancing earthquake resistance, taking into consideration failure modes, in particular the Geogrids in the upper portion of the reinforced zone must be adequately long.
