# Effect of natural weathering on the water permeability behaviour of nonwoven polypropylene geotextiles

Moreira, S.P., Carneiro, J.R., Lopes, M.L.

Department of Civil Engineering, Faculty of Engineering, University of Porto, Rua Dr. Roberto Frias, 4200-465 Porto, Portugal

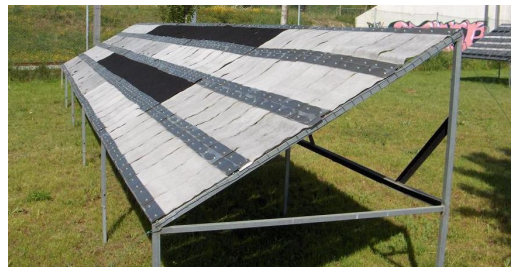
The GTXs were exposed to natural weathering in Portugal (latitude 41°13' N, longitude 8°39' W, 49 m above sea level). The test-specimens were installed on exposure racks facing south with a 30° inclination angle (Figure 1).

Figure 1. GTXs exposed to natural weathering

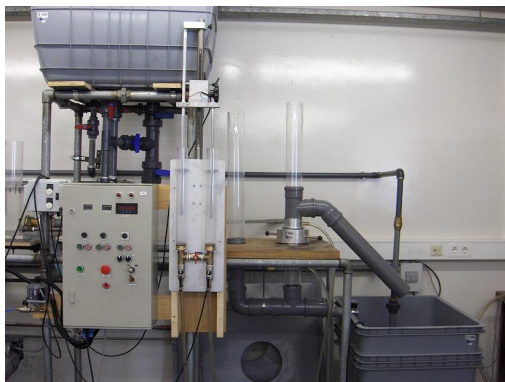
The equipment (a prototype) used in the hydraulic tests was developed by our research team (Figure 2).

Figure 2. Equipment used in the hydraulic tests

The specimens used in the hydraulic tests (at least 5 specimens; circular shape) had a useful diameter (part exposed to the water flow) of 83.5 mm (value defined by the internal diameter of the equipment); this way, the specimens had an exposition area of

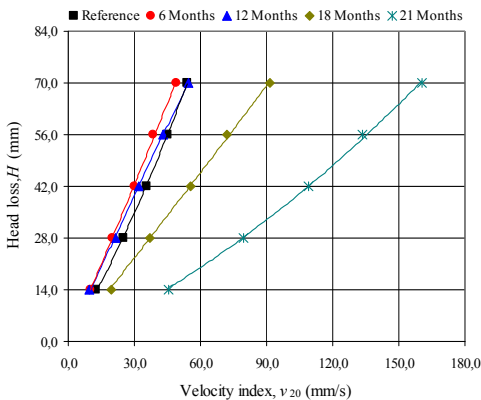
The hydraulic properties ( $v_{20}$  and  $\Psi$ ) of the GTX G0 suffered substantial changes during the 24 months of natural weathering (Figure 3 and Table 3).

Figure 3. Plot of  $H = f(v_{20})$  for geotextile G0, before and after the natural weathering tests (mean quadratic curves)

The  $v_{20}$   $H50$  of the GTX G0 had no major changes during the first 12 months of natural weathering ( $v_{20}$   $H50$  of 38.2 mm.s<sup>-1</sup> after 12 test-months).

The increase of the exposition time caused a great increase of the  $v_{20}$   $H50$  of the GTX G0. Indeed, after

21 test-months, the GTX G0 had a  $v_{20}$   $H50$  of 125 mm.s<sup>-1</sup> (after 18 months,  $v_{20}$   $H50$  of 65.3 mm.s<sup>-1</sup>).

This increase on the  $v_{20}$   $H50$  (and on the  $\Psi$   $H50$ ) can be attributed to the massive degradation suffered by the GTX G0 during the natural weathering tests.

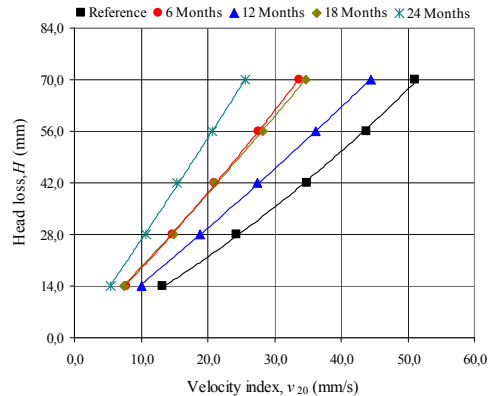
The  $v_{20}$  and the  $\Psi$  of the GTX G2 decreased after the natural weathering tests (Figure 4 and Table 4). After 24 test-months, the  $v_{20}$   $H50$  (18.5 mm.s<sup>-1</sup>) of the GTX G2 was reduced to about half of its original value (39.7 mm.s<sup>-1</sup>).

Figure 4. Plot of  $H = f(v_{20})$  for geotextile G2, before and after the natural weathering tests (mean quadratic curves)

The decrease of the  $v_{20}$   $H50$  and of the  $\Psi$   $H50$  can be ascribed to the dirt accumulated in the nonwoven structure of GTX G2. The dirt can fill up the inner empty spaces between the fibres, obstructing the water flow. Moreover, the thickness of the exposed specimens did not suffer a well-marked decrease (a substantial decrease in thickness would contribute for increasing the  $v_{20}$   $H50$  and the  $\Psi$   $H50$ ).

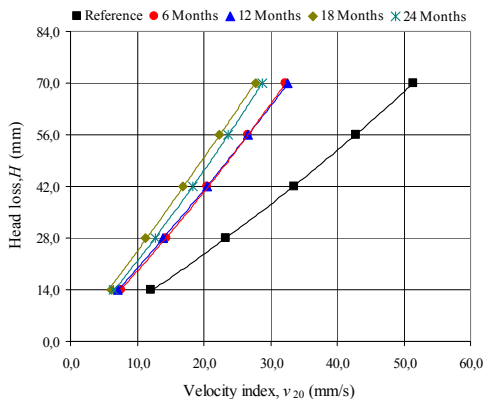
Similarly to what happened for the GTX G2, the  $v_{20}$  and the  $\Psi$  of the GTX G4 also decreased during the natural weathering tests (Figure 5 and Table 5). This

decrease can also be imputed to the dirt accumulated in the nonwoven structure.

Figure 5. Plot of  $H = f(v_{20})$  for geotextile G4, before and after the natural weathering tests (mean quadratic curves)

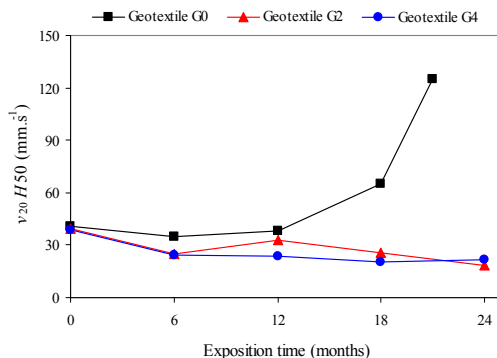
The 24-month outdoor exposition caused significant changes on the  $v_{20} H50$  of the nonwoven PP GTXs. However, the changes occurred on the GTXs G2 and G4 (stabilised with C944) differed significantly from the changes occurred on the GTX G0 (unstabilised) (Figure 6).

Figure 6. Evolution of the  $v_{20} H50$  of the nonwoven GTXs (with different mounts of C944) during the natural weathering tests

The damages occurred on the polymeric structure (loss of polymeric mass) of the GTX G0 during the exposition to natural weathering caused a significant increase on the  $v_{20} H50$ . The GTXs G2 and G4 had a higher weathering resistance (due to the presence of C944) than the GTX G0 and did not suffer a massive degradation. This way, the  $v_{20} H50$  (and the  $\Psi H50$ ) of these materials decreased due to the dirt clogged in their pores.

So, and in the lack of substantial damages (with a significant decrease on thickness and mass per unit area), the  $v_{20}$  (and the  $\Psi$ ) of nonwovens exposed to weathering will almost certainly decrease (due to the unavoidable dirt).
