Erosion control test plot in steep slopes at an amazonic rainforest highway

Keywords: indented surface, perforated geocellular confined system (IS&PGCS), slope erosion control

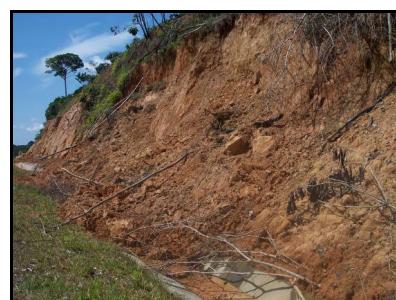
Photo 1 Sediments clogs side channels and culverts frequently.

The soil erosion produces considerable soil slides, which obstruct the ditches, overfilling them, and impounding the waters, forcing the water to flow aside the ditch, moistening the slope toe, which increases the soil loss and causing new soil slides, also causing the flooding of the highway damaging its structure.

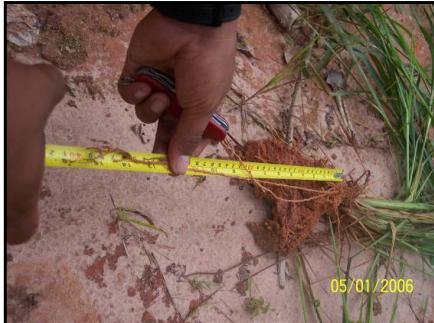
Photo 4 some species had roots length up to 40 centimeters.

The roots are strong with a good length covering all the spaces of the cell, and achieve penetration into the soil of the slope in depths superior to 10 centimeters (some measured species had roots length up to 40 centimeters, showing that at least 30 centimeters went through the natural slope for at least 30 centimeters), indicative of favorable conditions. The penetration of the roots into the natural slope would work as anchorage of the revegetated I&PGCS to the slope.

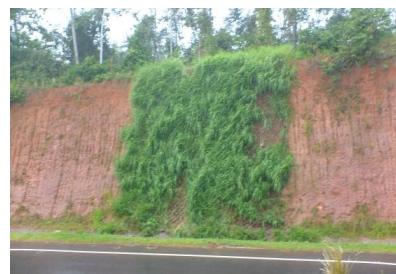
Photo 5 Final version of the project
